COLORADO DIVISION OF RECLAMATION, MINING AND SAFETY COAL PROGRAM INSPECTION REPORT

Permit Number: C-1980-006 Mine Name: Marr Mine Operator: Kerr Coal Company Operator Address: Mr. George Patterson C/O Energy Fuels Coal, Inc. P.O. Box 459 Florence, CO 81226	County: Jackson Operation Type: Surface Permit Status: Permanent Cessation Ownership: Federal
	Operator Representative Present: None
Operator Representative Signature: (Field Issuance Only)

Inspection Start Date: May 23, 2013 Inspection Start Time: 08:00 Inspection End Date: Inspection End Time:	Inspection Type: Coal Complete Inspection Inspection Reason: Normal I&E Program Weather: Clear
Joint Inspection Agency: None	Joint Inspection Contacts:
Post Inspection Agency: None	Post Inspection Contacts:
Inspector(s): Robert D. Zuber, P.E.	Inspector's Signature: <i>Robert D. Zuber</i> Signature Date: 5/24/2013

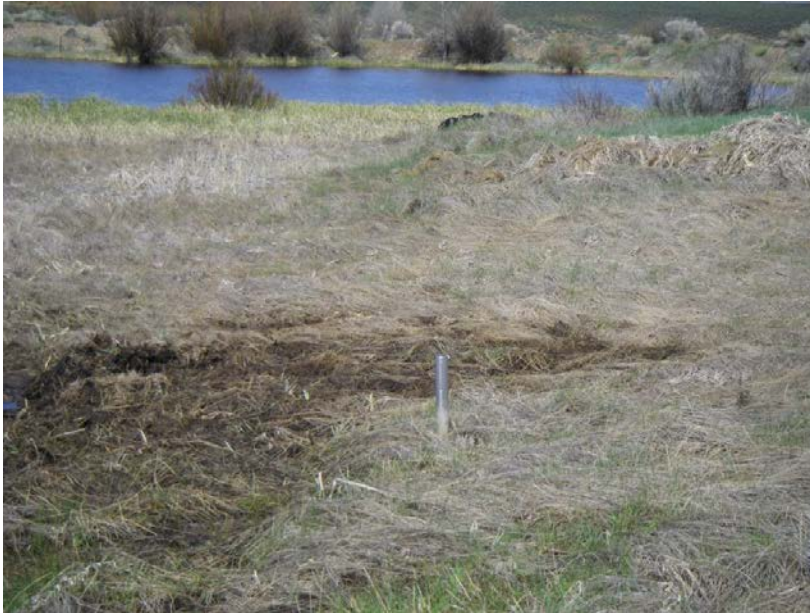
Well AP-1 appears to have been removed. There are tracks indicating that the site was recently accessed. Also, there is no PVC pipe visible. There is, however, an aluminum pipe sticking out of the ground. It is unclear if this was left to mark the site or for another reason. The Division will clarify this with Energy Fuels.

Area where Well AP-1 was located. Uncertainty regarding whether tube is marker.

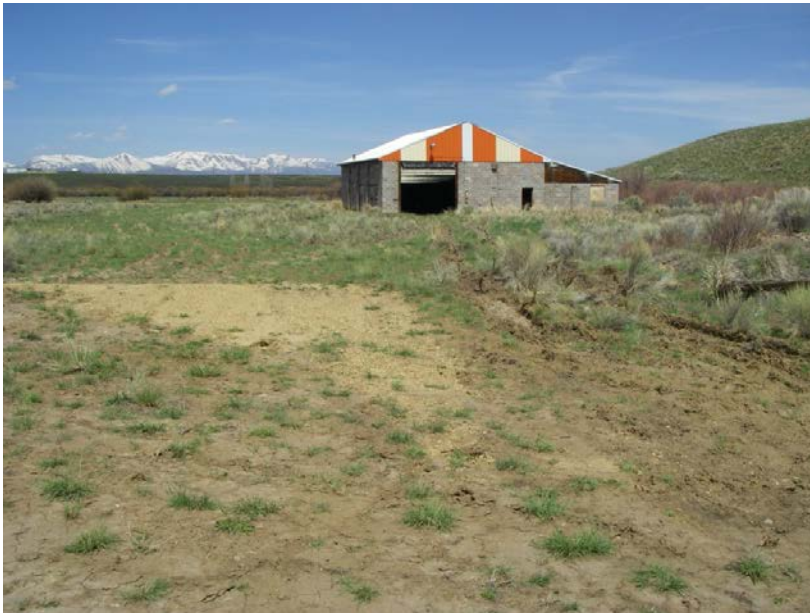
However, the reclaimed pond at the loadout (and the access area to this pond) has seen damage caused by trespassers. Several sets of tire tracks have cut gauges in the ground. From a point approximately 100 feet west of the entrance gate, the tracks begin. They extend to the garage door of the old shop building, and they also extend across the reclaimed pond area to the railroad grade. Most of the tracks are approximately four inches deep. Two areas have deeper gauges that are approximately a foot deep; these two areas are each approximately five feet wide by ten feet long. The overall disturbance caused by the tire tracks is approximately 600 feet long by 40 feet wide.

Damaged ground at loadout (from gate on east side of site)

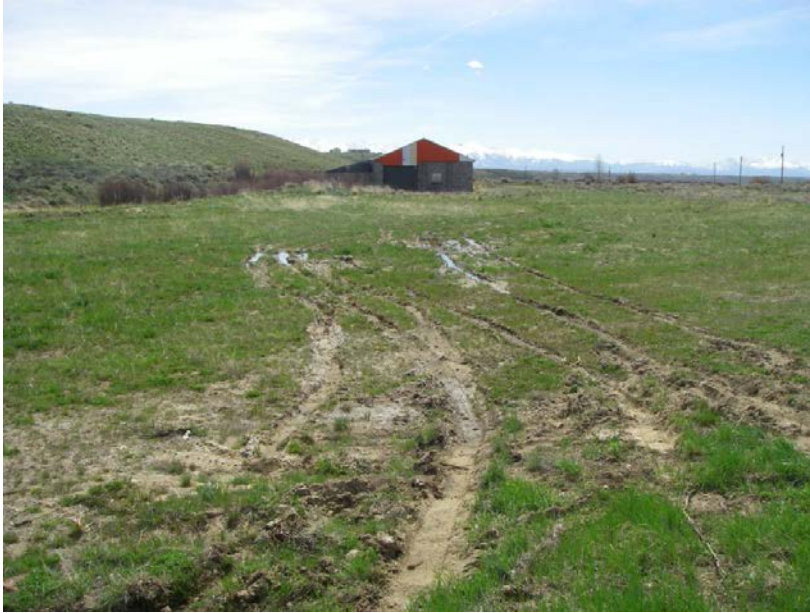
Damaged ground at loadout (from railroad embankment on west side of site)

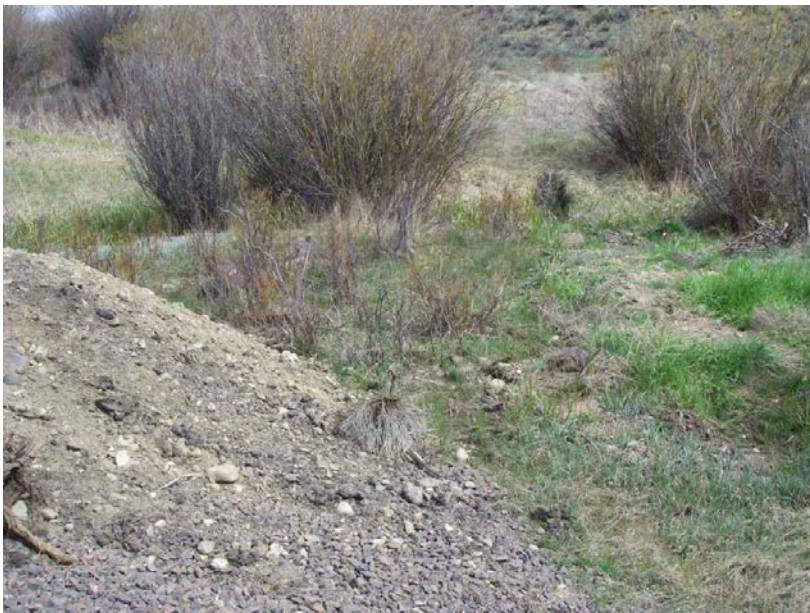
The Best Management Practices for sediment control from the reclaimed pond area at the loadout have been removed. The area has good vegetation except the small part of bare ground next to the railroad embankment. There is no signs of sediment having been transported into the receiving water.

Area at loadout where BMPs were removed

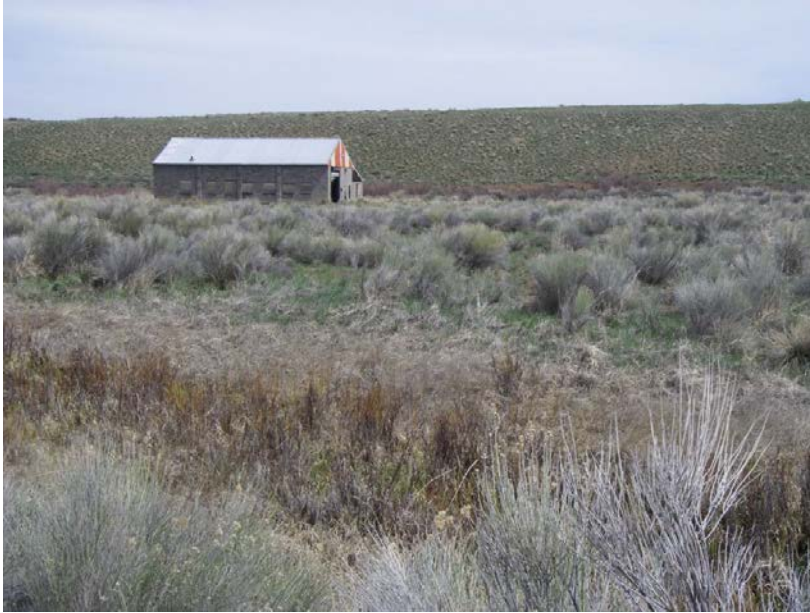
Area at loadout where no damage was incurred (looking north)

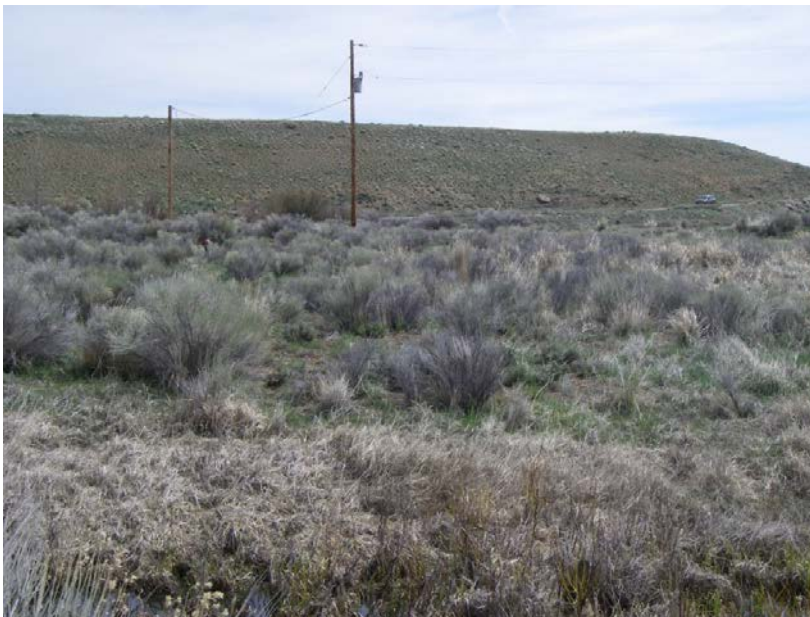
Area at loadout where no damage was incurred (looking northeast)

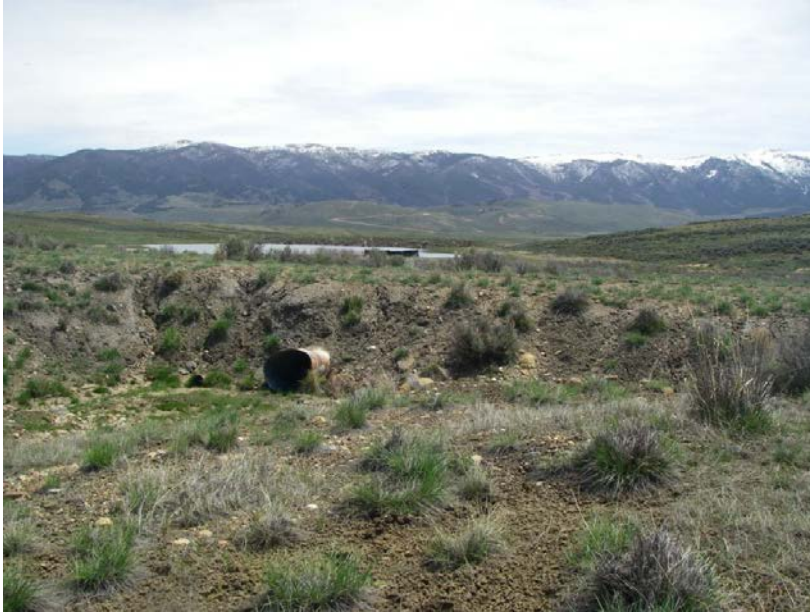
At the mine site, no significant problems were observed with the culverts. At the south culvert, the smaller pipe is almost completely covered with sediment at the downstream end. However, there is no sign of erosion or other problems with the road at this point.

Mine site – south culvert and road

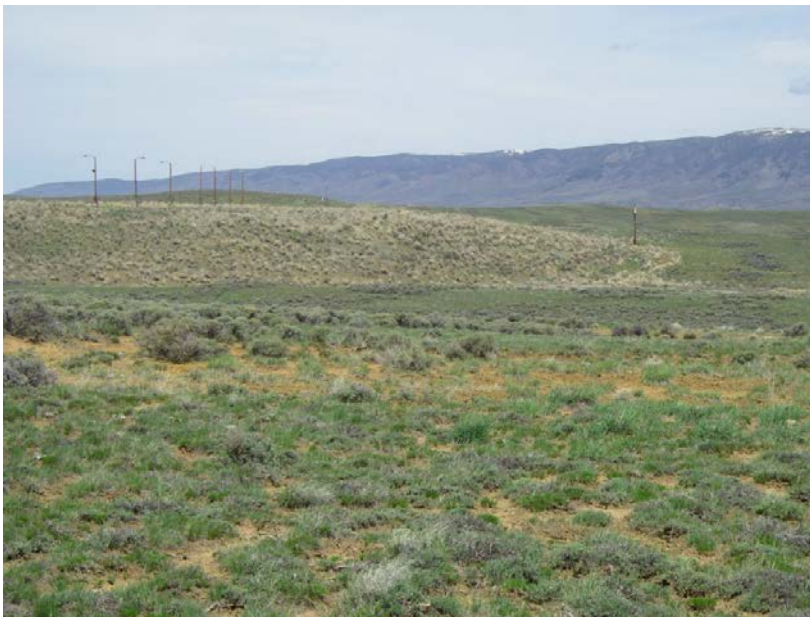
Mine site – 4-acre parcel to north (from south parcel)
