## COLORADO DIVISION OF RECLAMATION, MINING AND SAFETY COAL PROGRAM INSPECTION REPORT

<b>Permit Number:</b> C-1992-080 <b>Mine Name:</b> Carbon Junction Mine <b>Operator:</b> Oakridge Energy, Inc. <b>Operator Address:</b> Mr. Michael S. Savage 4610 Haystack Drive Windsor, CO 80550	<b>County:</b> La Plata <b>Operation Type:</b> Surface <b>Permit Status:</b> Inactive <b>Ownership:</b> Private
	<b>Operator Representative Present:</b>  None
<b>Operator Representative Signature: (Field Issuance Only)</b>  This report was issued electronically from the Division's Durango Field Office.

<b>Inspection Start Date:</b> April 30, 2013 <b>Inspection Start Time:</b> 09:40 <b>Inspection End Date:</b> April 30, 2013 <b>Inspection End Time:</b> 14:25	<b>Inspection Type:</b> Coal Partial Inspection <b>Inspection Reason:</b> OSM Special Focus <b>Weather:</b> Windy
<b>Joint Inspection Agency:</b>  OSM	<b>Joint Inspection Contacts:</b> Elizabeth Shaeffer Joe Wilcox Howard Strand Spencer Shumate
<b>Post Inspection Agency:</b>  None	<b>Post Inspection Contacts:</b>
<b>Inspector(s):</b>  Marcia L. Talvitie, P.E.  Sandra L. Brown	<b>Inspector's Signature:</b>

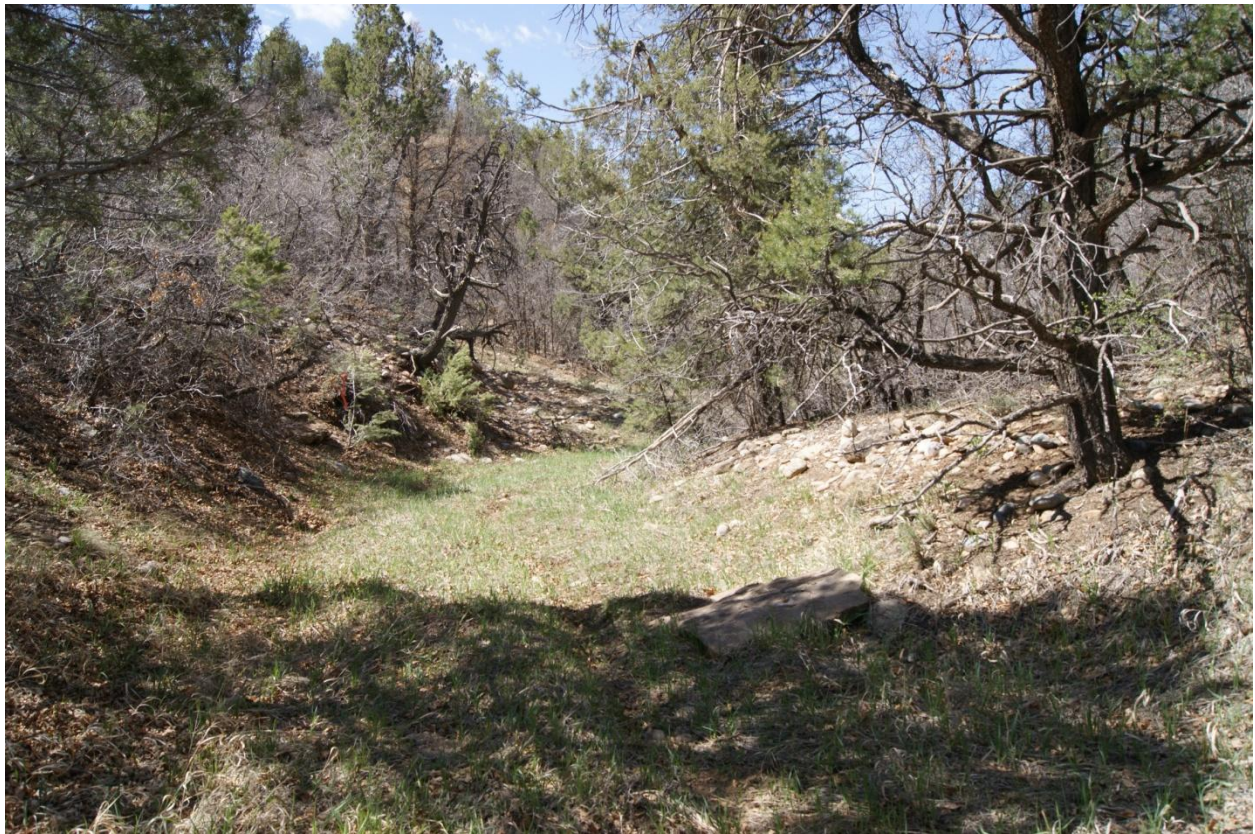
Undisturbed Carbon Junction channel, downstream of permanent diversion

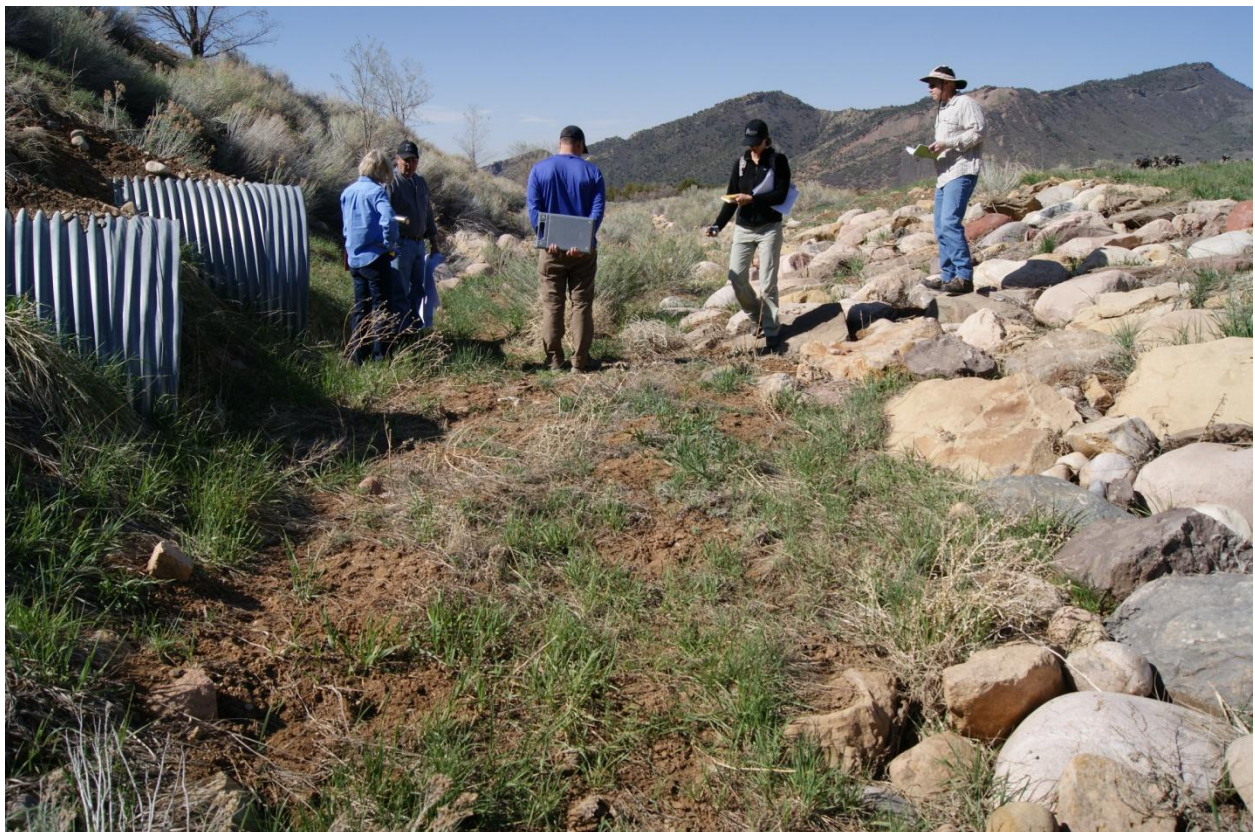
The permanent diversion channel was stable; however, certain field measurements indicate that the channel was not constructed as designed:

- The riprap size was frequently coarser than what was required.
- For the culvert crossing of the permanent haul road (Segment 4), the design called for a single pipe arch culvert, whereas twin 66" CMPs were installed. An as-built design for the twin culverts was submitted in May 2007; however, the design was not revised in the permit.

Permanent diversion channel at outlet of twin 66" CMPs

Submit a complete Technical Revision to the permit that accurately represents the as-built configuration of the Carbon Junction Permanent Diversion, with supporting design details per Rule 4.05.3. This revision shall also include an updated, accurate post-mining topography map for the entire permit area and a map delineating the Carbon Junction drainage area.

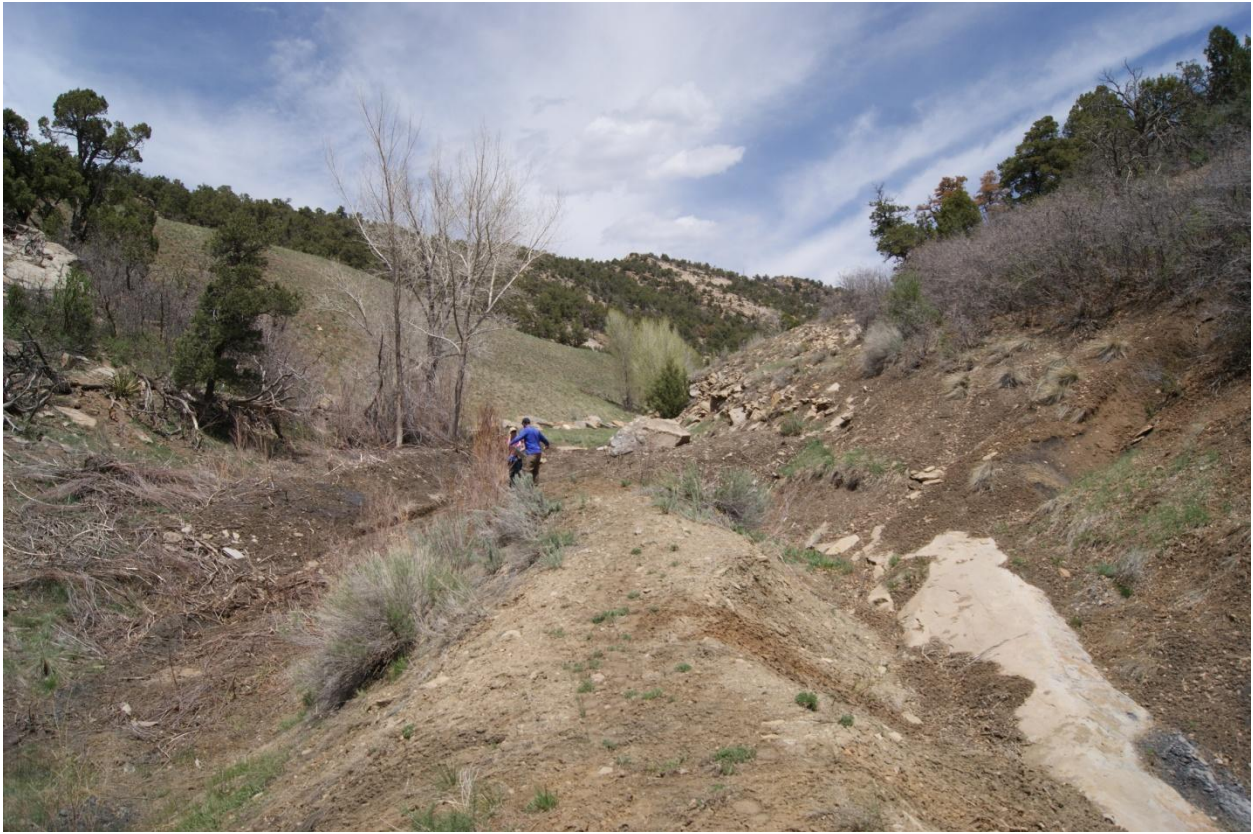
- At the location where the diversion berm was breached in the fall of 2012, the profile of the channel is significantly steeper than what exists both upstream and downstream. Head-cutting of the channel could potentially result from this nick point.

View upstream from remnant diversion berm; breach to CJ channel on L, diversion channel on R

Abatement Description: Submit a complete Technical Revision to the permit that presents designs and plans for reestablishment of the Upper Carbon Junction Channel, including the un-named tributary that enters the drainage from the east, and reclamation and stabilization of the Carbon Junction Temporary Diversion and gully erosion. [The Upper Carbon Junction channel segment runs from the undisturbed channel upstream of the North Pit down to the beginning of the rip-rapped Carbon Junction Permanent Diversion, a distance of approximately 1900 feet.]

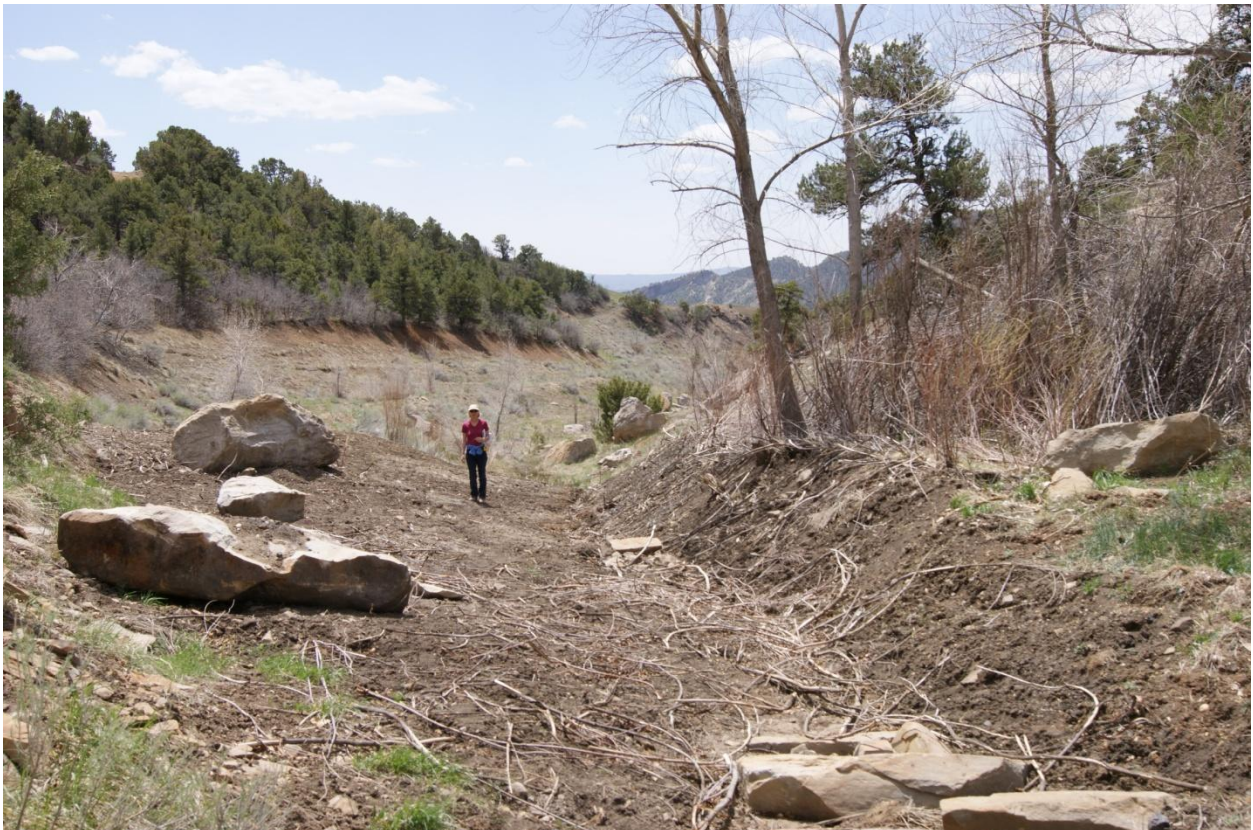
Looking downstream through breached diversion berm
