COLORADO DIVISION OF RECLAMATION, MINING AND SAFETY COAL PROGRAM INSPECTION REPORT

Permit Number: C-1983-059 Mine Name: Terror Creek Loadout Operator: Terror Creek LLC Operator Address: Mr James A Kiger P.O. Box 535 3737 Highway 133 Somerset, CO 81434	County: Delta Operation Type: Loadout Permit Status: Active Ownership: Private
	Operator Representative Present: Jim Kiger
Operator Representative Signature: (Field Issuance Only)

Inspection Start Date: May 21, 2013 Inspection Start Time: 13:30 Inspection End Date: May 21, 2013 Inspection End Time: 15:30	Inspection Type: Coal Partial Inspection Inspection Reason: Normal I&E Program Weather: Clear	
Joint Inspection Agency: None	Joint Inspection Contacts:	
Post Inspection Agency: None	Post Inspection Contacts:	
Inspector(s): Leigh D. Simmons Daniel I. Hernandez	Inspector's Signature:

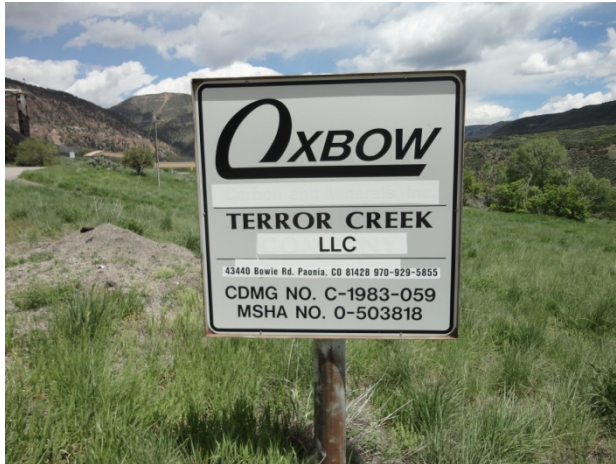
Mine ID signs were in place at both entrances to the site, and were in compliance with the specifications described by rule 4.02.2.

Photo 1: Mine ID sign

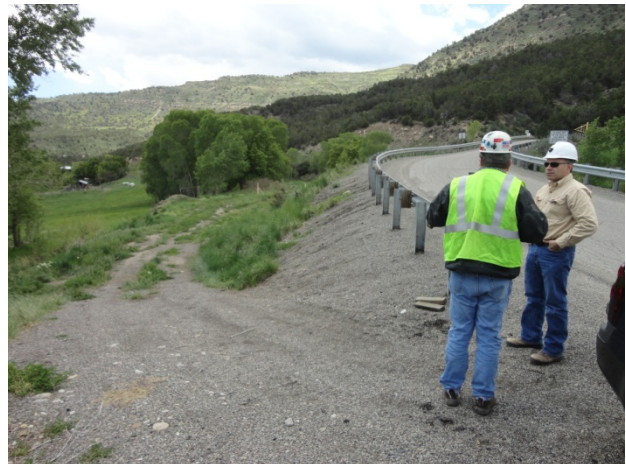
As has been described in previous inspection reports, the newly positioned access gate on the haul road

remains the subject of a dispute with the neighboring landowner to the west. The gate was open at the time of the inspection, and the haul road was in good condition.

Photo 2: Neighboring land owner access from Terror Creek haul road

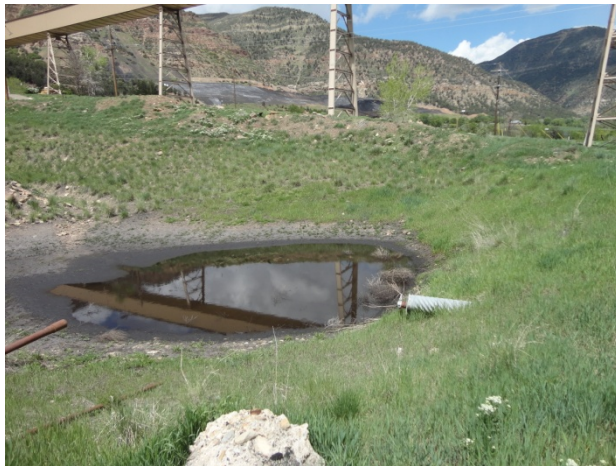
The main sediment pond at the eastern end of the site was holding water, although well below the discharge point. The embankment and both spillways of the pond appeared to be in good order. A valve at the inlet to the primary spillway was closed.

Photo 3: Sediment pond

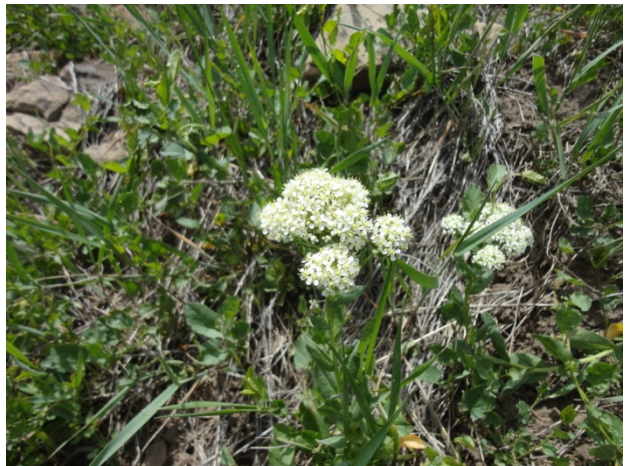
The site was generally well vegetated. Woods Rose, Cicer Milkvetch and Asparagus were among the species observed. Noxious weeds were not dominant in any areas of the site, although Whitetop/Hoary Cress (*Cardaria Draba*) and what appeared to be Musk Thistle (*Carduus Nutans*) were both observed. These are list B species and should be carefully monitored and controlled. Mr Kiger explained that weeds would be controlled by spraying.

Photo 4: Whitetop

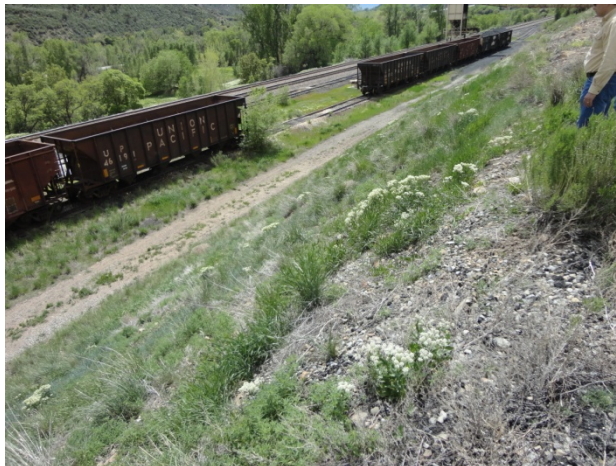
Photo Whitetop on embankment of railroad SAE

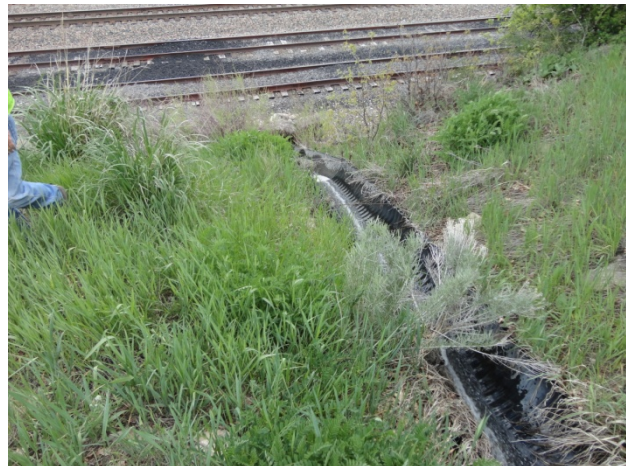
An open half culvert at the western end of the site was flowing with water, which appeared to be conveyed across the Fire Mountain Canal and the Terror Creek site from north of the permit area. It did not appear to convey any run-off from any of the Terror Creek disturbance.

Photo 6: Half culvert conveying water across site

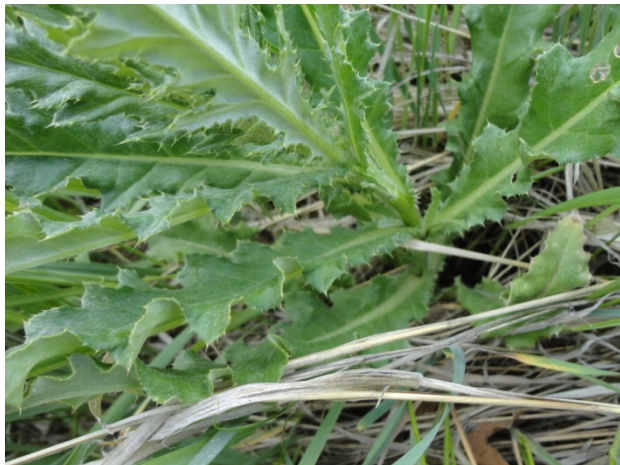
Photo 7: Musk Thistle

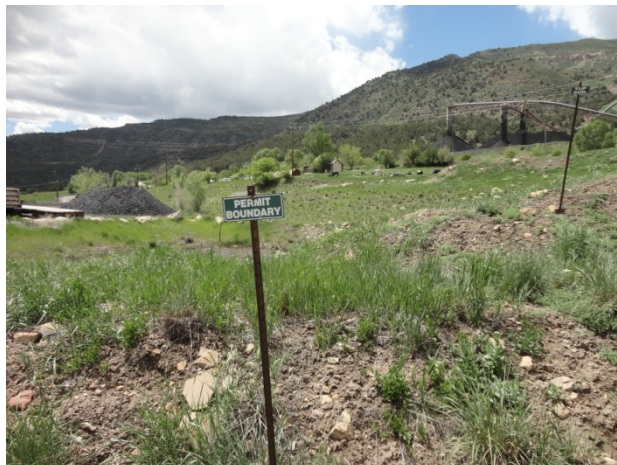
Permit boundary signs were in place and clearly visible.

Photo 8: Permit boundary marker

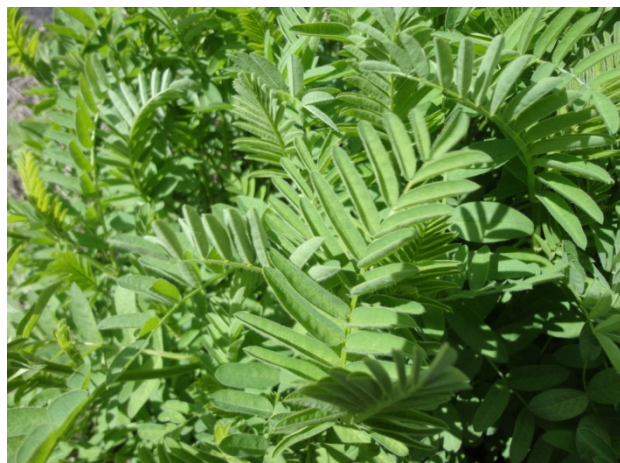
Photo 9: Cicer Milkvetch

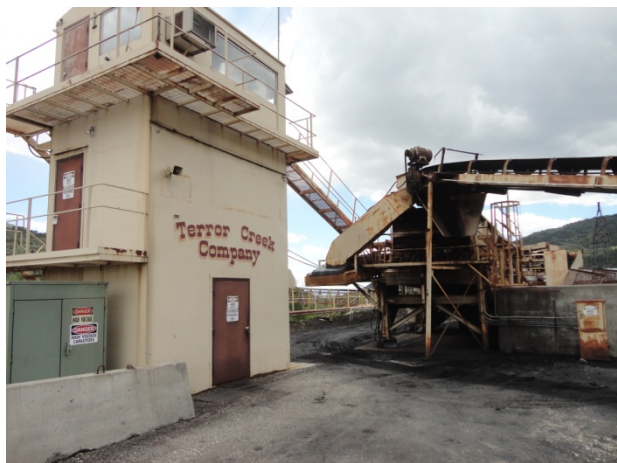
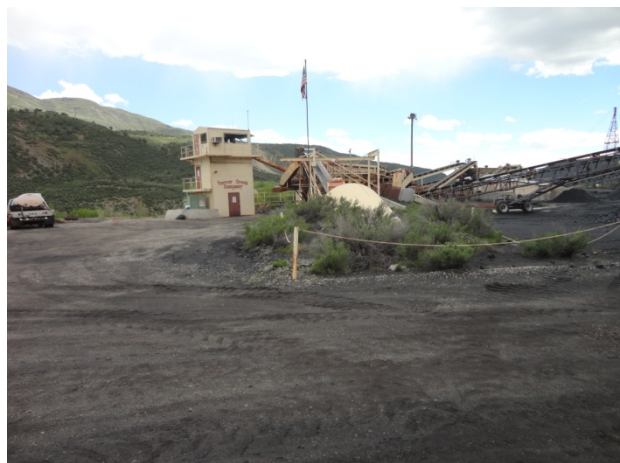
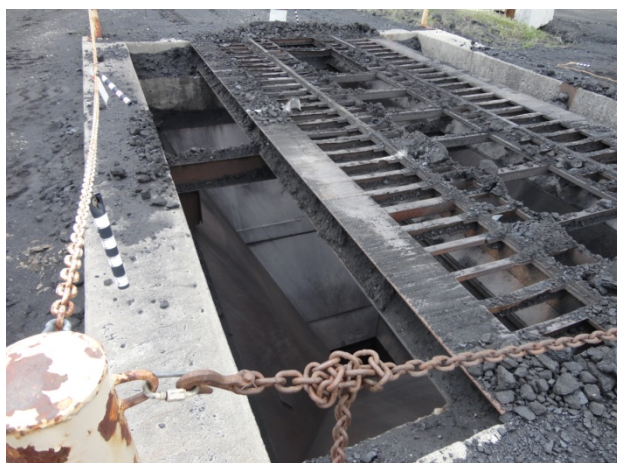
Terror Creek continues to lease facilities within the permit area to a private trucking company. This is in compliance with the operation plan described in the permit.

Photo 10: Facilities (1)

Photo 10: Facilities (2)

Photo 10: Facilities (3)
