**COLORADO DIVISION OF RECLAMATION, MINING AND SAFETY  
COAL PROGRAM INSPECTION REPORT**

<b>Permit Number:</b> C-1981-018 <b>Mine Name:</b> Deserado Mine <b>Operator:</b> Blue Mountain Energy, Inc <b>Operator Address:</b> Mr Scott Wanstedt 3607 County Road 65 Rangely, CO 81648	<b>County:</b> Rio Blanco <b>Operation Type:</b> Underground <b>Permit Status:</b> Active <b>Ownership:</b> Federal
	<b>Operator Representative Present:</b>  Scott Wanstedt
<b>Operator Representative Signature: (Field Issuance Only)</b>

<b>Inspection Start Date:</b> May 22, 2013 <b>Inspection Start Time:</b> 09:30 <b>Inspection End Date:</b> May 22, 2013 <b>Inspection End Time:</b> 13:30	<b>Inspection Type:</b> Coal Partial Inspection <b>Inspection Reason:</b> Normal I&E Program <b>Weather:</b> Clear
<b>Joint Inspection Agency:</b>  None	<b>Joint Inspection Contacts:</b>  None
<b>Post Inspection Agency:</b>  None	<b>Post Inspection Contacts:</b>  None
<b>Inspector(s):</b>  Janet H. Binns  Zach T. Trujillo	<b>Inspector's Signature:</b>

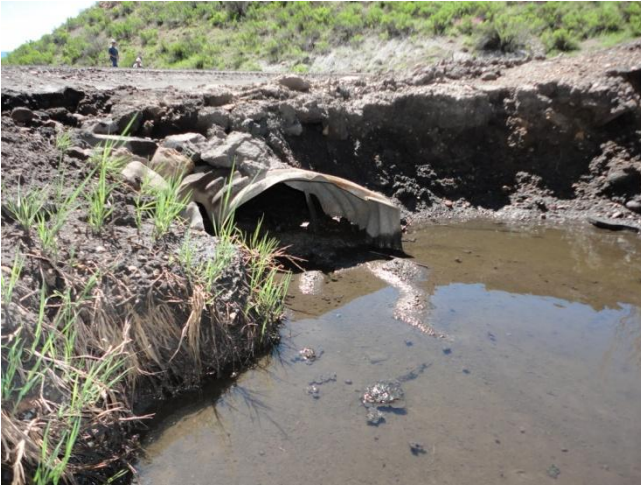
The culvert just south of the refuse bin and truck loadout needs to be cleaned out. The inlet was roughly 50% full

of sediment.

Culvert south of truck loadout.

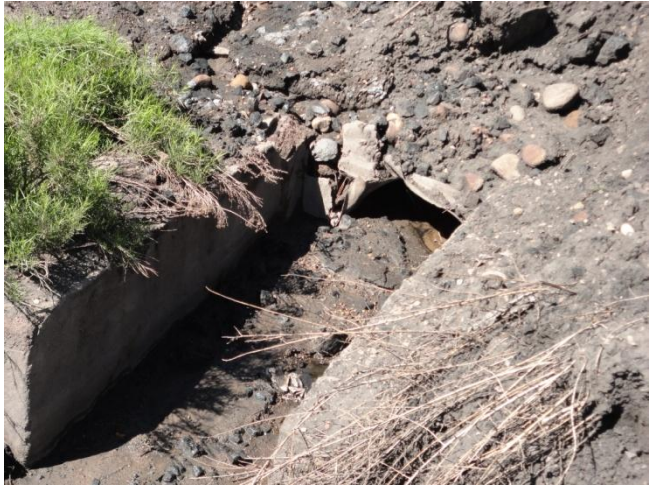
The culvert outlet beneath the access road to the Moon Lake Substation needs to be cleaned along the outlet. The outlet was roughly 75% full of sediment.

Culvert below access road to Moon Lake Substation.

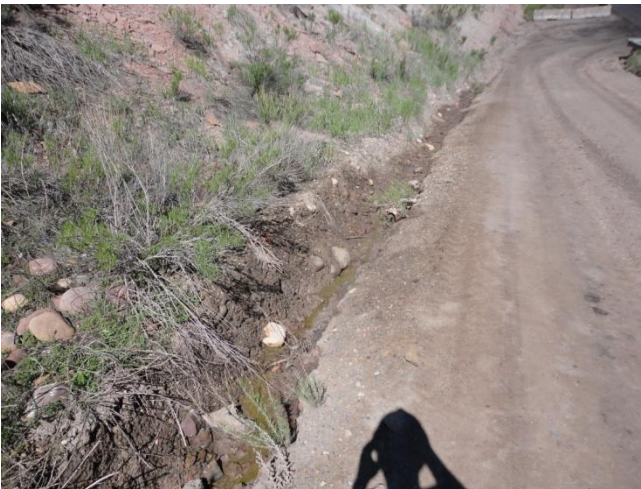
A damp spot was observed on the hillside below the process water pond (PP-2). Water was seeping into the ditch. This site should be monitored to observe if it dries up during the season.

Runoff created by damp section below Pond PP-2.

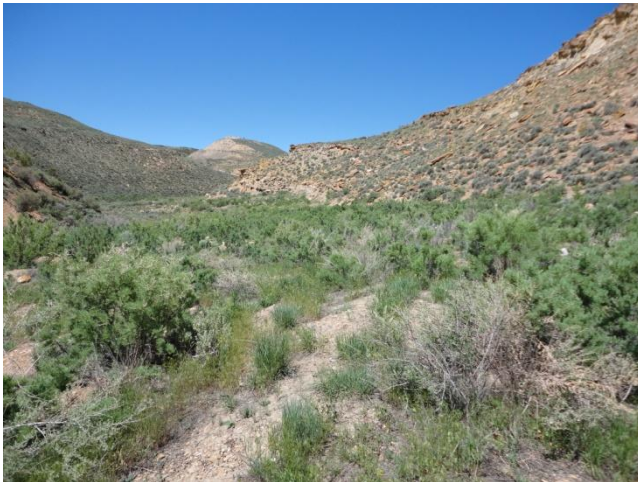
East portal reclamation vegetation is good along the reclaimed access road. At the reclaimed East Portal area there is an increase in Cheatgrass as well as greasewood, 4-wing saltbrush, Forage kochia, and Russian wildrye. The Inspector discussed options for management of the Cheatgrass in portal area with the operator. Implementation of BME's weed management plan in specific spots is an option. The Division has prepared a technical bulletin regarding management of Japanese brome and Cheatgrass. This bulletin is available on the Division's website: <http://mining.state.co.us/Programs/Coal/Pages/HelpfulLinks.aspx> "Data/Documents" "Cheatgrass Technical Bulletin".

Other than the Cheatgrass in specific areas, the East portal reclamation appears stable and the vegetation well established.

East portal reclamation looking to NW.

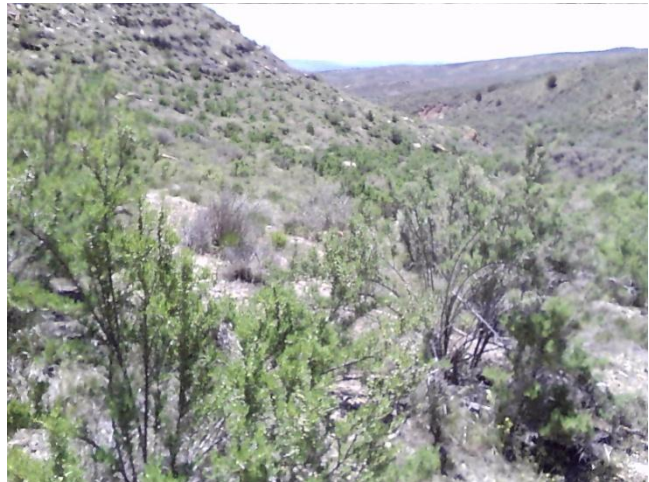
East portal reclamation looking to SE

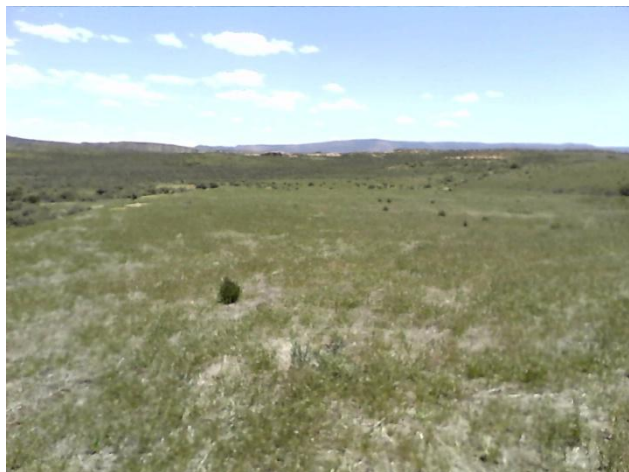
Topsoil stockpile RP-2/3

RP 2/3 Topsoil pile has fairly consistent stand of Cheatgrass on the north east side. Scott said he sprayed Roundup on this area in the spring 8-10 years ago. The Cheatgrass came back. The southern and western portions of the pile have a good wheatgrass stand. The north and east extent of the RP 2/3 topsoil stockpile is predominately Cheatgrass. The operator said he has had success seeding forage Kochia into Cheatgrass stands.

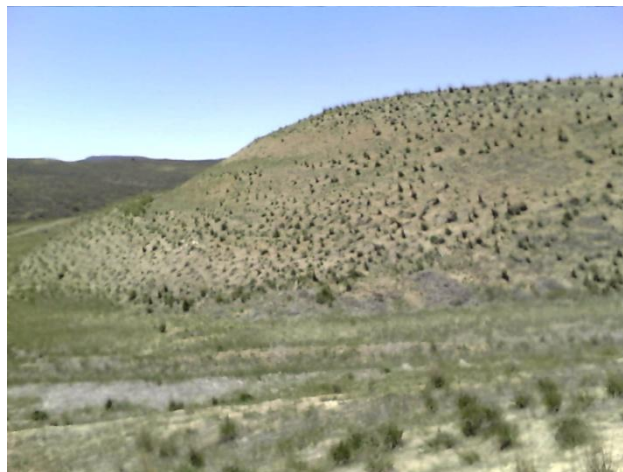
east slope of Subsoil stockpile RP-5A

Subsoil stockpile RP-5A (map 77A) had a good stand of perennial grasses. No problems were noted on the RP-5A subsoil stockpile.

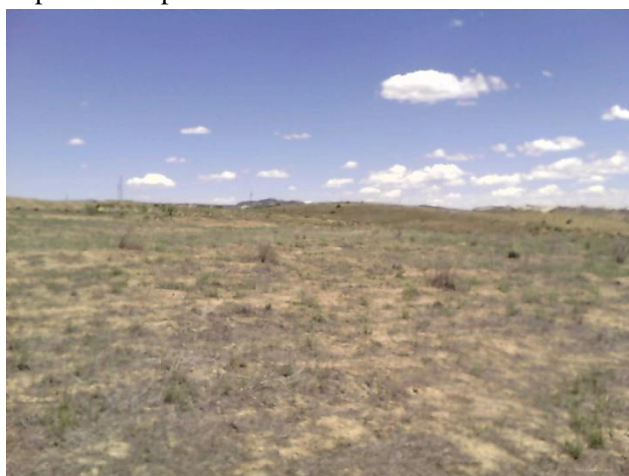
Top of topsoil stockpile RP-5A

Topsoil Stockpile RP-5A exhibited a poor stand of vegetation predominately composed of Cheatgrass. However, the Cheatgrass provided vegetative cover and litter cover. The pile was not eroding. Very little cover was attributed to perennial grasses. The out slopes of Topsoil Stockpile RP-5A rather bare, though not eroding.

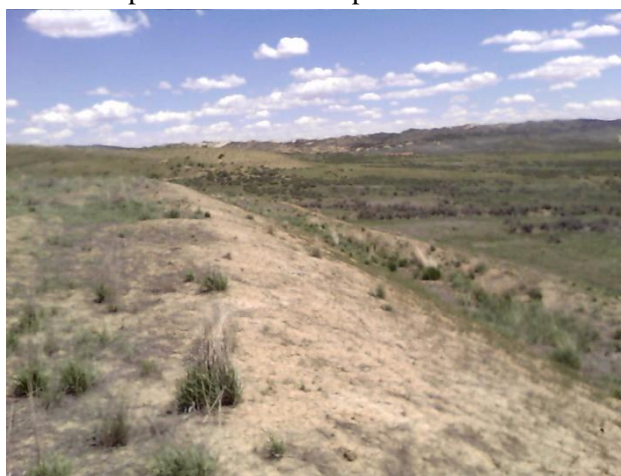
Outslope (south) of topsoil stockpile RP-5A

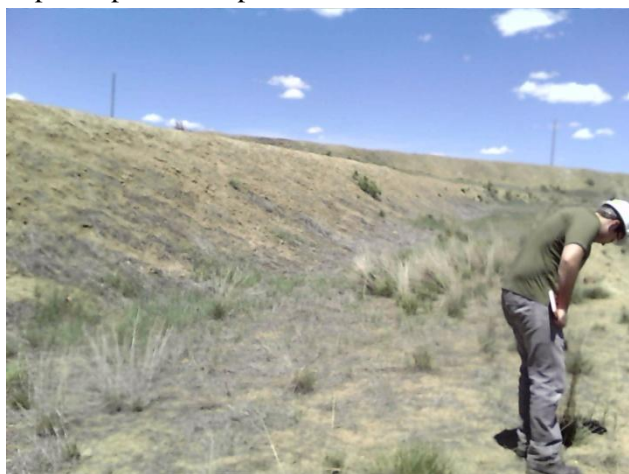
Eastern slope of subsoil stockpile RP-4

Subsoil stockpile RP-4 has excellent perennial grass cover, composed predominately of wheatgrasses and Russian wildrye.

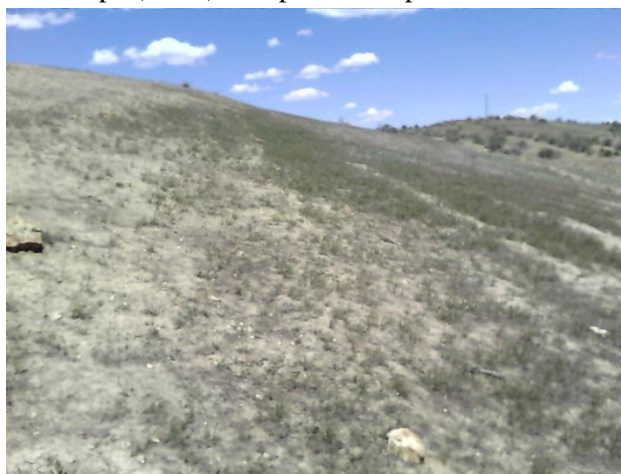
Outslope of topsoil stockpile RP-4

Topsoil stockpile RP-4 west side has good perennial cover. The east side of this pile is mostly Cheatgrass, (photo)

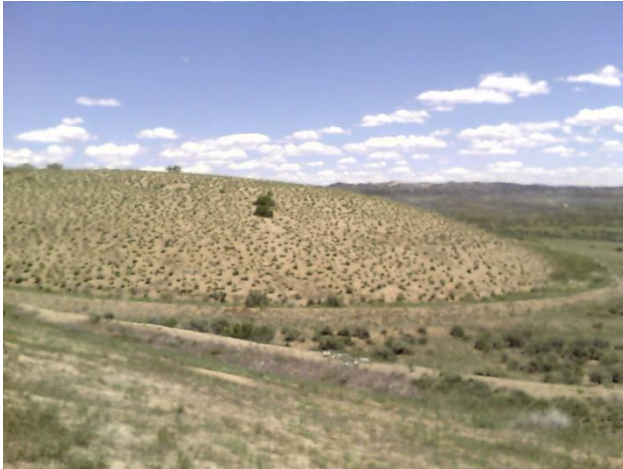
Western slope of Subsoil stockpile RP-2/3

Subsoil Stockpile RP-2/3 has a fair cover of bunchgrass. Subsoil Stockpile -2/3 did have some cheat in open areas between the bunchgrasses. There is a small amount of sediment transport in these open areas, though minimal. Western wheatgrass and Russian wildrye were prevalent on this stockpile.

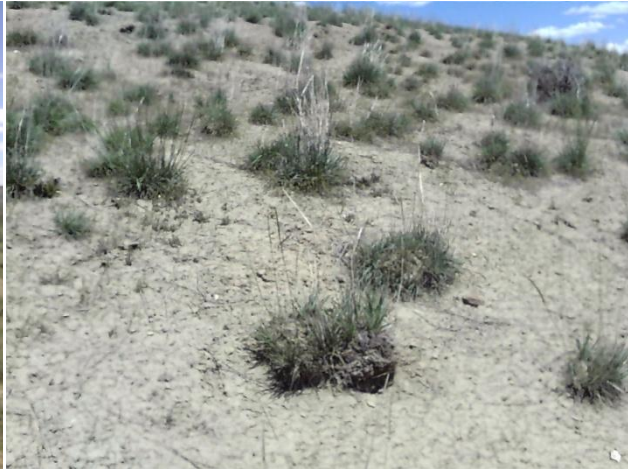
Open ground between bunch grasses on Subsoil RP-2/3  
Some sediment transport down slope is visible.
