**COLORADO DIVISION OF RECLAMATION, MINING AND SAFETY
COAL PROGRAM INSPECTION REPORT**

Permit Number: C-1981-044 Mine Name: Williams Fork Mines Operator: Moffat County Mining, LLC Operator Address: Mr. Jason Davis 29515 Routt County Road #27 Oak Creek, CO 80467	County: Moffat Operation Type: Underground Permit Status: Active Ownership: Federal
	Operator Representative Present: Brian Watterson
Operator Representative Signature: (Field Issuance Only)

Inspection Start Date: May 23, 2013 Inspection Start Time: 10:00 Inspection End Date: May 23, 2013 Inspection End Time: 12:00	Inspection Type: Coal Partial Inspection Inspection Reason: Normal I&E Program Weather: Clear
Joint Inspection Agency: None	Joint Inspection Contacts: None
Post Inspection Agency: None	Post Inspection Contacts: None
Inspector(s): Zach T. Trujillo	Inspector's Signature:

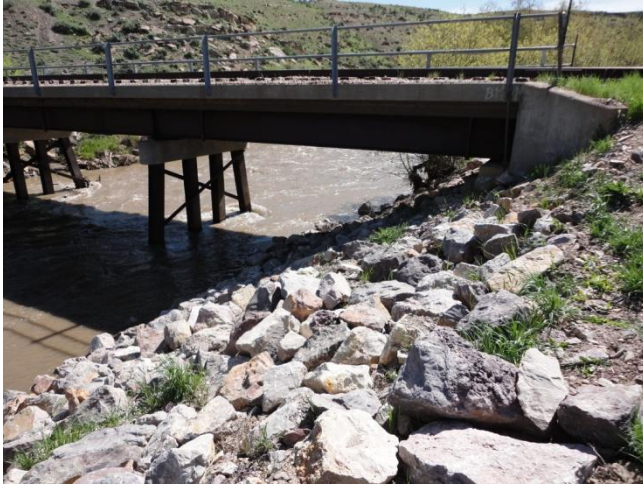
Recent snow melt has increased the flow of the Williams Fork River. In 2011, maintenance was performed beneath the rail road spur bridge due to undercutting of the foundation of the bridge from the river. The maintenance performed remains stable. No additional cutting or erosion was observed.

Maintenance from 2011 river undercut.

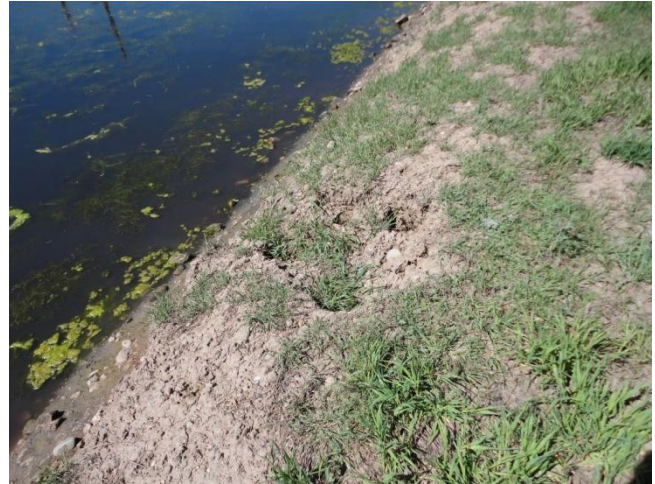
The Mine No. 5 dewatering pump was not operating at the time of the inspection. Ponds 5-P5, 5-P6 and 5-P7 all held water minimal water with no discharge. The mine dewatering pump will remain off until temperature gauges have been installed. The temperature gauges are to be installed as per request of CDPHE. Brian Watterson stated that Moffat County Mining has until August 1st to install the temperature gauges. All embankments of Ponds 5-P5, 5-P6 and 5-P7 were stable. Maintenance to the northern embankment of Pond 5-P7 is still needed from the rodent holes. Additionally, some slumping has occurred along the same embankment and is in need of repair.

Slumping along Pond 5-P7 embankment.

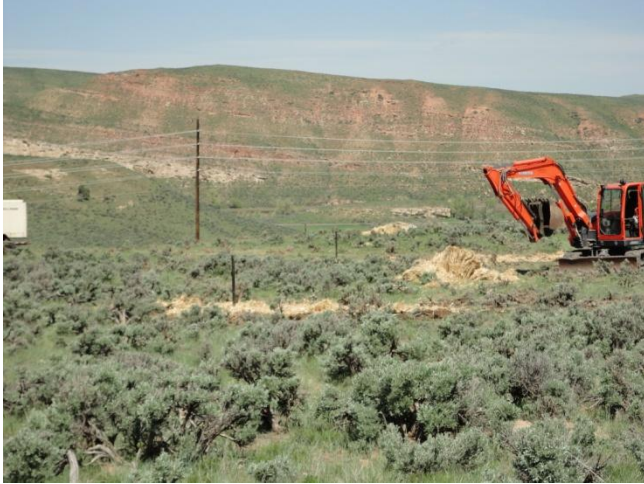
It appears investigative drilling had been conducted along the ridge east of Highway 13 by the Colorado Division of Reclamation, Mining and Safety - Abandoned Mine Lands (DRMS - AML) prior to the inspection. DRMS - AML has been conducting investigative drilling to learn the extent of an underground coal seam fire within the historic Wise Hill No. 3 Mine. A small crew was spreading hay along the drill pad sites for erosion control. As a pre-law mine, Moffat County Mining has no direct responsibility or liability for the Wise Hill No. 3 Mine fire.

Dill pads from investigative drilling.

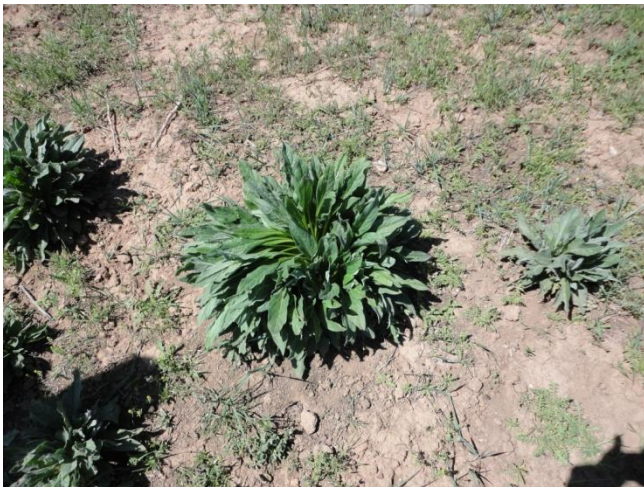
Thistle and houndstongue were observed south of pond 9-P8 along the topsoil pile and will need to be sprayed once the annual weed spraying occurs.

Houndstongue along topsoil pile.
