**COLORADO DIVISION OF RECLAMATION, MINING AND SAFETY
COAL PROGRAM INSPECTION REPORT**

| Permit Number: C-1982-056 Mine Name: Foidel Creek Mine Operator: Twentymile Coal, LLC Operator Address: Mr Jerry Nettleton 29515 Routt County Road No. 27 Oak Creek, CO 80467 | County: Routt Operation Type: Underground Permit Status: Active Ownership: Federal |

| Inspection Start Date: May 29, 2013 Inspection Start Time: 09:00 Inspection End Date: May 29, 2013 Inspection End Time: 12:45 | Inspection Type: Coal Partial Inspection Inspection Reason: Surety Release Requested Weather: Raining |

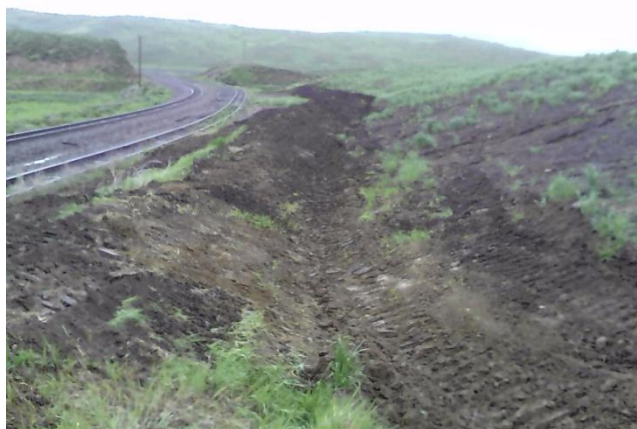
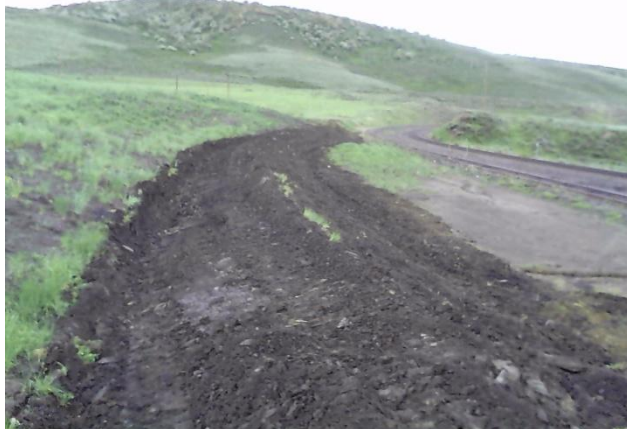
Fish Creek Tipple West Collection Ditch

- The west side of the Fish creek Tipple pad outslope above the containment ditch displayed small rills throughout. These rills are not substantial, but will require monitoring and maintenance if additional down-cutting is observed.

- The Fish Creek Tipple reclamation will require inter-seeding on the recently repaired collection ditch.
- Whitetop, houndstongue rosettes, and thistle were starting to establish at the reclaimed topsoil footprint and the Fish Creek Tipple Pad.

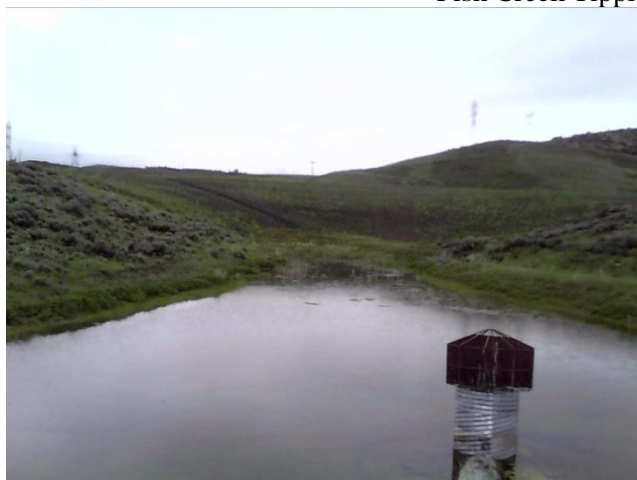
Fish Creek Tipple Pond

- The outslope of the Fish Creek Tipple pad above the Fish Creek Tipple Sedimentation Pond displayed minimal rills.
- The two erosion control fabric lined ditches to the east and the west of the FCT Pond were stable. Heavy sediment buildup at the outlets of these established ditches was observed. This sediment build-up is expected due to the recent reclamation of the site. The FCT Pond was discharging at the time of the inspection and both the water in the pond and the discharge was clear at the time of the inspection.

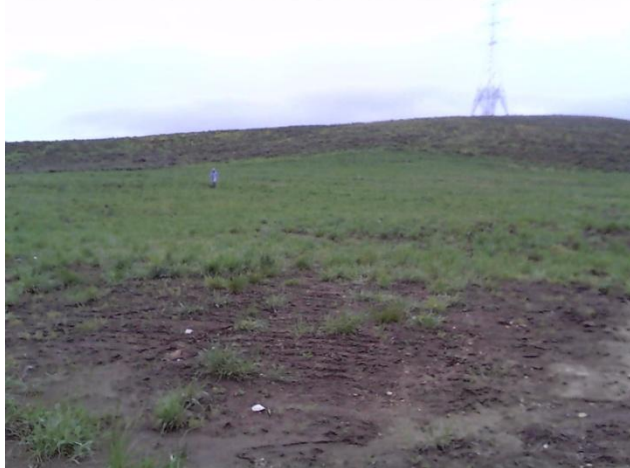
18 Right Vent Shaft Pad

Disturb area markers were in place at the 18RT reclamation area.

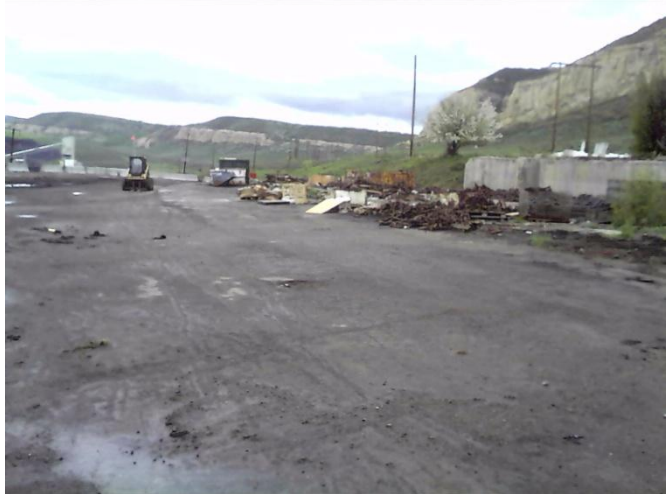
Area of "Brown Palace"

Although not a criterion for Phase 1 bond release, all requested bond release sites have been reseeded with the exception of the "Brown Palace" location. All sites displayed good vegetation establishment with no problems noted, with the exception of the following:

Although not a criteria for Phase 1 bond release, all requested sites have had topsoil replaced and seeded with the exception of the "Brown Palace" location. Topsoil depths were not verified during this inspection as depths were measured previously. Records are available at the Division offices and at the Foidel Creek Mine site. No problems were noted with topsoil at the time of the inspection.
