## COLORADO DIVISION OF RECLAMATION, MINING AND SAFETY COAL PROGRAM INSPECTION REPORT

<b>Permit Number:</b> C-1981-035 <b>Mine Name:</b> King Coal Mine <b>Operator:</b> GCC Energy, LLC <b>Operator Address:</b>  Mr. Tom Bird 6473 County Road 120 Hesperus, CO 81326	<b>County:</b> La Plata <b>Operation Type:</b> Underground <b>Permit Status:</b> Active <b>Ownership:</b> Federal
	<b>Operator Representative Present:</b>  Wade Wymore
<b>Operator Representative Signature: (Field Issuance Only)</b>  This report was issued electronically from the Division's Durango Field Office.

<b>Inspection Start Date:</b> May 29, 2013 <b>Inspection Start Time:</b> 12:20 <b>Inspection End Date:</b> May 29, 2013 <b>Inspection End Time:</b> 15:30		<b>Inspection Type:</b> Coal Complete Inspection <b>Inspection Reason:</b> Normal I&E Program <b>Weather:</b> Clear	
<b>Joint Inspection Agency:</b>  None		<b>Joint Inspection Contacts:</b>	
<b>Post Inspection Agency:</b>  None		<b>Post Inspection Contacts:</b>	
<b>Inspector(s):</b>  Marcia L. Talvitie, P.E.	<b>Inspector's Signature:</b>

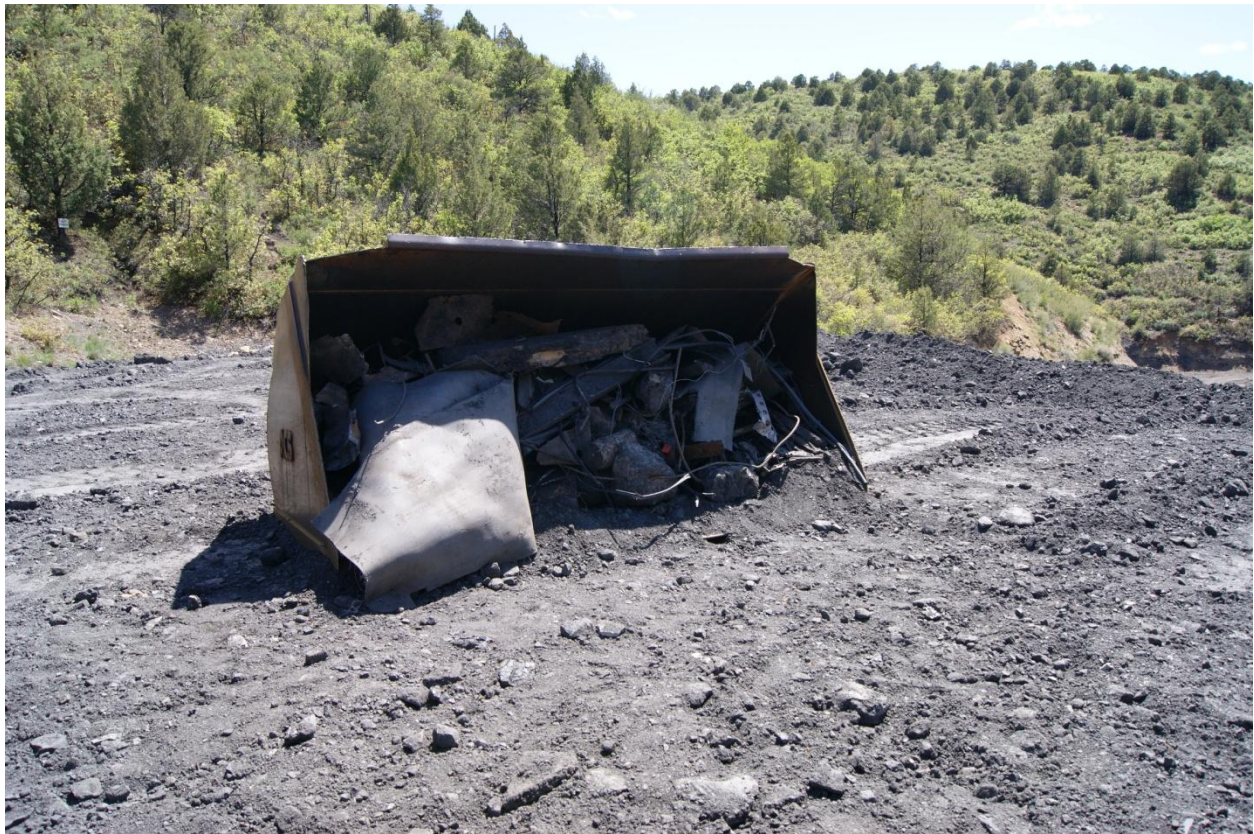
- During the April 2013 inspection, the Division had observed that there were a number of non-coal waste items (metal and some wood) protruding from the top surface of the refuse pile. A conscientious effort has since been made to collect those materials in a single location (presently a loader bucket – Photo 1) for disposal in an appropriate manner. As we walked across the pile, we saw a few extraneous objects that still remain to be gathered for removal. The condition has dramatically improved, however, over what was observed previously.

Photo 1 – Collection of non-coal waste from refuse pile

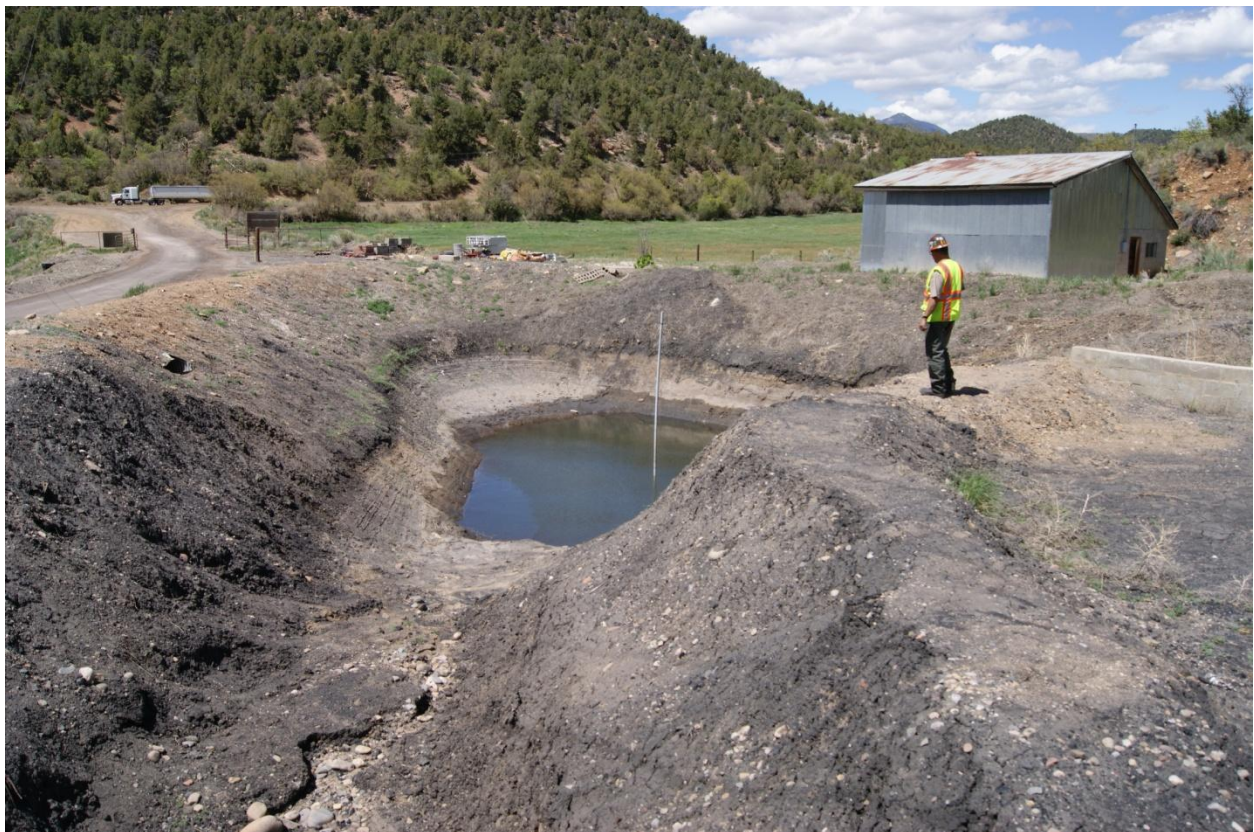
- No significant precipitation has been received during the month of May, and the ground surface throughout the region is dry except where irrigated.
- The King I East Sediment Pond had some water in it (Photo 2), but the West Pond was completely dry. The King II Sediment Pond was also dry.
- The dams for all of the ponds appeared to be stable, and no problems were noted with the primary or emergency spillways.
- Diversion ditches and collection ditches throughout the permit area were dry. Grasses are growing in the riprapped west clearwater diversion ditch at King II (Photo 3). Mr. Wymore said they may be trimmed back later this year. Vegetation is sparse in the east clearwater diversion, probably due to the drier conditions that have existed this year.
- Tumbleweeds have collected at various pipe inlets and outlets. Mr. Wymore noted those sites for necessary maintenance.

Photo 2 – East Sediment Pond at King I

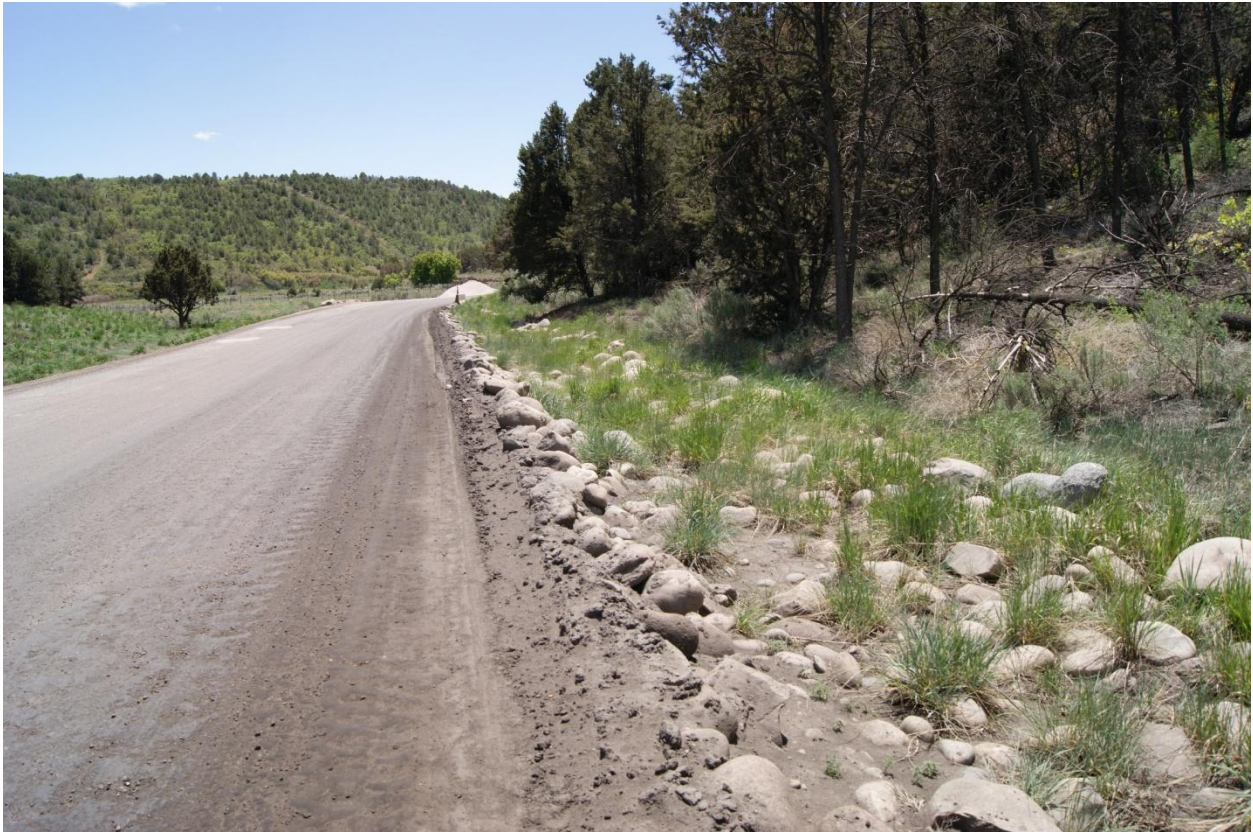
Photo 3 – West Clearwater Diversion Ditch at King II, looking south

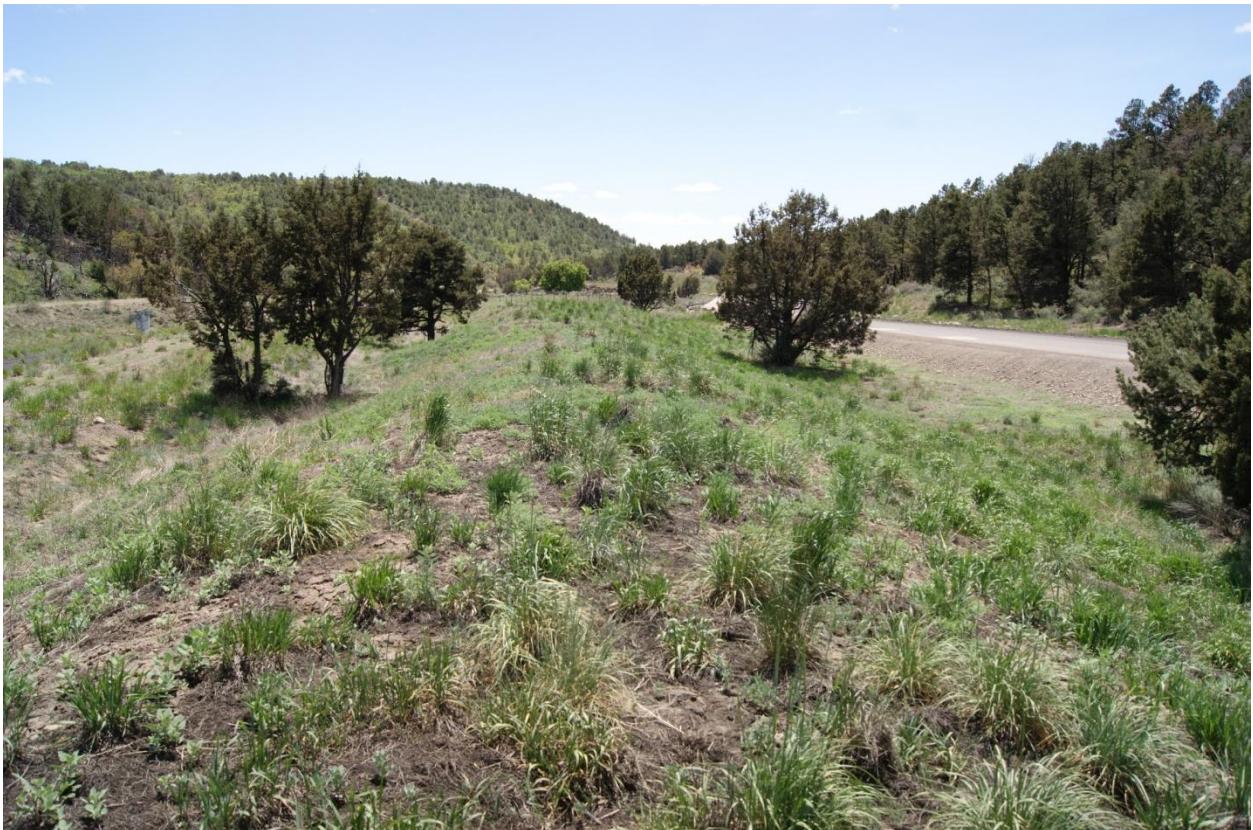
- The topsoil stockpile for the King II Sediment Pond was nicely vegetated, and stable with respect to erosion (Photo 4). A containment berm surrounds the pile to prevent any loss of the resource.
- Identification signs for the stockpile have been posted on two trees located between the pile and the haul road. We discussed the possibility of posting signs directly on the pile itself, one at each end, to further identify the pile's contents.

Photo 4 – King II Sediment Pond topsoil stockpile, looking S (pond on left, haul road on right)
