**COLORADO DIVISION OF RECLAMATION, MINING AND SAFETY  
MINERALS PROGRAM INSPECTION REPORT  
PHONE: (303) 866-3567**

<b>MINE NAME:</b> Hawkeye Mine	<b>MINE/PROSPECTING ID#:</b> M-1978-311	<b>MINERAL:</b> Uranium and vanadium	<b>COUNTY:</b> San Miguel
<b>INSPECTION TYPE:</b> Monitoring	<b>INSPECTOR(S):</b> Bob Oswald, Russ Means	<b>INSP. DATE:</b> May 16, 2013	<b>INSP. TIME:</b> 12:00
<b>OPERATOR:</b> Gold Eagle Mining, Inc.	<b>OPERATOR REPRESENTATIVE:</b> Don Corum	<b>TYPE OF OPERATION:</b> 110d - Designated Limited Impact

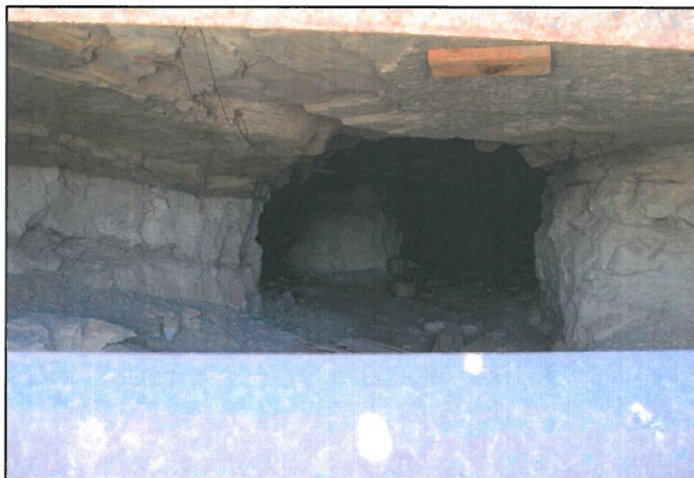
The permitted mine contains only one underground portal, which is located on the vertical face of a layer of massive, competent sandstone. The adit is safeguarded by a heavy gauge steel portal grate that is welded to steel anchors set into the solid sandstone. The grate prevents all human access; there is no locked door to open and no gap large enough to allow entry by anyone. Construction of the grate appears to meet Inactive Mines Program specifications. The adit entry is dry and no groundwater issues have been reported or observed in regard to the underground workings. No other openings, such as portals or vent shafts, are included in the permitted area or associated with this mine. The current approved reclamation plan requires this closure, and the Division considers this portion of the reclamation to be adequately completed.

Photo at left shows view of the adit immediately inside the welded steel portal grate (note cross bars of grate visible at top and bottom of view)
