**COLORADO DIVISION OF RECLAMATION, MINING AND SAFETY
COAL PROGRAM INSPECTION REPORT**

Permit Number: C-1981-020 Mine Name: Munger Canyon Mine Operator: CAM Mining, LLC Operator Address: Mr. Corey Heaps P.O. Box 98 Loma, CO 81524	County: Garfield, Mesa Operation Type: Underground Permit Status: Permanent Cessation Ownership: Federal
	Operator Representative Present: None
Operator Representative Signature: (Field Issuance Only)

Inspection Start Date: May 29, 2013 Inspection Start Time: 09:15 Inspection End Date: May 29, 2013 Inspection End Time: 11:30		Inspection Type: Coal Partial Inspection Inspection Reason: Normal I&E Program Weather: Cloudy	
Joint Inspection Agency: None		Joint Inspection Contacts: 	
Post Inspection Agency: None		Post Inspection Contacts: 	
Inspector(s): Michael P. Boulay Carla V. DeMasters	Inspector's Signature: <i>Michael P. Boulay</i>		Signature Date: 5/31/13

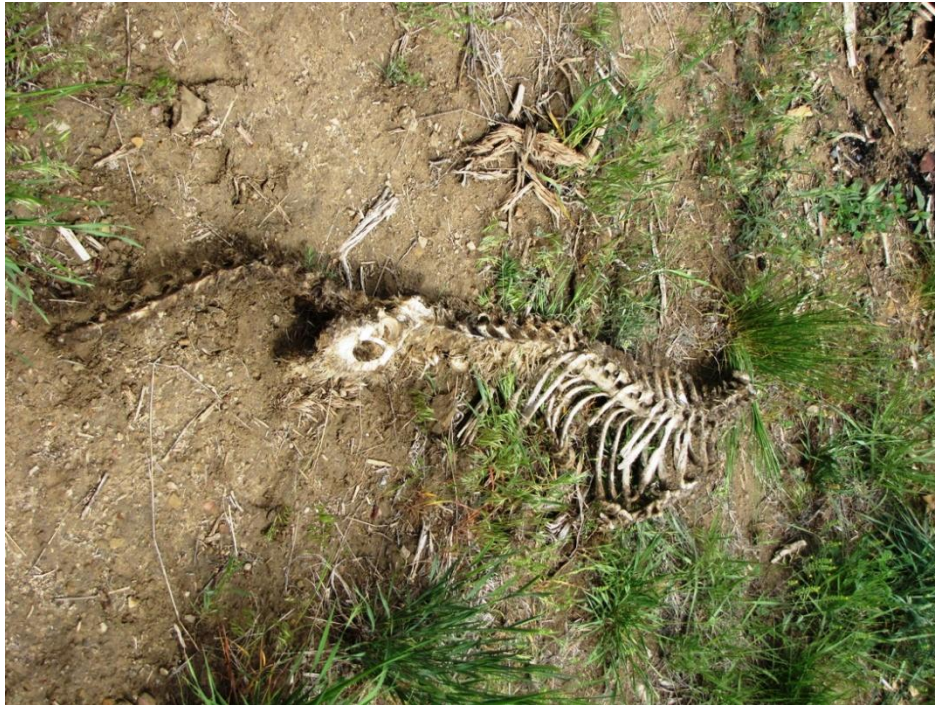
The skeletal remains of a large Mountain Lion were found along the light use road near the north branch of Munger Creek (see Photograph No. 1).

Photo No. 1 - Mountain Lion Skeleton.

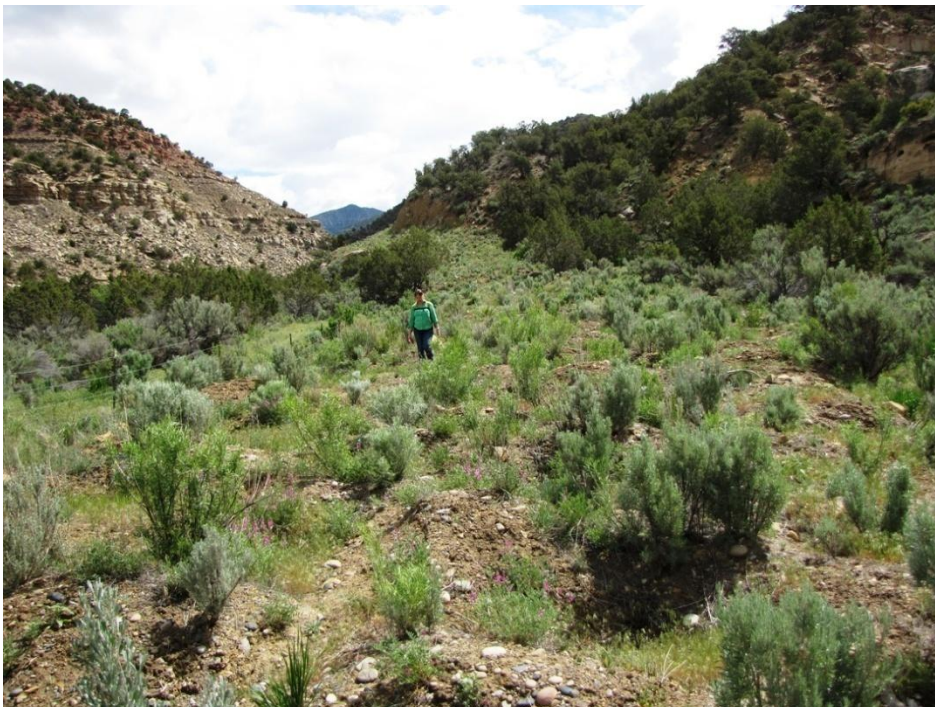
portal bench access road was inspected (see Photograph No. 2.) The reclamation looks very good and there has been minimal erosion since the reclamation was completed in 2007. The shrubs, perennial grasses and forbs are well established on the lower portion of the reclaimed portal bench access road. Rock lined drainage channels along the access road are in good condition.

Photo No. 2 – Revegetation on lower portion of reclaimed access road.

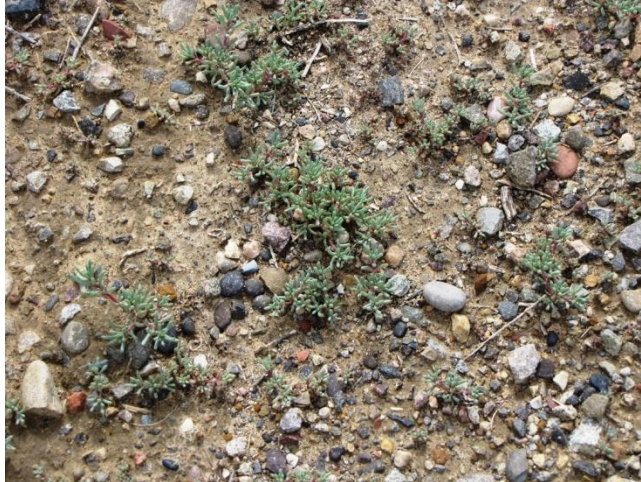
There were no signs of significant erosion or instability noted during this inspection and the site appears well maintained; however, three species of noxious weeds were identified at the lower elevations of the site. Halogeton (Colorado List C Noxious Weed) was growing in the roadbed in several spots along the reclaimed haul road (see Photograph No. 3). Whitetop (AKA hoary cress, Colorado List B Noxious Weed) was noted in several areas primarily around the cover soil pile and waste disposal site. See Photograph No. 4 taken on the west side of the waste disposal site. A small patch of jointed goatgrass (Colorado List B Noxious Weed) was identified along the reclaimed light use road that previously accessed the emergency drill hole (see Photograph No. 5). To ensure compliance please spray or otherwise manage these noxious weeds identified in this inspection report in accordance with the weed management plan of the approved permit.

Photo No. 3 - Halogeton on reclaimed haul road.

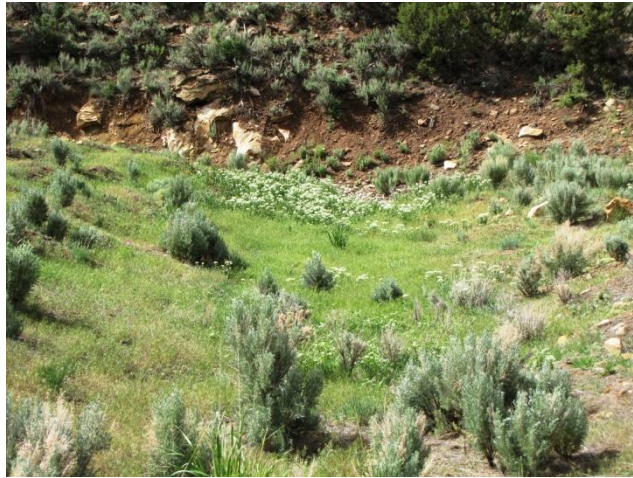
Photo No. 4 - Whitetop between waste disposal site and cover soil pile.

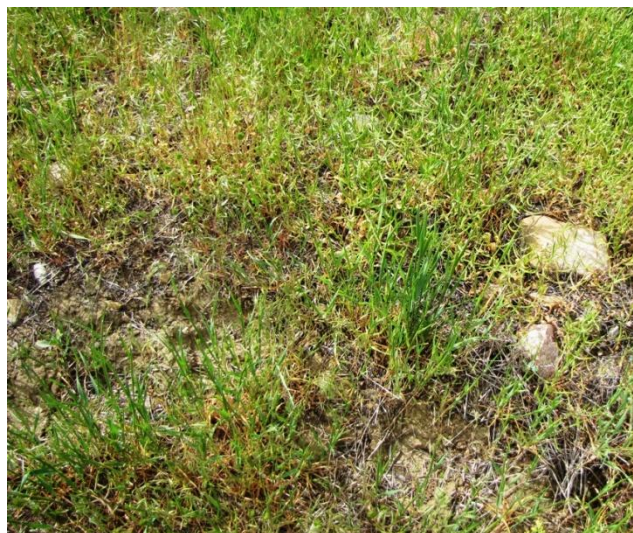
Photo No. 5 - Jointed goatgrass at reclaimed light use road.
