COLORADO DIVISION OF RECLAMATION, MINING AND SAFETY COAL PROGRAM INSPECTION REPORT

Permit Number: C-1981-028 Mine Name: Keenesburg Strip Mine Operator: Coors Energy Company Operator Address: Mr. Benjamin Moline P.O. Box 4030 Suite 400 Golden, CO 80401 County: Weld Operation Type: Surface Permit Status: Active Ownership: Private

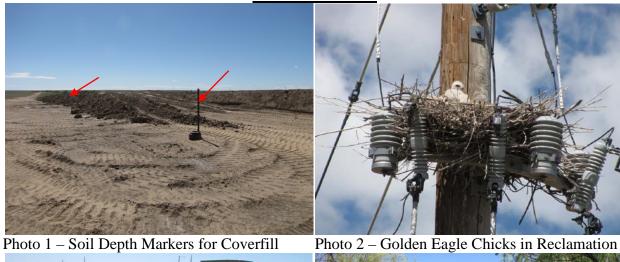
Photo 3 – Ditch by Permanent Sediment Pond Photo 4 – Cattails in Dugout Pond

The permanent sediment pond was damp but did not contain standing water. The drainage ditch along the main haul road by the permanent sediment pond was recently cleaned out and maintained (photo 3). The permanent dugout pond was mostly damp with some standing water. Cattails in the bottom of the pond were starting to sprout (photo 4).

The main haul road was well maintained and passable. The haul road drainage ditch from the dugout pond to the sediment pond was recently cleaned out and maintained.

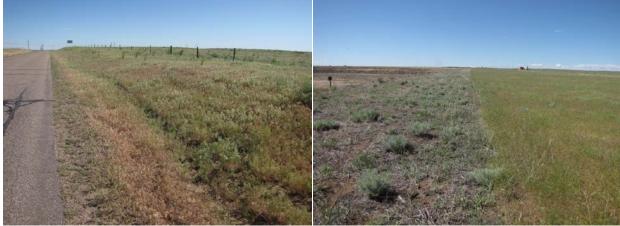
Photo 5 – Cheatgrass on Mine Entrance Road

The sides of the main access road to the mine were dense with cheatgrass. The roadsides were being mowed to control the cheatgrass during the inspection (photo 5). The pre-emergent herbicide Panoramic was applied to some areas of the mine last August to control cheatgrass. As an experiment, the undisturbed area along the west perimeter of the B-Pit was treated. The results of the application were very good (photo 6). Mr. Kipp explained that the remaining area between last years' application and the permit boundary will be treated this coming year to create a buffer between the adjacent property and the current reclamation. Other areas of the mine will be treated as well. Panoramic has been effective on both reclaimed and undisturbed parcels.

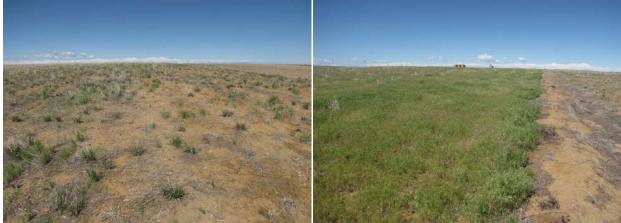
Photo 8 – Section 30

Section 30 was seeded in 2006 and has a dense stand of cheatgrass. Mr. Kipp said this section will get treated with the Panoramic this year (photo 8).
