**U.S. DEPT. OF THE INTERIOR
OFFICE OF SURFACE MINING
Mine Site Evaluation
State Program**

Carbon Junction Mine Partial Oversight Inspection
Colorado Division of Reclamation, Mining and Safety (DRMS) Permit ID # C-1992-080
Tuesday, April 30, 2013, 9:30 p.m. – 2:30 p.m.
Operator: Oakridge Energy, Inc.

I&E Inspection Photos

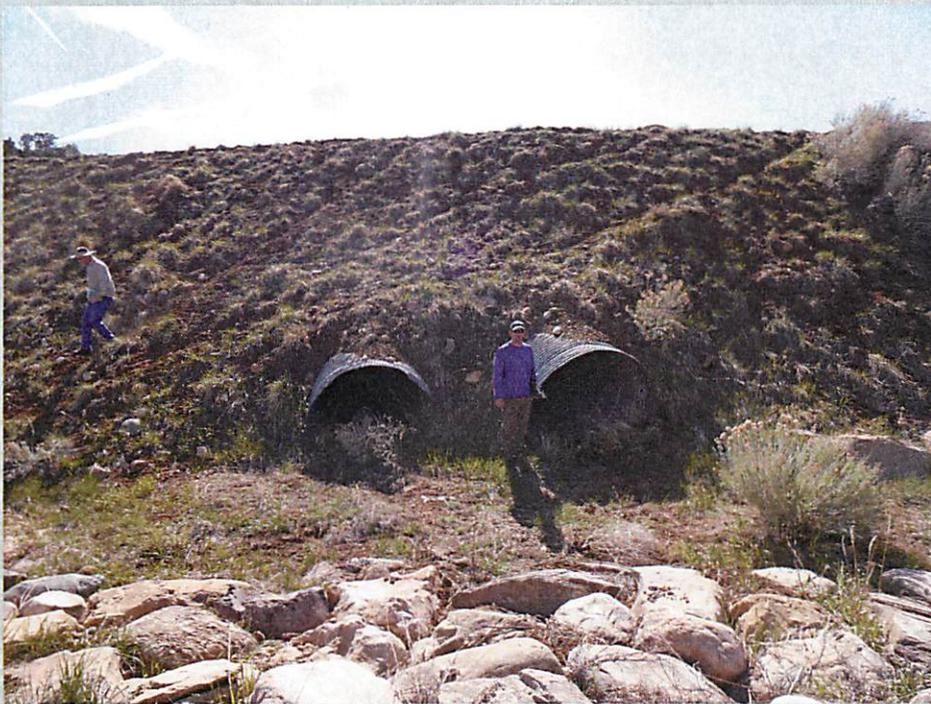
Photo ID: 11386
Photographer: SMESHAEFFER
Date Taken: 4/30/2013
State: CO
County: LA PLATA
Latitude: 37.23483611
Longitude: -
107.85075611

4. On all observed maps (Mine Hydrology Map, PMT Map, and the Site Cross Sections Map), the twin culverts in Segment 4 of the Carbon Junction Canyon drainage are not correctly identified. The maps show a single pipe arch culvert that is 9 feet 4 inches in diameter passing under the main road, not the existing two side-by-side 66" culverts. The Division has received as-builts for the twin culverts, but the as-builts have not been incorporated into the MRP.

Segment 4 contains two culverts with 66-inch diameters that pass under the main haul road. Ms. Talvitie informed us that the culverts were installed when Sediment Ponds 1 and 2 were removed in 2008 and 2009. The Site Cross Sections Map approved with TR-11 indicates that Segment 4 contains a single pipe arch culvert that is 9 feet 4 inches in diameter passing under the main road. The designs in the current MRP do not reflect field conditions (Photo 11386).

Subject: CULVERTS UNDER MAIN ACCESS ROAD

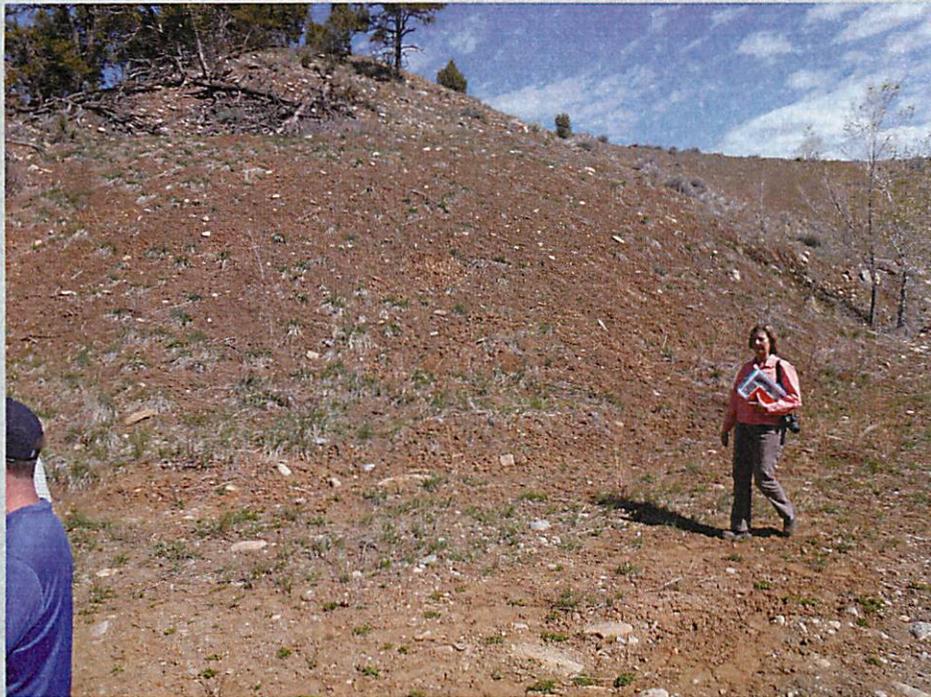
Photo ID: 11388
Photographer: SMESHAEFFER
Date Taken: 4/30/2013
State: CO
County:
Latitude: 37.23460861
Longitude: -
107.85084639

Sediment Pond 2 was inspected. Ms. Talvitie informed us that the dam was removed in 2009. The high banks above Pond 2 are not well vegetated, and the site has historic problems with Canada thistle (Photo 11388). There is not a truly defined channel that carries water from above Pond 2 and meets the original stream, and it is apparent that water collects in a flat, wide area (Photo 11389).

Bare bank with historic Canada thistle problems

Subject: HIGH BANK ABOVE POND 2

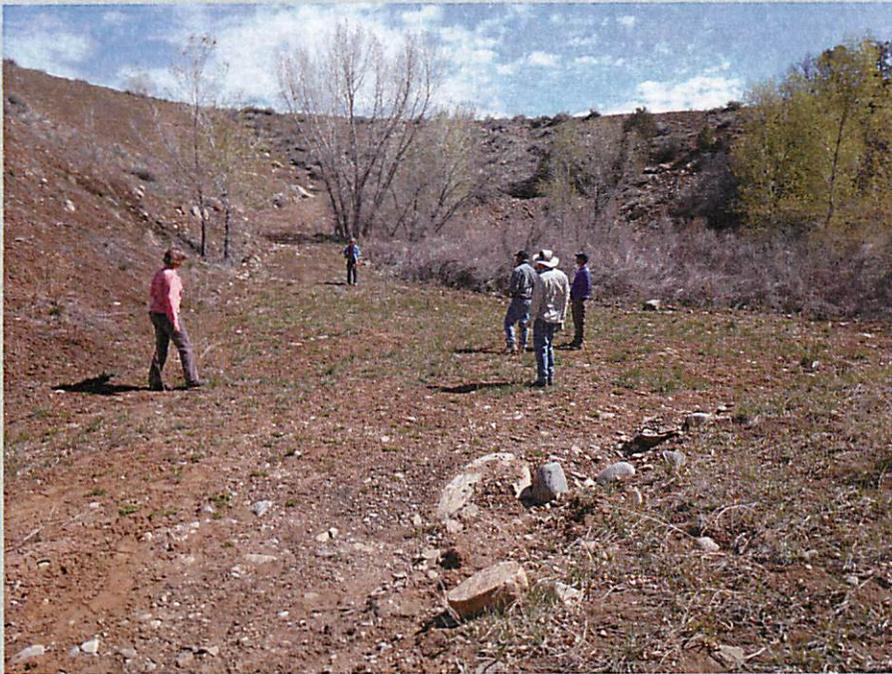
Photo ID: 11389
Photographer: SMESHAEFFER
Date Taken: 4/30/2013
State: CO
County: LA PLATA
Latitude: 37.23460861
Longitude: -
107.85084639

Pond 2 and area in left foreground of photo where water collects

Subject: POND 2

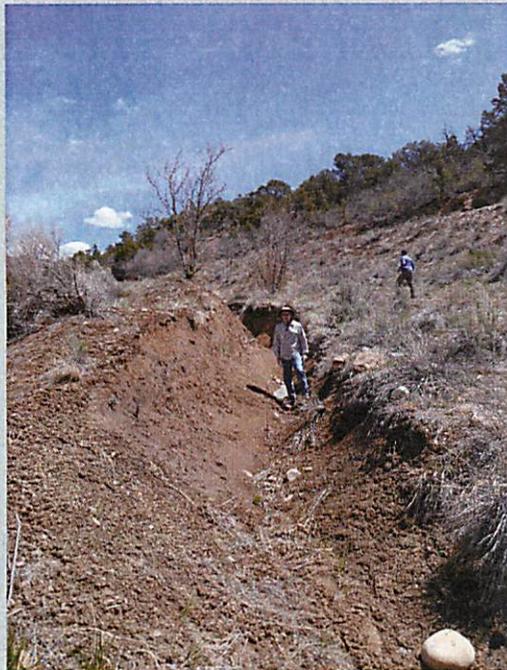
Photo ID: 11390
Photographer: SMESHAEFFER
Date Taken: 4/30/2013
State: CO
County: LA PLATA
Latitude: 37.23489667
Longitude: -
107.85036278

2. The Mine Hydrology Map, approved on October 9, 2002, as part of Technical Revision 11(TR-11) shows a diversion channel located to the left of the original Carbon Junction Canyon drainage (upstream of the reconstructed channel). In the field, the Team observed that this channel has erosion and down cutting that has not been reclaimed. The original channel has filled in with vegetation and needs additional work in order to be reestablished to its original condition all the way upstream to the undisturbed natural Carbon Junction Channel and downstream to the Carbon Junction Canyon drainage.

As noted in Item 2 above, the Team observed that the diversion channel located to the left of the original Carbon Junction Canyon drainage (upstream of the reconstructed channel) has erosion and down cutting that has not been reclaimed (Photos 11390 and 11391). The Team walked the entire length of the drainage until the undisturbed, original channel was identified. The Team estimated the depth of this drainage in certain areas to be up to 10 feet. Ms. Talvitie informed us that last fall, she directed the mine operator to eliminate the berm directing the flow to the left of the original Carbon Junction Canyon drainage so that the natural drainage channel could be restored. At the location where the berm was removed, there is a large bare area that should be seeded and mulched to prevent further erosion (Photos 11392 and 11393). The original channel has filled in with vegetation and needs additional work in order to be reestablished to its original condition all the way upstream to the undisturbed natural Carbon Junction Channel and downstream to the reconstructed Carbon Junction Canyon drainage.

Channel is located upstream of reconstructed riprap channel, erosion and downcutting has not been reclaimed.

Subject: CHANNEL LEFT OF ORIGINAL CJC DRAINAGE

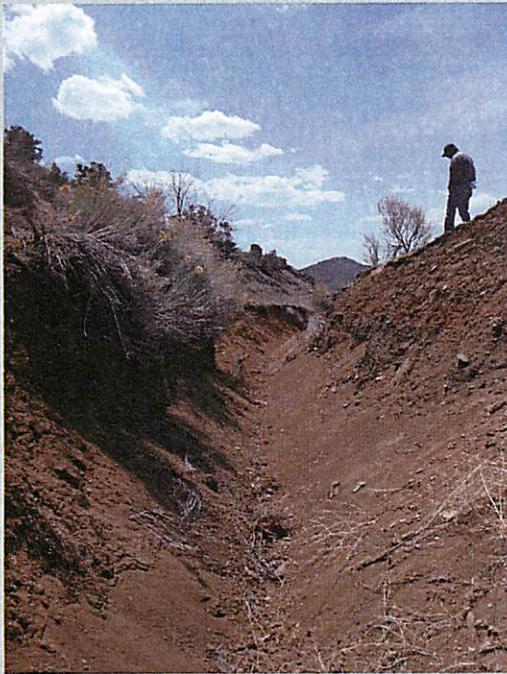
Photo ID: 11391

Channel is located upstream of reconstructed riprap channel, erosion and downcutting has not been reclaimed. Photo is taken from floor of gully with person for scale on upper right bank.

Subject: Channel left of original CJC Drainage 2

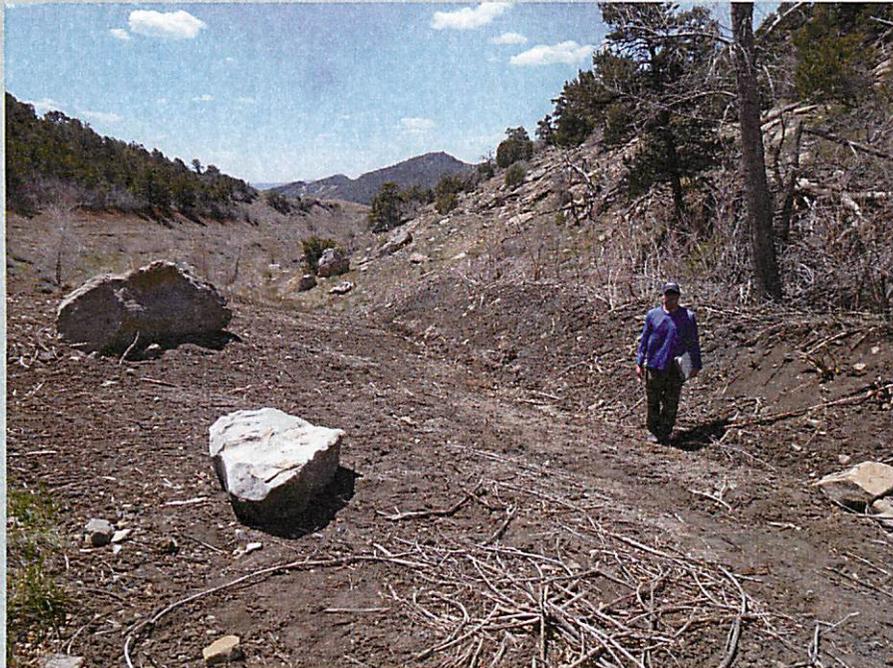
Photo ID: 11392

Subject: BARE AREA NEAR CJC BERM REMOVAL

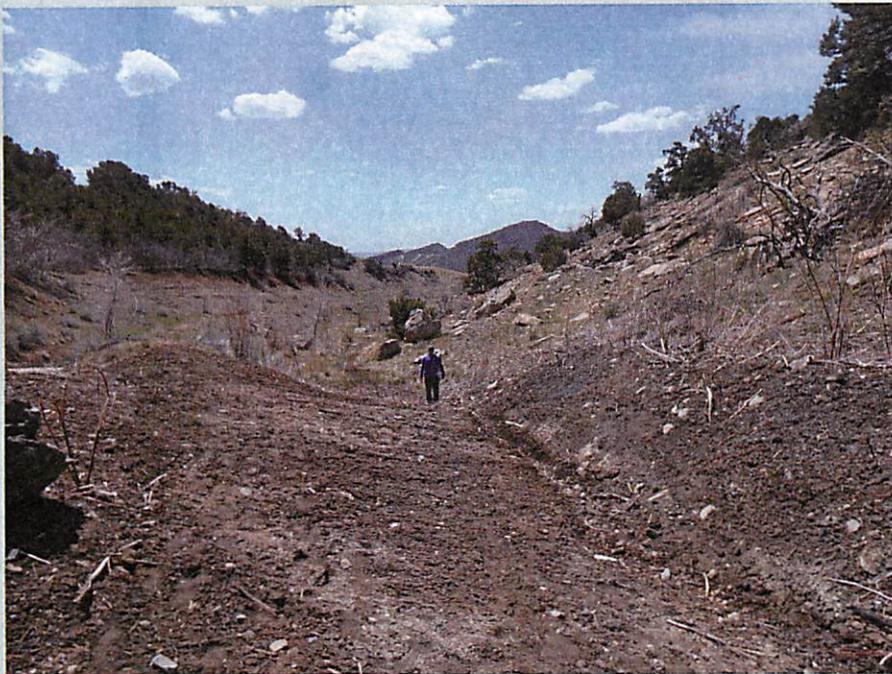
Photo ID: 11393
Photographer: SMESHAEFFER
Date Taken: 4/30/2013
State: CO
County: LA PLATA
Latitude: 37.25009111
Longitude: -
107.85019917

disturbed area

Subject: BARE AREA NEAR CJC berm REMOVAL 2

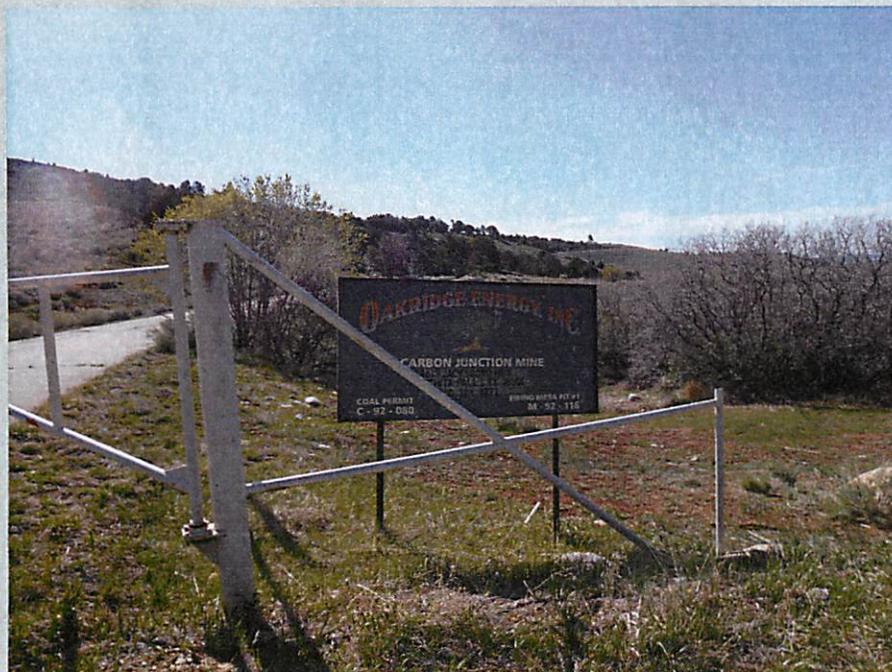
Photo ID: 11394
Photographer: SMESHAEFFER
Date Taken: 4/30/2013
State: CO
County: LA PLATA
Latitude: 0.00000000
Longitude: 0.00000000

The mine ID sign at the entrance gate was intact and contained all of the necessary information. Permit boundary markers were visible from the main access road (Photo 11394).

Subject: MINE ID SIGN
