COLORADO DIVISION OF RECLAMATION, MINING AND SAFETY
MINERALS PROGRAM INSPECTION REPORT
PHONE: (303) 866-3567

| MINE NAME: Anderson Pit | MINE/PROSPECTING ID#: M-2005-021 | MINERAL: Sand and gravel | COUNTY: Delta |
| INSPECTION TYPE: Monitoring | INSPECTOR(S): Dustin M. Czapla | INSP. DATE: March 20, 2013 | INSP. TIME: 09:30 |

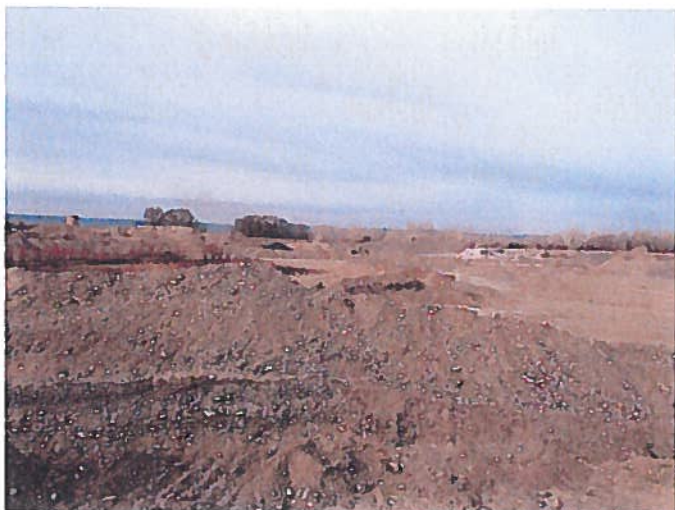
Figure 1: View from the southeast side of the Phase 1 pit, facing west.

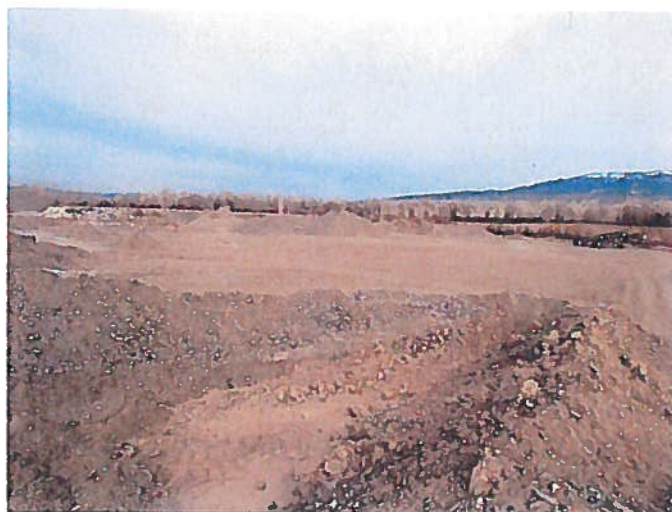
Figure 2: View from the southeast side of the Phase 1 pit, facing northwest.

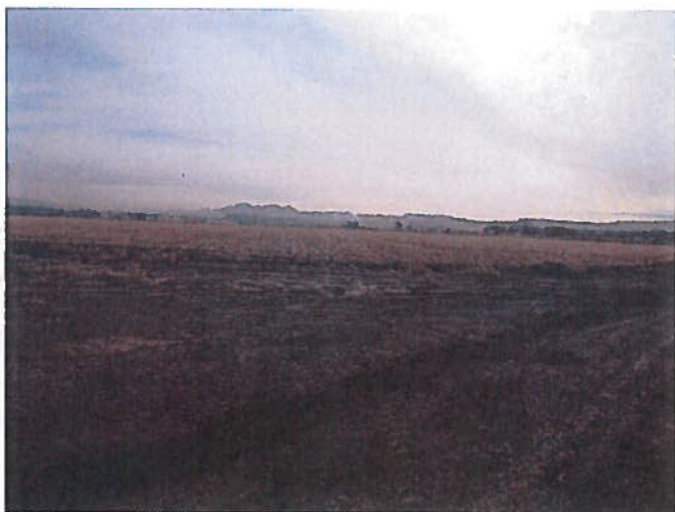
Figure 3: View from the southeast side of the Phase 1 pit, facing east toward Phase 2-4 areas.

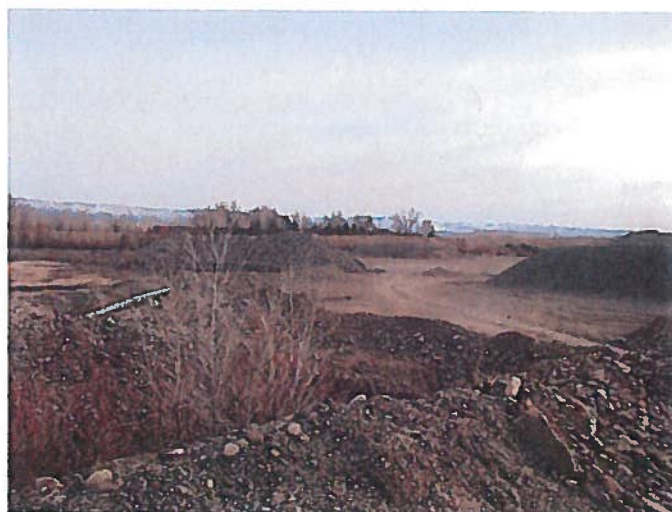
Pit excavation has occurred in the Phase 1 area, progressing toward the Phase 2 area. The pit has not reached its maximum depth yet. The dewatering trench has been constructed along the west side of the pit. Tamarisk is beginning to infest the areas where dewatering trenches have been constructed. Various materials stockpiles were located throughout the disturbed area. The Ready Mix plant has been constructed in the Phase 11 area and was operating during this inspection.

Figure 4: View from the west side of the Phase 1 pit, facing northeast. Tamarisk have begun to infest the dewatering trenches.

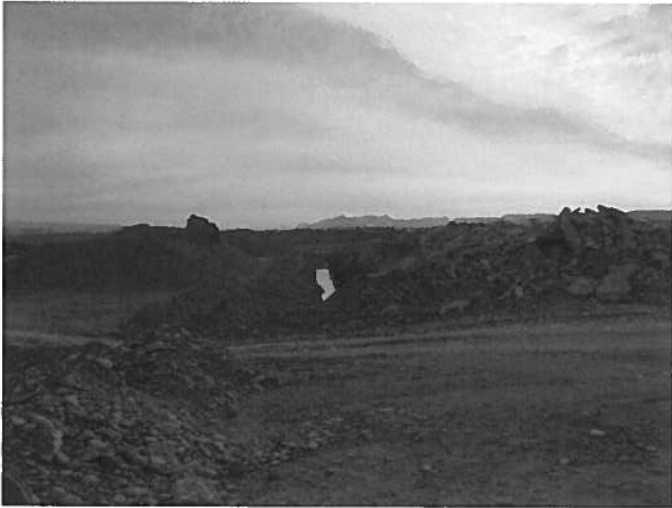
Figure 5: View from the west side of the Phase 1 pit, facing east. Tamarisk have begun to infest the dewatering trenches.

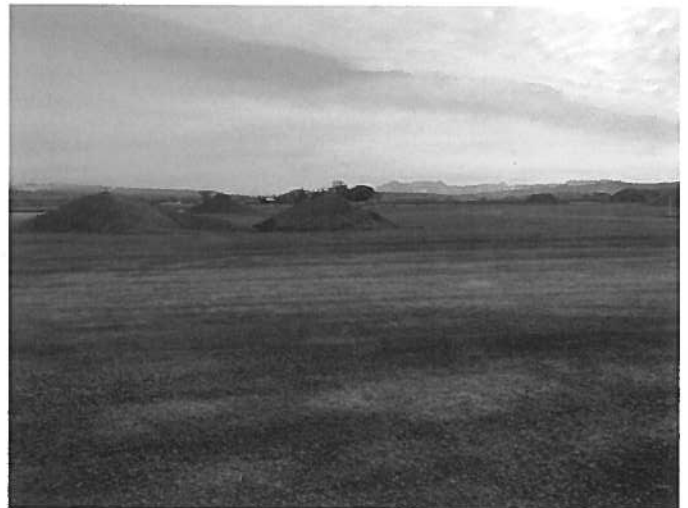
Figure 6: Phase 11 area, on the north side of the Ready Mix plant, facing east.

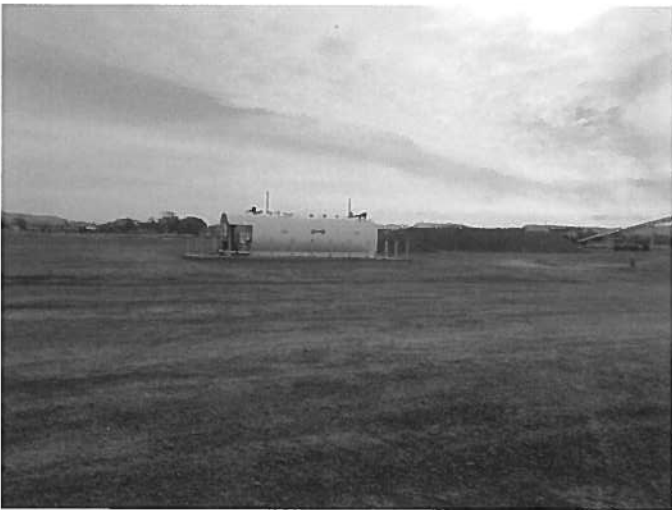
Figure 7: Phase 11 area, on the north side of the Ready Mix plant, facing east.

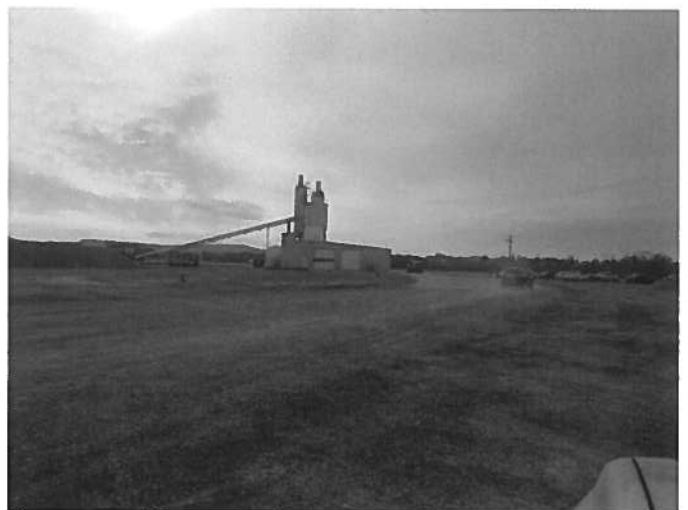
Figure 8: Ready Mix plant in the Phase 11 area.
