**COLORADO DIVISION OF RECLAMATION, MINING AND SAFETY**  
**MINERALS PROGRAM INSPECTION REPORT**  
**PHONE: (303) 866-3567**

<b>MINE NAME:</b> Willow Creek Mine	<b>MINE/PROSPECTING ID#:</b> M-1983-011	<b>MINERAL:</b> Gold	<b>COUNTY:</b> Lake
<b>INSPECTION TYPE:</b> Monitoring	<b>INSPECTOR(S):</b> Dustin M. Czapla	<b>INSP. DATE:</b> May 21, 2013	<b>INSP. TIME:</b> 11:00
<b>OPERATOR:</b> Mt. Elbert Mining Co., L.L.C.	<b>OPERATOR REPRESENTATIVE(S):</b> Angela Bellantoni, J.J. Johnson, Ben Langenfeld	<b>TYPE OF OPERATION:</b> 112 - Hard Rock Regular Operation

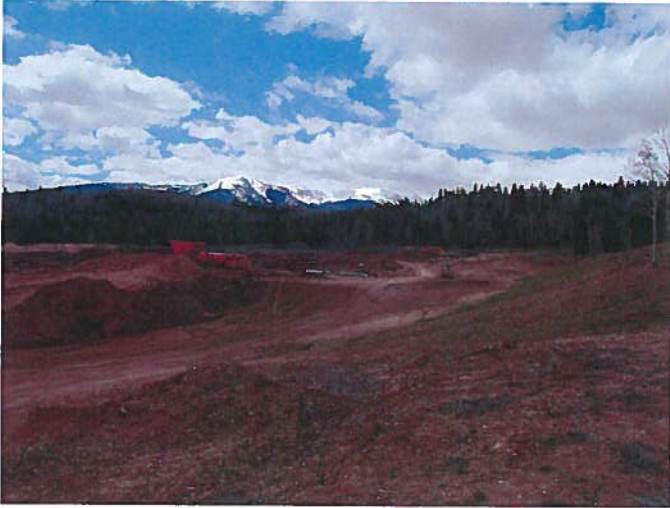
Figure 1: View from the north end of the USFS slope, facing southwest.

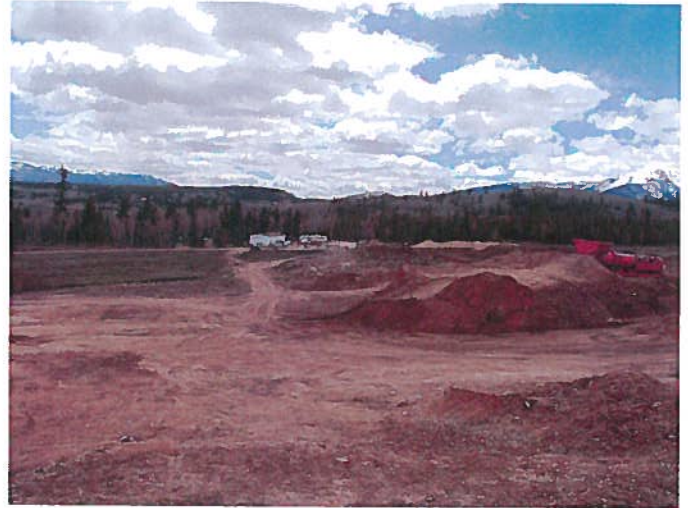
Figure 2: View from the north end of the USFS slope, facing southeast.

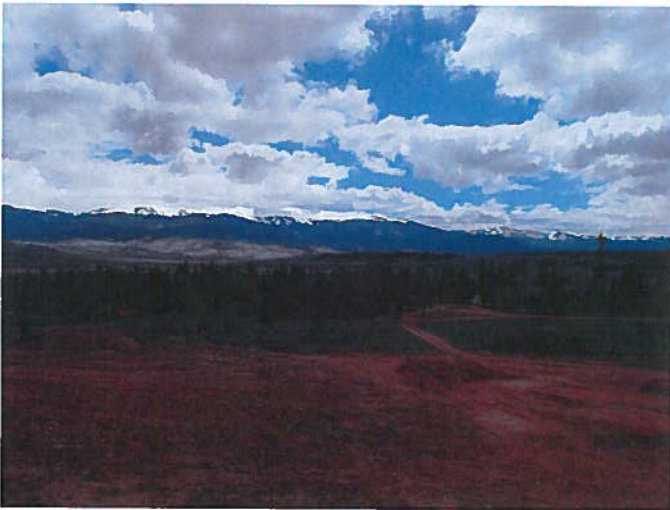
Figure 3: View from the north end of the USFS slope, facing east.

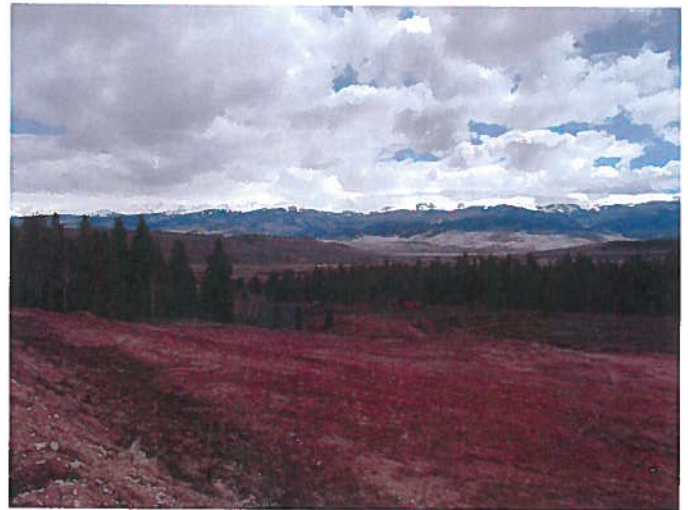
Figure 4: View from the north end of the USFS slope, facing northeast.

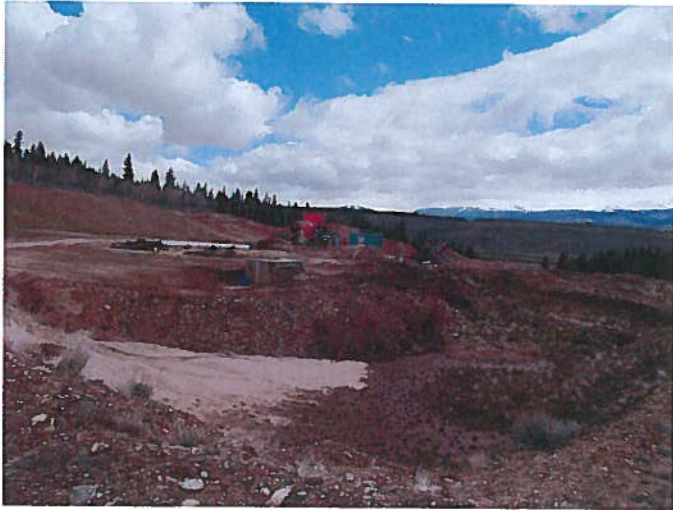
General site clean-up has continued since issuance of the 112 permit, improving the overall appearance of the site. The operator anticipates that more of the dilapidated equipment and debris stored on site will be removed this operating season. Most of the old processing equipment, which was located just west of the current processing area, has been removed.

Figure 5: View from the south side of the processing area, facing north.

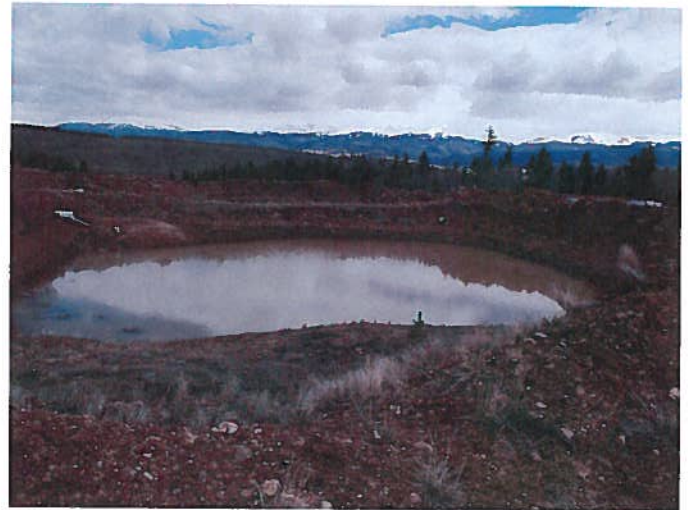
Figure 6: View from the south side of the processing area, facing north.

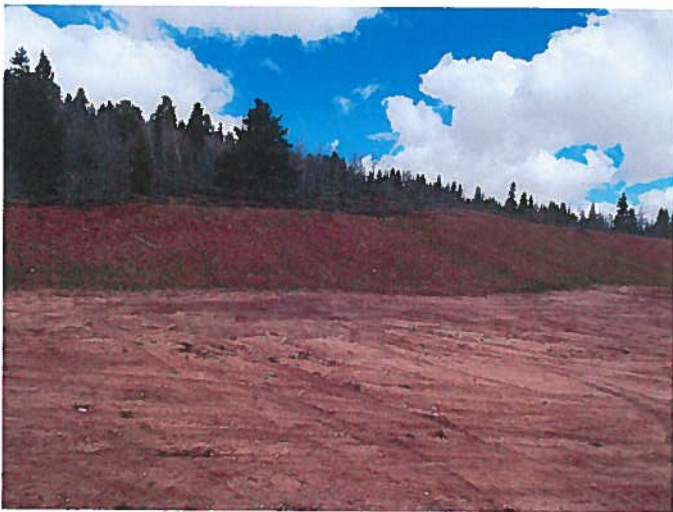
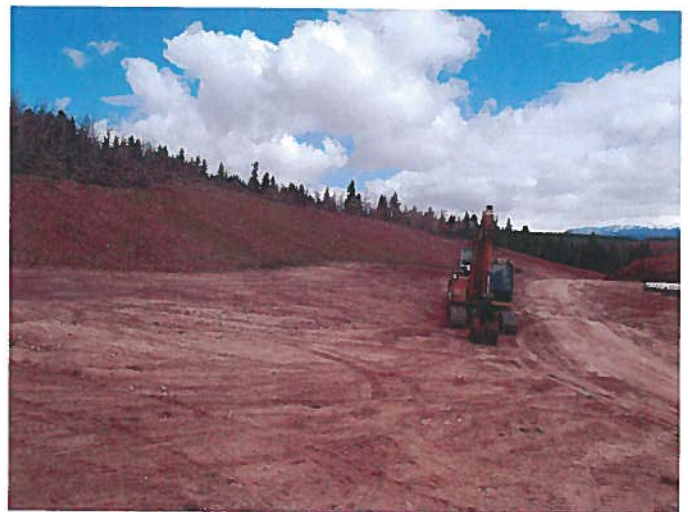
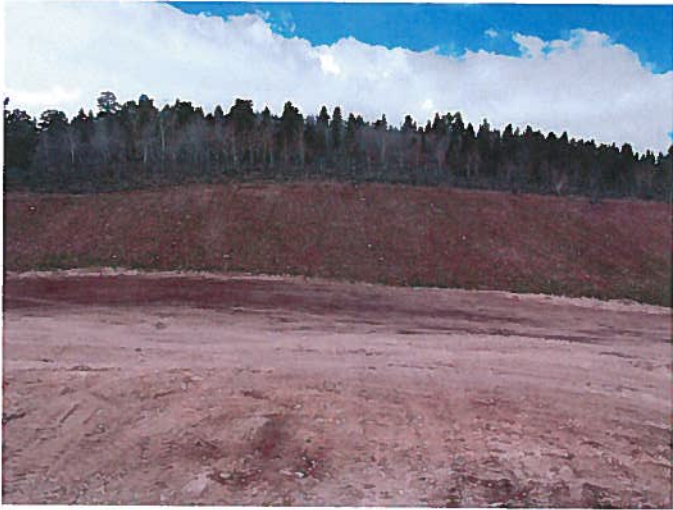
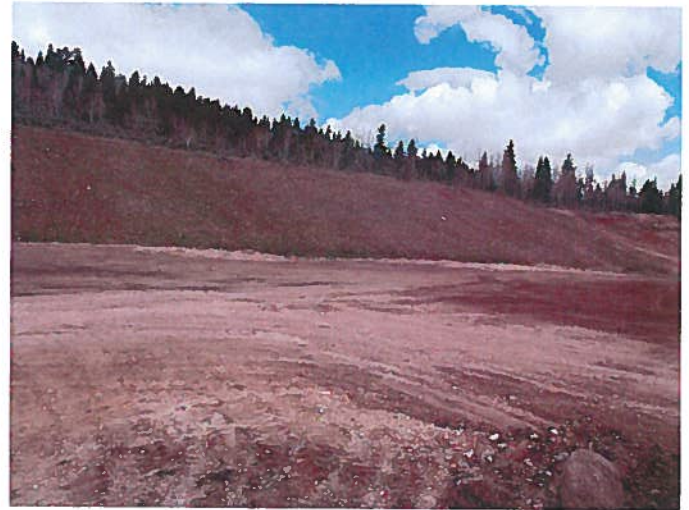
Reclamation of the USFS slope, on the west side of the permit area, appears that it will be successful. The slope appears stable and vegetation is becoming established. Noxious weeds were not noted on the slope. A flat area at the base of the slope, less than approximately 0.25 acres that was determined to be USFS property, remains to be reclaimed.

Figure 7: Reclaimed USFS slope.

Figure 8: Reclaimed USFS slope.

Figure 9: Reclaimed USFS slope.

Figure 10: Reclaimed USFS slope.

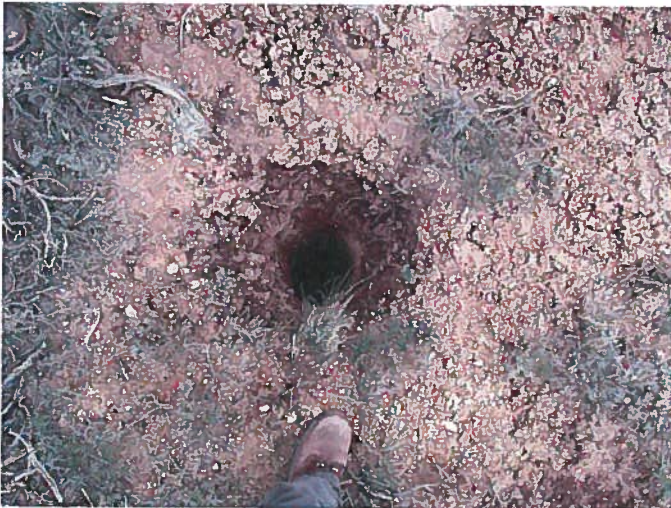
An unreclaimed auger hole was located northeast of the currently disturbed area, just beyond the stormwater berm at approximately 39.124455°, -106.366016°. The hole was dry and was estimated to be around twenty feet deep. The hole shall be backfilled immediately.

Figure 11: Unreclaimed auger hole located just beyond the stormwater berm on the northeast side of the disturbed area.
