# COLORADO DIVISION OF RECLAMATION, MINING AND SAFETY MINERALS PROGRAM INSPECTION REPORT

MINE NAME: Cook Pit	MINE/PROSPECTING ID#: M-2013-013	MINERAL: Gravel and sand	COUNTY:
INSPECTION TYPE: Preoperation Inspection	INSPECTOR(S): Dustin M. Czapla	INSP. DATE: May 29, 2013	INSP. TIME:
OPERATOR: Delta County		TYPE OF OPERATION:

### **OBSERVATIONS**

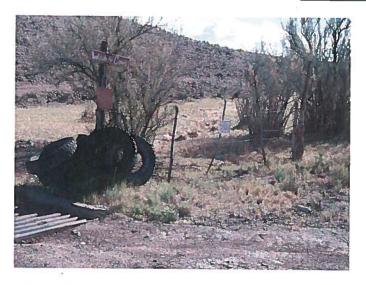
Figure 1: Entrance to the site from 25 Mesa Road.

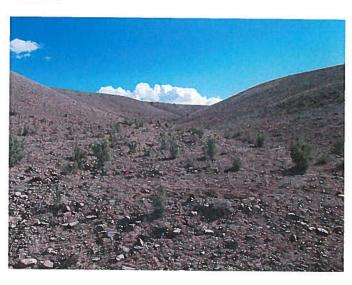
Figure 2: Location for proposed access road.

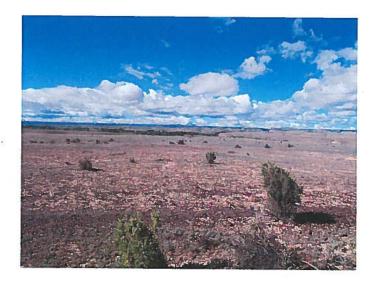
Figure 3: View from the old air strip facing southwest.

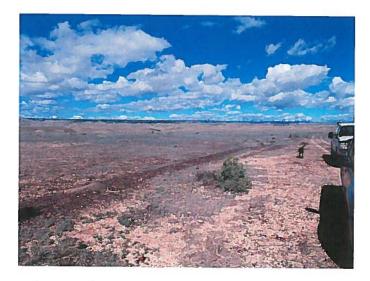
Figure 4: View from the old air strip facing west.

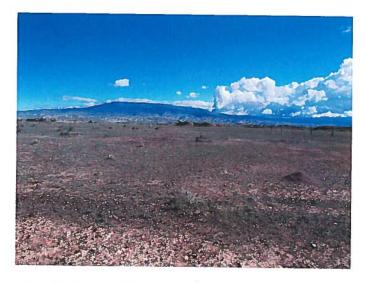
Figure 5: View from the old air strip facing north.

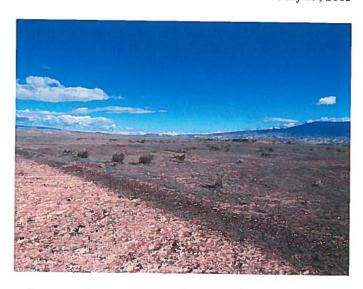
Figure 6: View from the old air strip facing northwest.

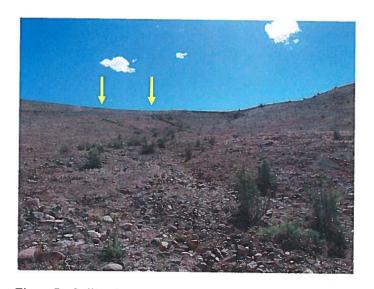
Several significant erosional features were noted on the slope beneath the existing access road.

Figure 7: Gullies forming beneath existing access road.

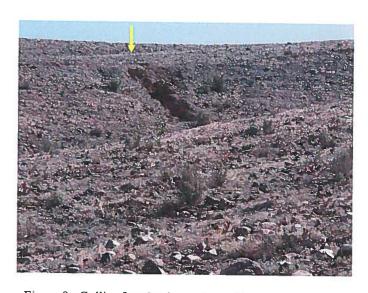
Figure 8: Gullies forming beneath existing access road.
