## COLORADO DIVISION OF RECLAMATION, MINING AND SAFETY COAL PROGRAM INSPECTION REPORT

<b>Permit Number:</b> C-1981-019 <b>Mine Name:</b> Colowyo Coal Mine <b>Operator:</b> Colowyo Coal Company L.P. <b>Operator Address:</b> Mr. Tony Tennyson 5731 State Highway 13 Meeker, CO 81641	<b>County:</b> Moffat, Rio Blanco <b>Operation Type:</b> Surface <b>Permit Status:</b> Active <b>Ownership:</b> Federal
<b>Operator Representative Present:</b>  Tennyson and Blunt	
<b>Operator Representative Signature:</b> (Field Issuance Only)

<b>Inspection Start Date:</b> May 21, 2013 <b>Inspection Start Time:</b> 08:00 <b>Inspection End Date:</b> May 22, 2013 <b>Inspection End Time:</b> 15:00	<b>Inspection Type:</b> Coal Complete Inspection <b>Inspection Reason:</b> Surety Release Requested <b>Weather:</b> Clear	
<b>Joint Inspection Agency:</b>  None	<b>Joint Inspection Contacts:</b>	
<b>Post Inspection Agency:</b>  None	<b>Post Inspection Contacts:</b>	
<b>Inspector(s):</b>  Robert D. Zuber, P.E.  Jason D. Musick	<b>Inspector's Signature:</b>

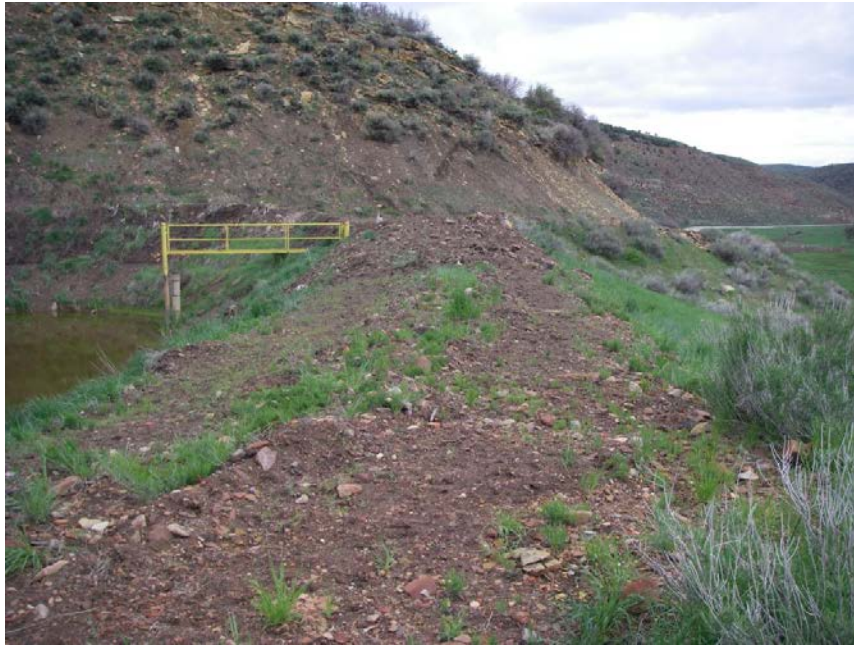
- On Prospect dam vegetation is emerging.
- Rail Loop requires cleaning.
- Section 16 flume contains mud that should be removed.
- A delta above East Taylor Pond has formed; there is no sign of erosion at this point in the channel.

**Prospect Pond embankment with emerging vegetation**

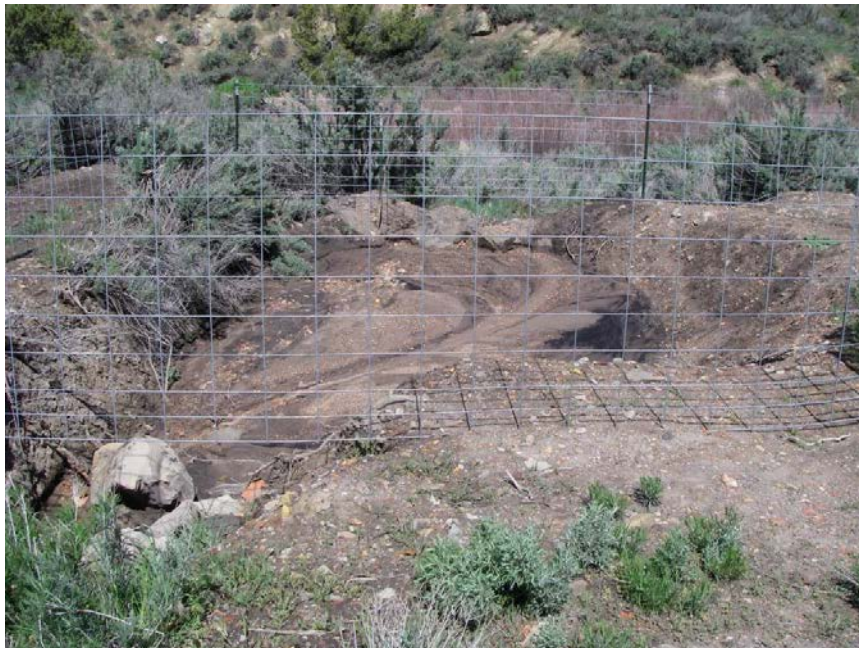
Several sumps along Taylor Creek require cleaning, including 1, 2, 4, and 5.

**Sump #1 – needs to be cleaned**

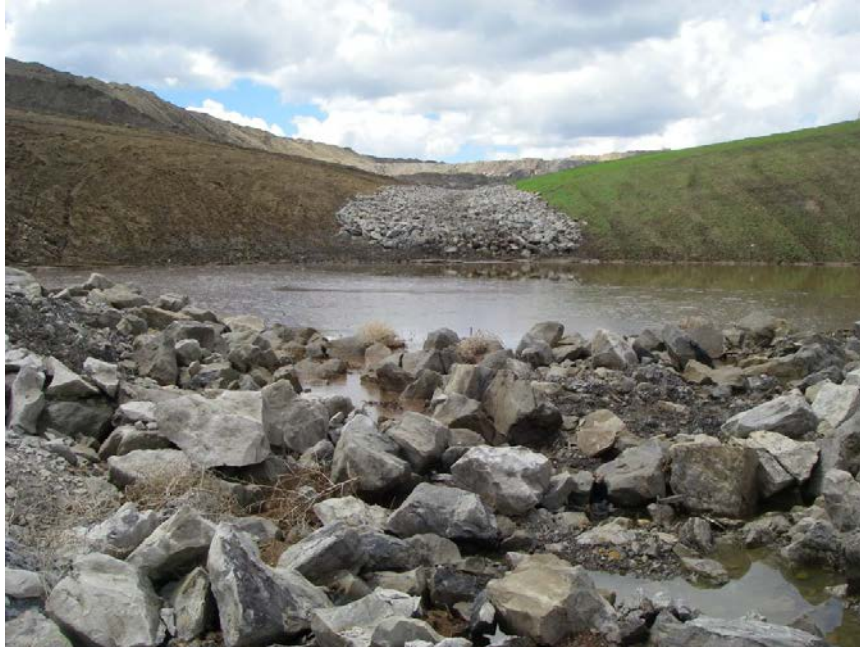
Pond EP2 was found to meet the specifications in the PAP, including a spillway of approximately 15 feet in width; however the depth could not be determined because the pond was full of turbid water.

**Pond EP2 with spillway in foreground**

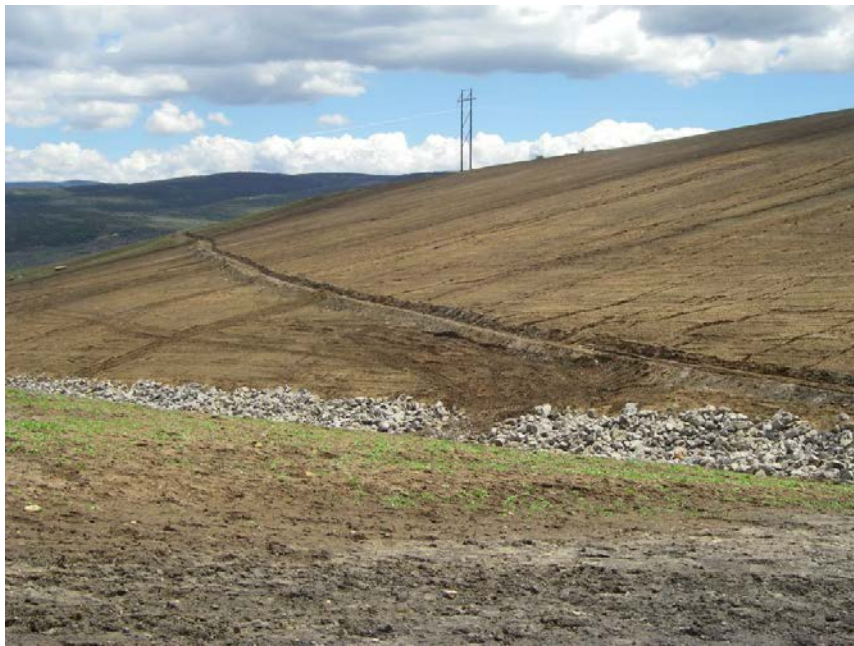
- Rills were observed in the East Pit reclamation.
- Rills have been repaired on the surface of the West Taylor fill, although some remain.
- A rill was observed near the upper contour ditch that flows to Taylor Ditch.

**East Pit reclamation with contour ditch**

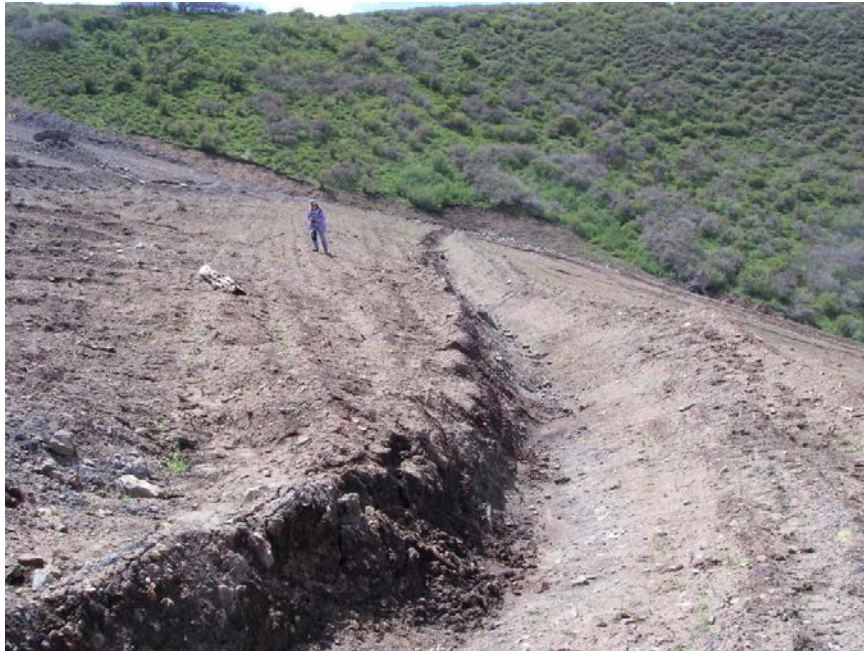
- In the East Pit area, blowouts of contour ditches have been repaired.
- On the West Taylor Fill, the contour ditches appear to be built to specifications in terms of depth and side slopes, although sediment accumulation has resulted in the ditches being slightly smaller in depth (based on general observation) than the 3.4 feet in the PAP (page Exh. 7-20G-7 of the PAP). Future maintenance of these ditches may be needed.
- On the south side of Prospect Ditch (about 100 feet from the ditch), a contour ditch has blown out.

**West Taylor Fill contour ditch (Jennifer Maiolo in background)**

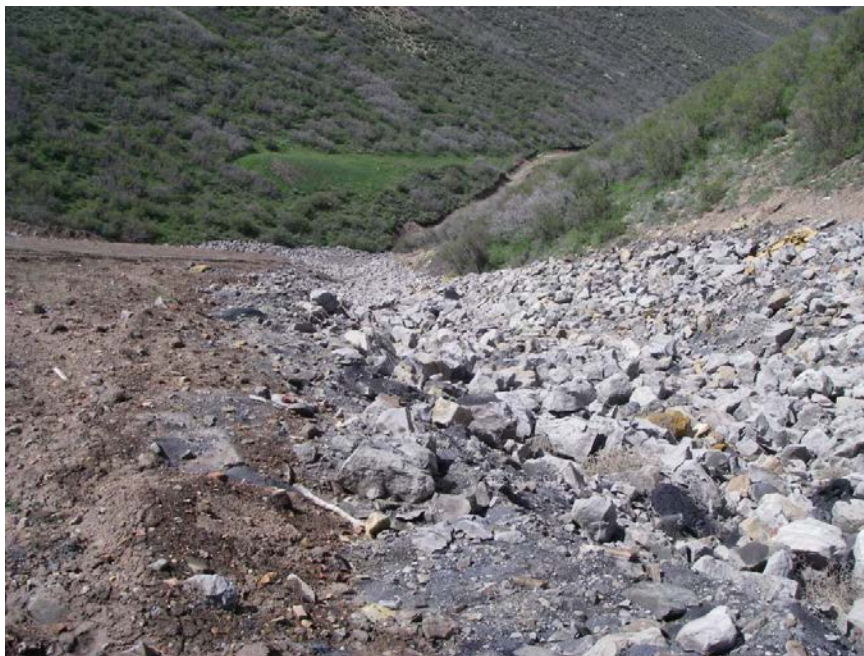
**West Taylor Fill side ditch**

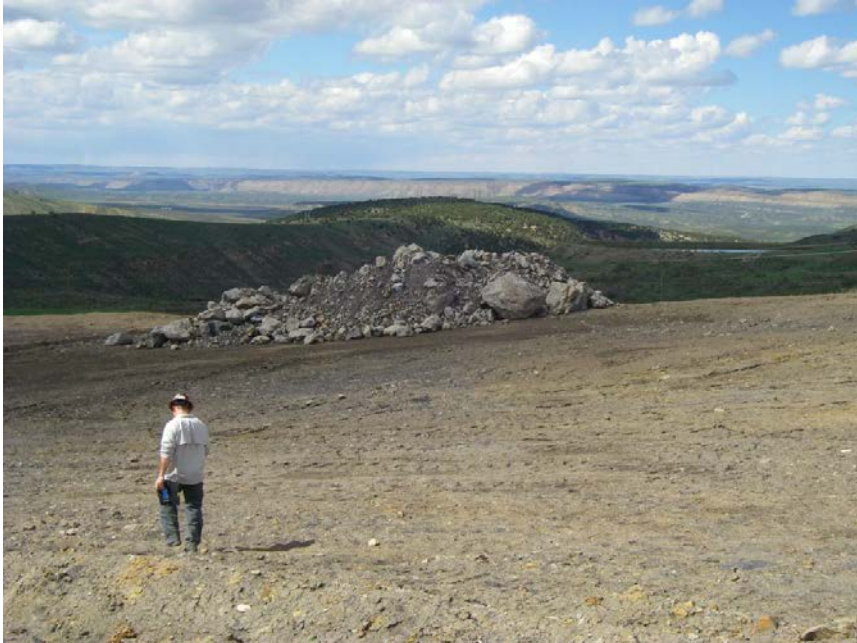
**West Pit reclamation with stockpile of riprap for channel construction**

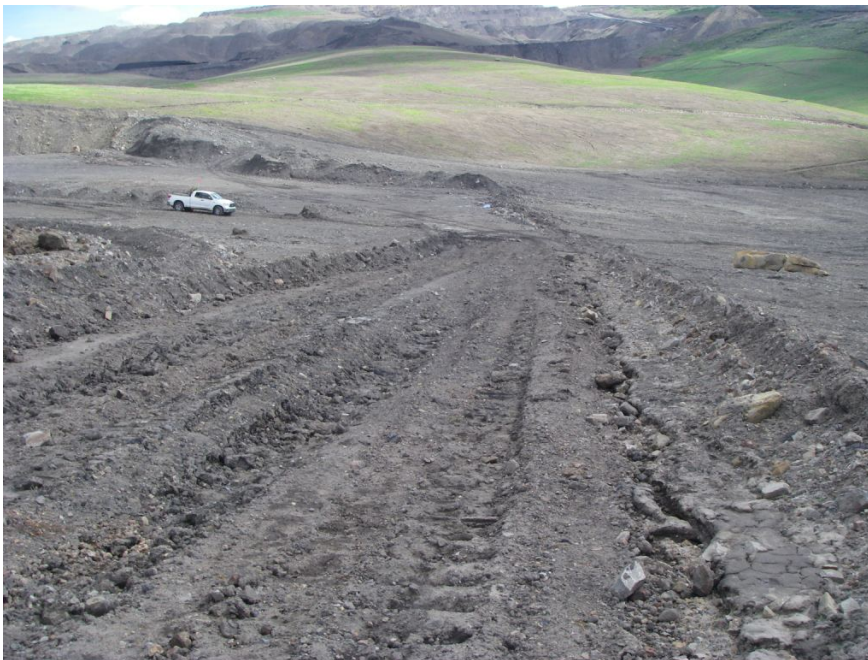
**West Pit reclamation with scraper road on edge of SL-07 parcel**

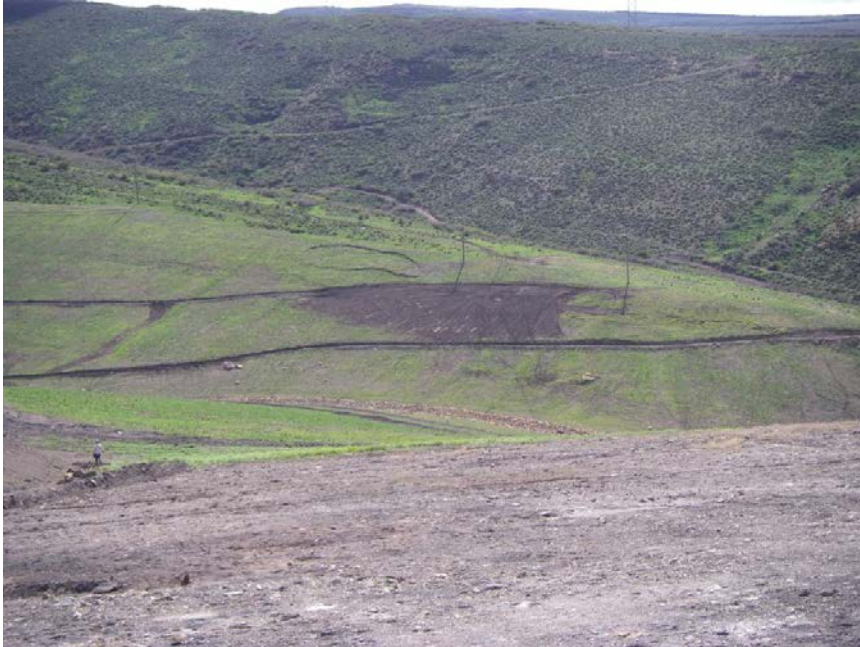
Slumps above East Taylor Pond still exist but do not appear to be growing; repairs have been completed on a slump west of the drainage.

**Repair of slump above East Taylor Pond**

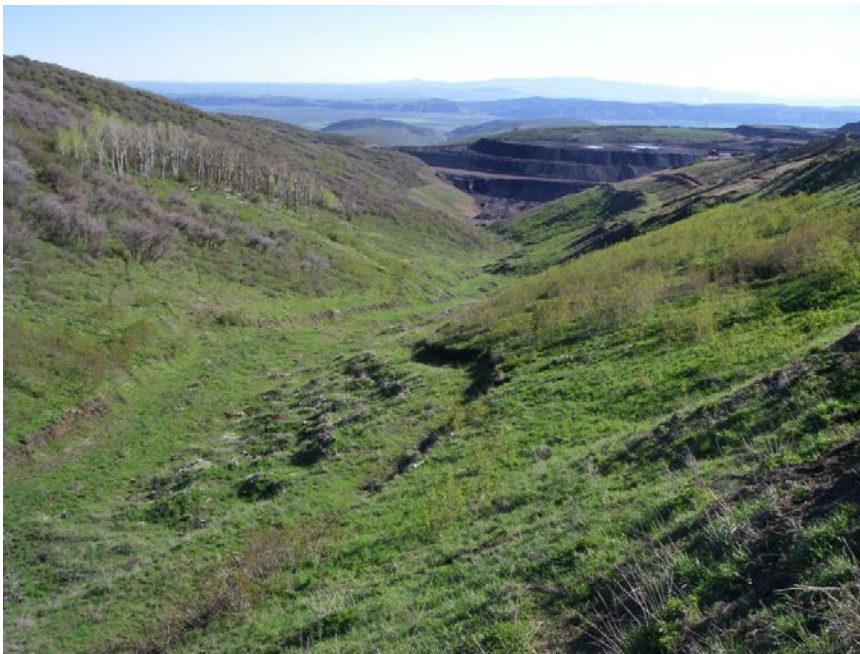
Topsoil stockpile 16I, which runs parallel to West Taylor West Tributary Ditch, was inspected from both ends (the pile is very long). No problems were seen with the diversion ditch that is above this stockpile. The feature that appeared to be a scarp in an aerial photograph (aerial inspection report from May 2013), was

determined to be an old road. The pile looks stable and well vegetated, and there is no sign that topsoil has been transported into the valley below. The stockpile does need markers at access points.

**Topsoil Stockpile 16I (from south) – feature in middle of photo is old road**

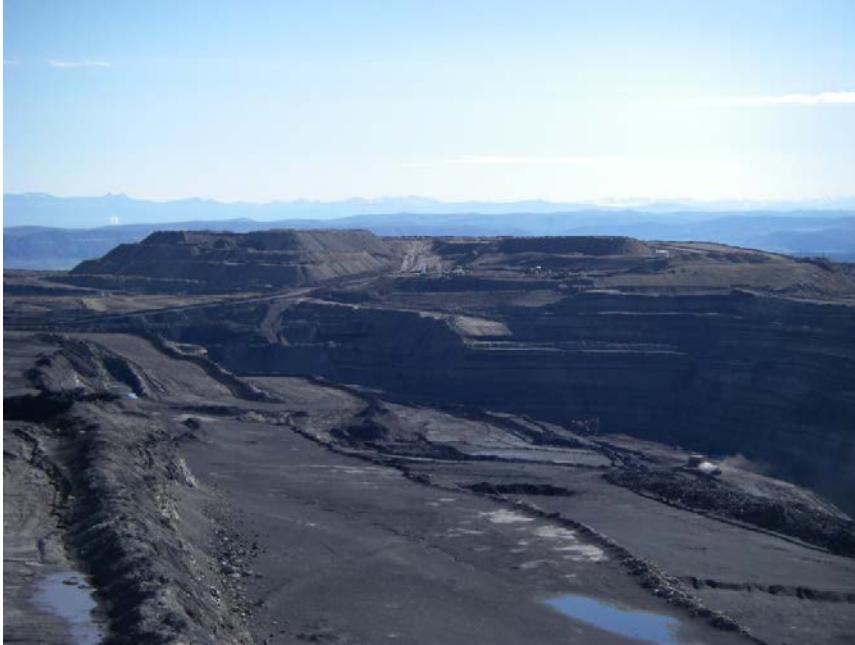
On May 22, in the South Taylor Pit the large excavator (115) was seen loading trucks with overburden.

**South Taylor Pit (facing northeast)**

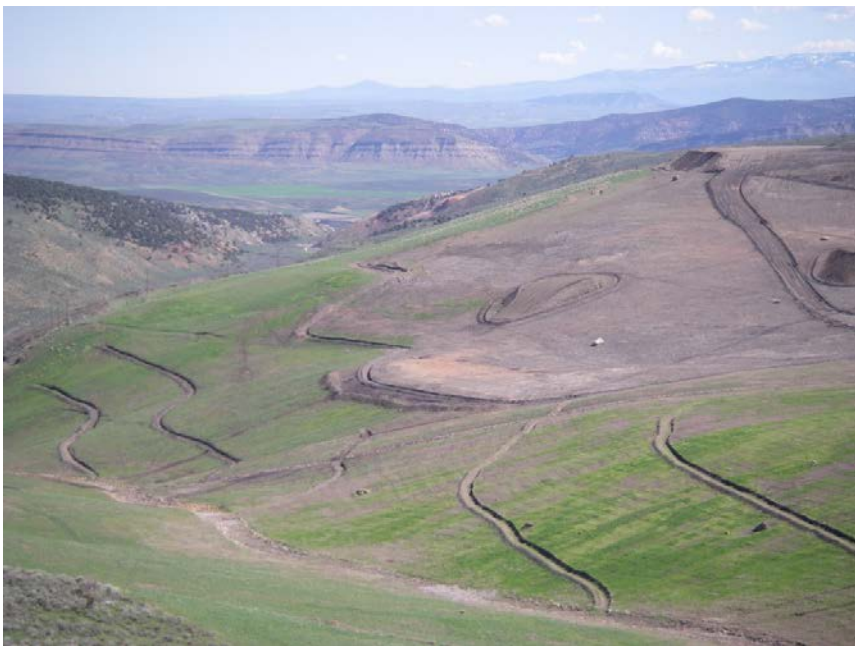
In the West Pit reclamation area, good vegetation growth was seen in the reclamation blocks from 2008 – 2011. The 2012 area is still relatively bare.

**West Pit reclamation (looking north from runaway truck ramp)**

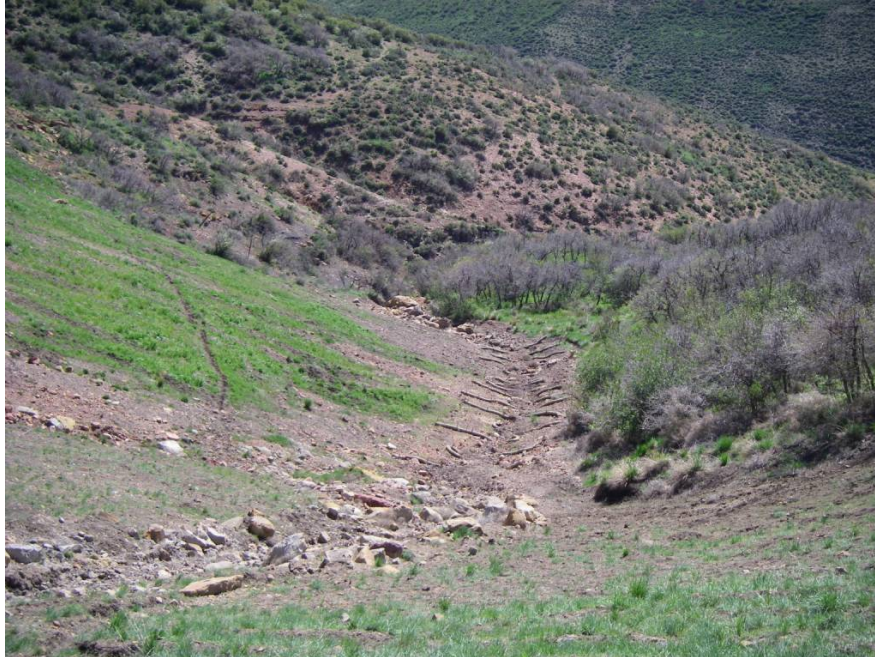
The section of Prospect Ditch that was repaired in 2012 (at the edge of the undisturbed area) was inspected, and it generally looked good. Some of the wattles require maintenance. Upper Prospect Ditch (above PD1 Pond) was inspected, and the following dimensions were estimated: the bottom was found to be approximately 12 feet wide, and the riprap D50 is greater than 18 inches. In the vegetated portion of the ditch below PD2 Pond, the bottom was estimated at 12 feet and the shape is basically trapezoidal; the depth appears to be less than two feet, however, only minor erosion was seen in the channel.

**Prospect Ditch - repairs with wattles**

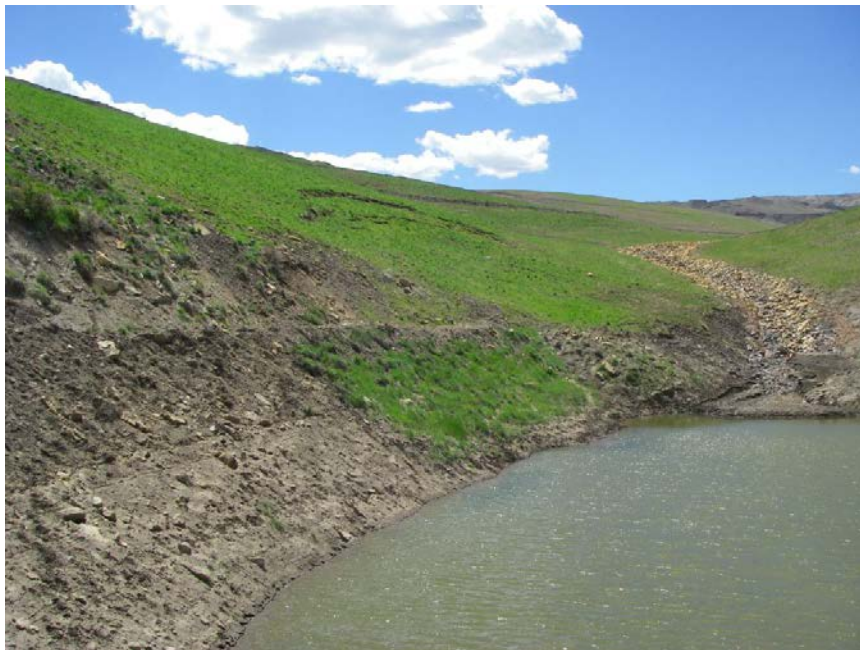
**Slump above East Taylor Pond**

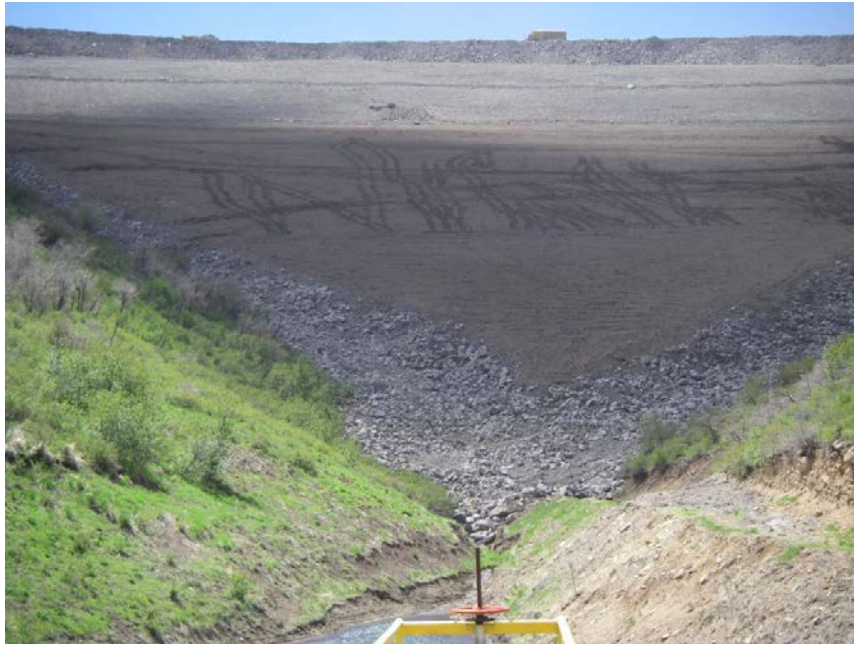
As noted elsewhere in this report, rills have been repaired on the surface of the West Taylor fill, although some remain. Also, the contour ditches and side ditches are in compliance with the PAP.

**West Taylor Fill – rills have been repaired**

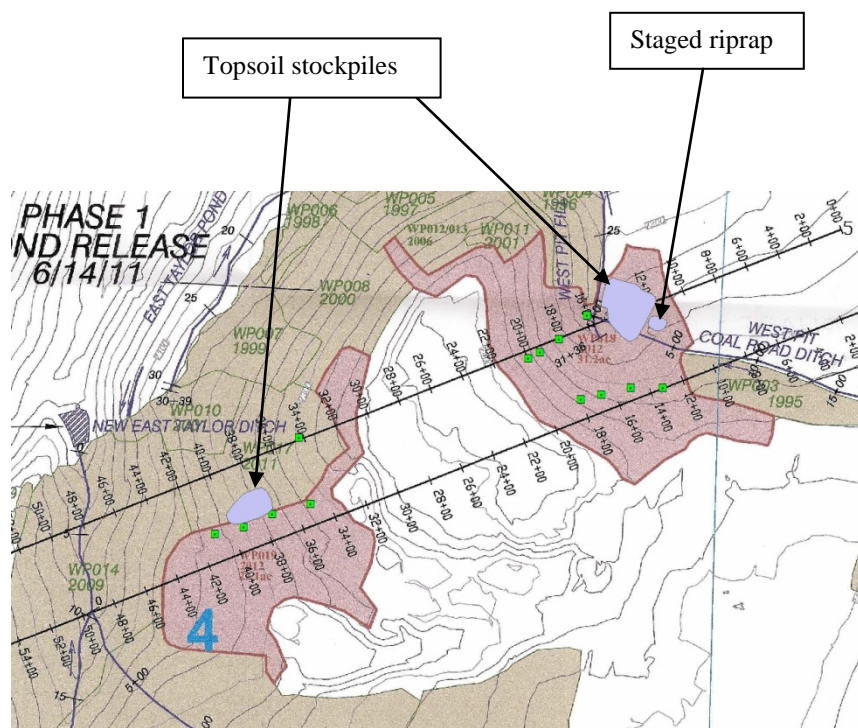
The elevations of the data collected by Jason have been compared to elevation information provided in the SL-7 Bond Release application. After the correction described above, all elevation points were found to be between +/- 20 feet of the as-built elevations, shown on SL-07 Exhibits 1, 2A, and 2B. Given the expanse of the mine site and the steepness of the terrain at Colowyo, the difference in elevation is acceptable.

**West Pit – approximate locations of GPS points for elevation check**

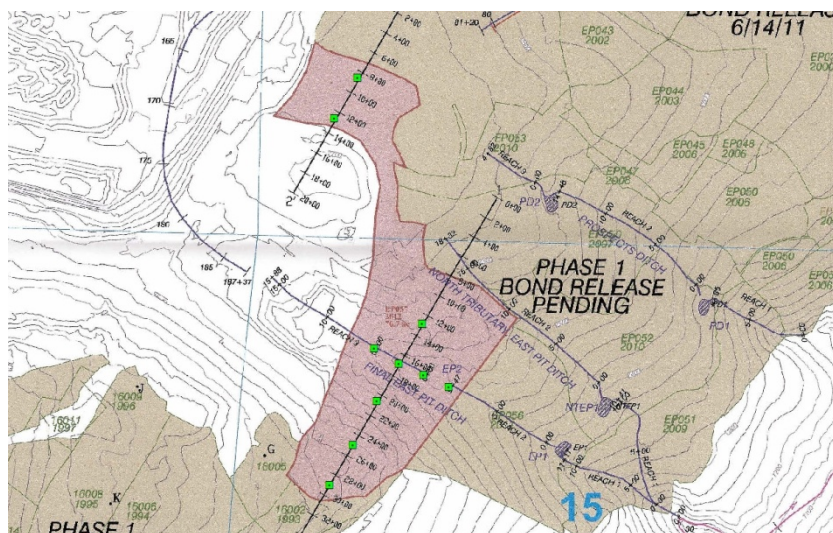
**East Pit – approximate locations of GPS points for elevation check**

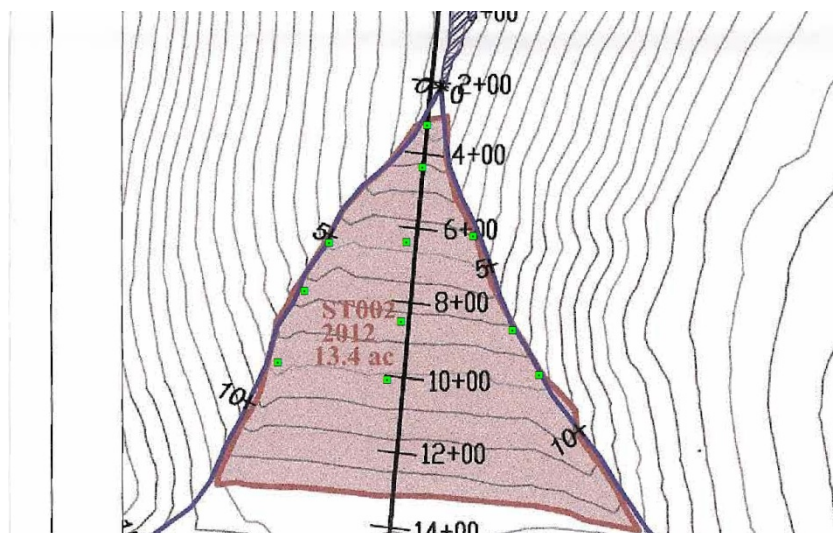
**West Taylor Fill – approximate locations of GPS points for elevation check**
