**COLORADO DIVISION OF RECLAMATION, MINING AND SAFETY
COAL PROGRAM INSPECTION REPORT**

Permit Number: C-1981-015 Mine Name: Fruita No 1 & 2 Operator: Dorchester Coal Company Operator Address:	County: Mesa Operation Type: Underground Permit Status: Revoked Ownership: Private
	Operator Representative Present: None
Operator Representative Signature: (Field Issuance Only)

Inspection Start Date: May 29, 2013 Inspection Start Time: 15:00 Inspection End Date: May 29, 2013 Inspection End Time: 15:45		Inspection Type: Coal Partial Inspection Inspection Reason: Normal I&E Program Weather: Clear	
Joint Inspection Agency: None		Joint Inspection Contacts:	
Post Inspection Agency: None		Post Inspection Contacts:	
Inspector(s): Michael P. Boulay Carla V. DeMasters	Inspector's Signature: <i>Michael P. Boulay</i>		Signature Date: 6/4/13

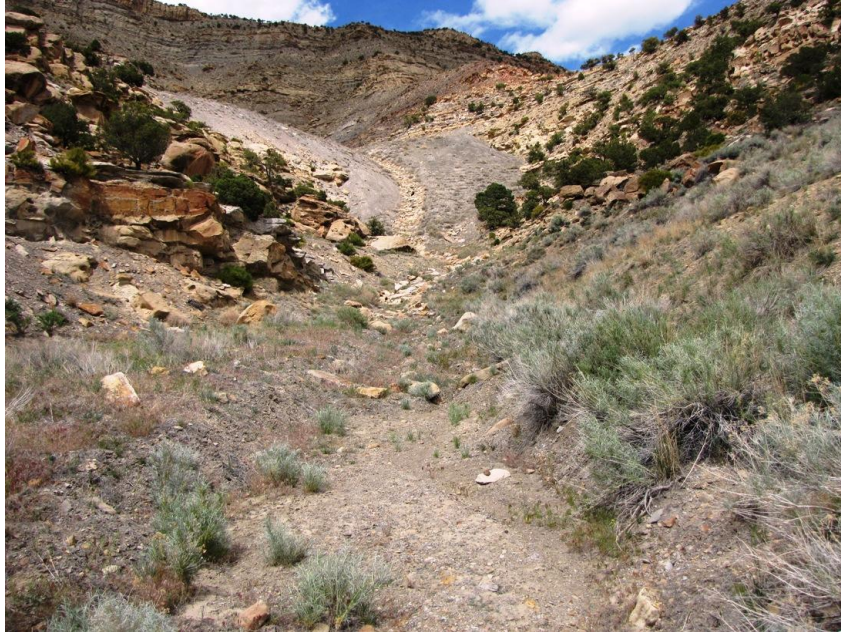
The mine site was dry at the time of the inspection. The main riprap drainage channel is well constructed and remains stable and in good condition (see Photograph No. 1). The sediment pond was completely dry. The pond embankment and spillway are stable.

Photo No. 1 - Fruita Mine portal bench and permanent drainage channel.

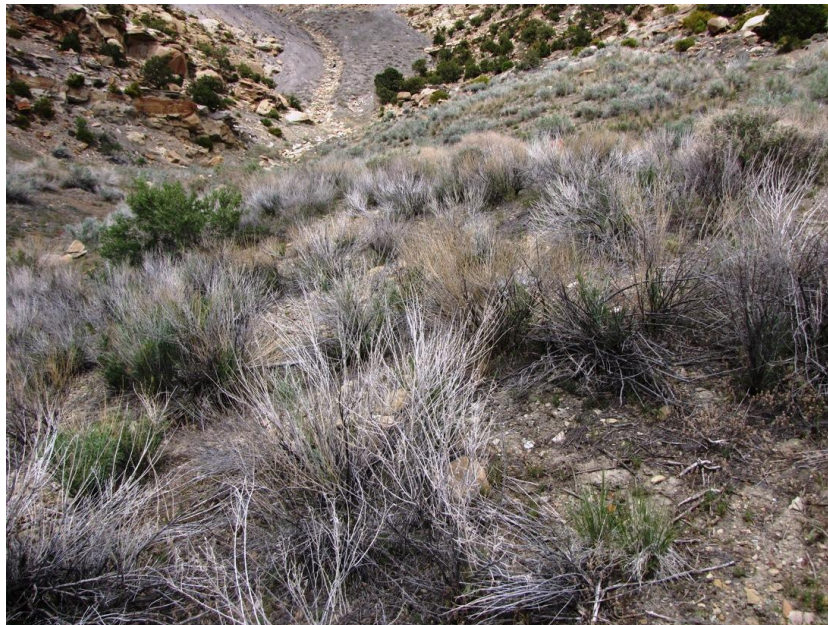
Shrubs were well established in the reclaimed areas at the Fruita Mine – dominant shrubs included fourwing saltbush and rubber rabbitbrush. Some die off of these shrub species was noted in the reclaimed areas as well (see Photograph No. 2). Perennial grass and forb establishment was minimal in the areas dominated by shrubs.

Photo No. 2 – Reclaimed area showing some die-off of shrub species.
