**COLORADO DIVISION OF RECLAMATION, MINING AND SAFETY
COAL PROGRAM INSPECTION REPORT**

Permit Number: C-1981-041 Mine Name: Roadside Portals Operator: Snowcap Coal Company, Inc. Operator Address: Ms. Tonya Hammond P.O. Box 1430 Palisade, CO 81526	County: Mesa Operation Type: Underground Permit Status: Permanent Cessation Ownership: Federal
	Operator Representative Present: None
Operator Representative Signature: (Field Issuance Only)

Inspection Start Date: May 30, 2013 Inspection Start Time: 09:00 Inspection End Date: May 30, 2013 Inspection End Time: 12:45		Inspection Type: Coal Partial Inspection Inspection Reason: Normal I&E Program Weather: Clear	
Joint Inspection Agency: None		Joint Inspection Contacts: 	
Post Inspection Agency: None		Post Inspection Contacts: 	
Inspector(s): Michael P. Boulay Carla V. Demasters	Inspector's Signature: <i>Michael P. Boulay</i>		Signature Date: 6/4/13

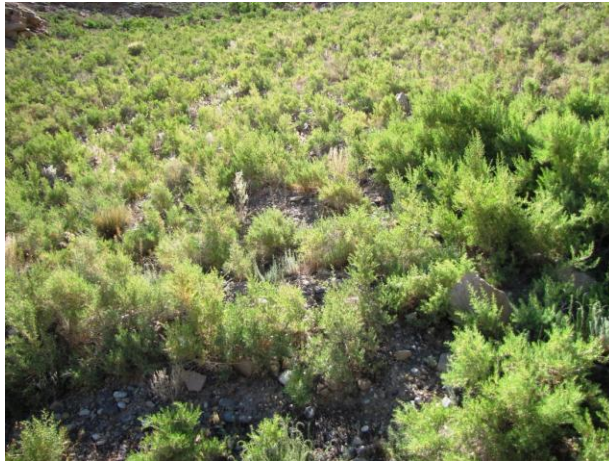
The South Portals Area was dominated by a dense stand of greasewood accompanied by lesser amounts of winterfat and forage kochia (AKA prostrate kochia). Perennial grass establishment in this area was minimal.

Reclaimed South Portal mine entries.

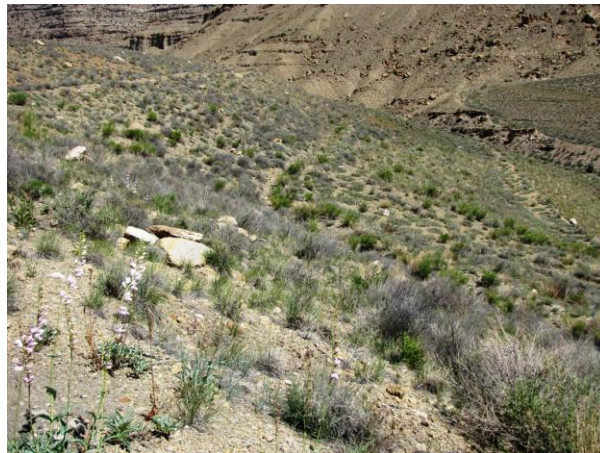
Revegetation was in excellent condition at CRDA-1 – which had a diverse mix of shrubs, perennial forbs, and cool and warm season perennial grasses. Cover by cheatgrass in the areas of CRDA-1 seen was minimal. Revegetation

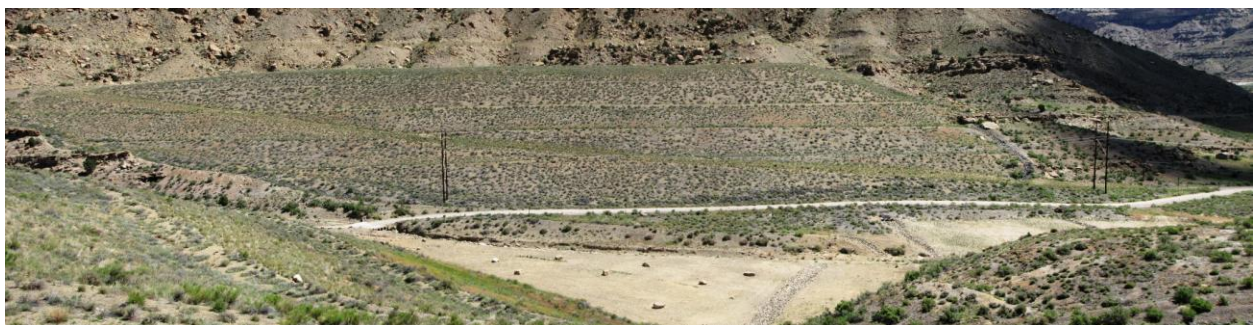
at CRDA-2 appeared to be well established from a distance.

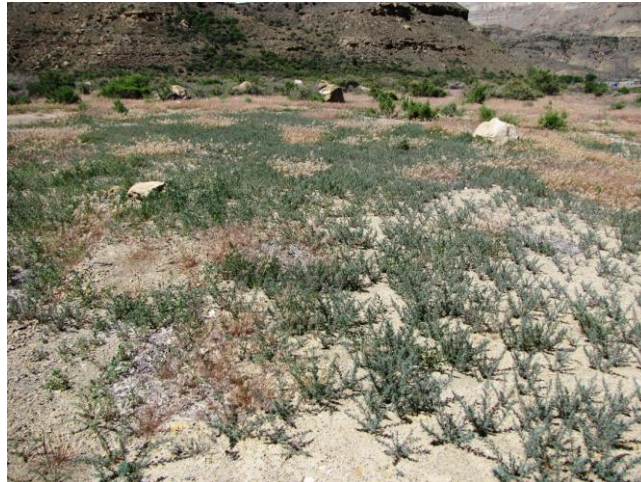
Vegetation at reclaimed Pond 7 was dominated by Halogeton (Colorado List C Noxious Weed) with smaller patches of cheatgrass. There was minimal presence of seeded species. To ensure compliance please manage the growth of noxious weeds at the reclaimed Pond 7 location.

Pond 7 - poor vegetation establishment and weed growth.

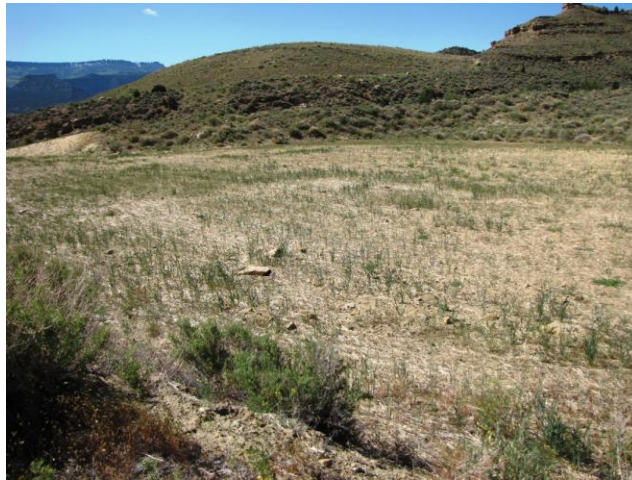
Location of reclaimed Pond 11.

Seeded plants were also not yet established at the newly reclaimed Ponds 11, 6 and 10, which had a patchy cover of weedy annual forbs and wheat introduced from the straw mulch, which covered these sites. These pond areas were all revegetated in October 2012.

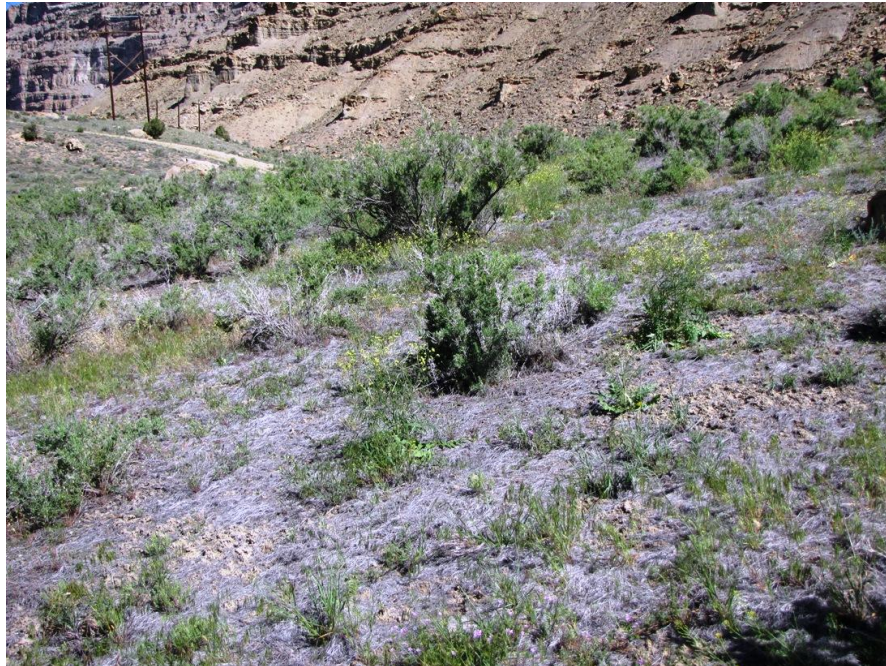
Greasewood Reference Area

Cheatgrass was present in abundance in both the Greasewood and Shadscale reference areas. Annual wheatgrass was also present in abundance in the Greasewood reference area. Annual forbs noted in the reference areas included tall tumbled mustard and stork's bill. Native thistles with white flowers (probably New Mexico thistle) were blooming in the Shadscale reference area. Evidence of heavy cheatgrass cover in previous years was present in the form of a cheatgrass litter layer on the ground in both areas.
