**COLORADO DIVISION OF RECLAMATION, MINING AND SAFETY
COAL PROGRAM INSPECTION REPORT**

Permit Number: C-1981-012 Mine Name: New Elk Mine Operator: New Elk Coal Company, LLC Operator Address: Mr. Ron Thompson 12250 Highway 12 Weston, CO 81091	County: Las Animas Operation Type: Underground Permit Status: Temporary Cessation Ownership: Private
	Operator Representative Present: Dennis Wilson
Operator Representative Signature: (Field Issuance Only) N/A – Report Issued from Denver Office

Inspection Start Date: May 23, 2013 Inspection Start Time: 07:30 Inspection End Date: May 23, 2013 Inspection End Time: 13:00	Inspection Type: Coal Partial Inspection Inspection Reason: Normal I&E Program Weather: Clear
Joint Inspection Agency: None	Joint Inspection Contacts: None
Post Inspection Agency: None	Post Inspection Contacts: None
Inspector(s): James R. Stark	Inspector's Signature:

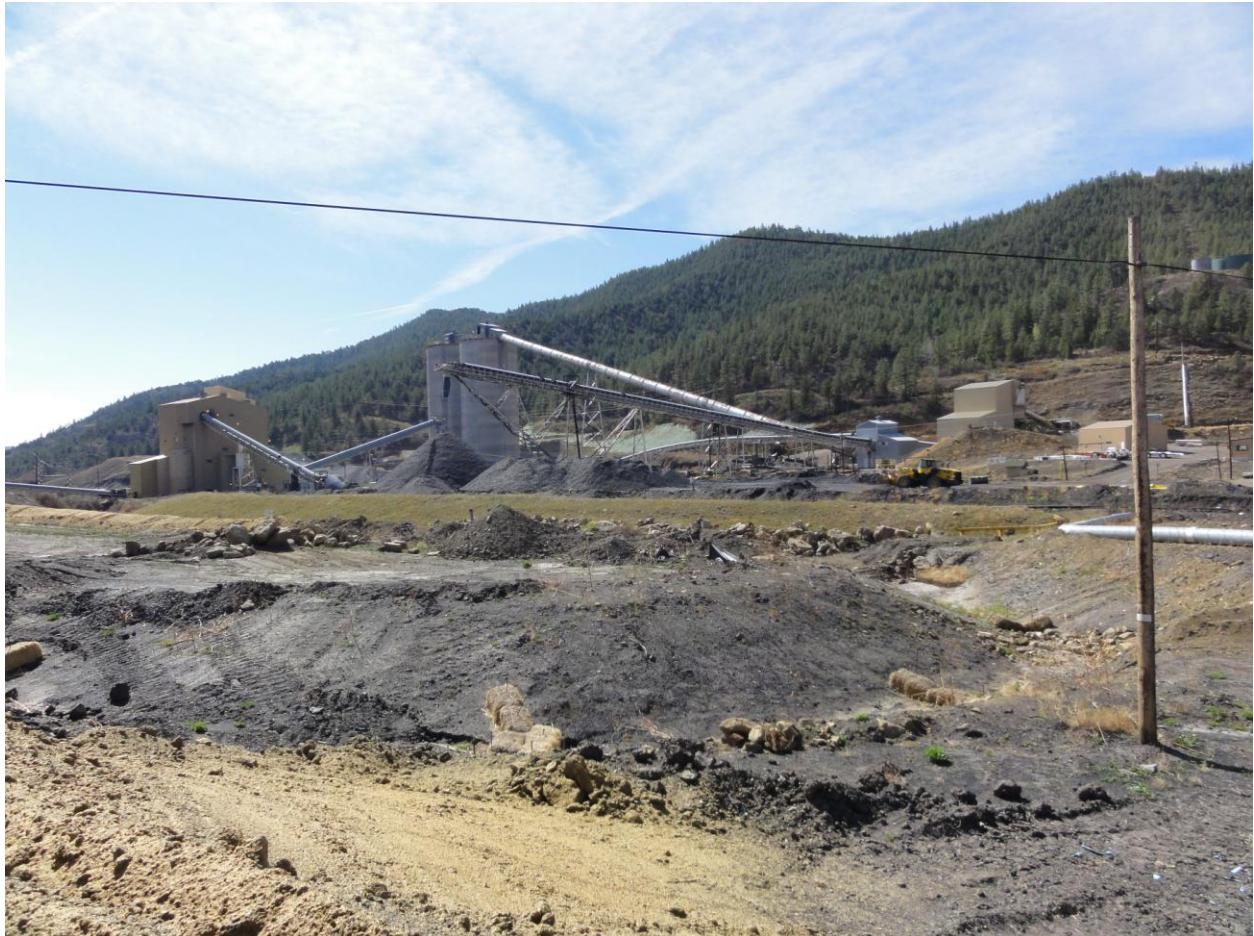
SAE at north side of new DWP

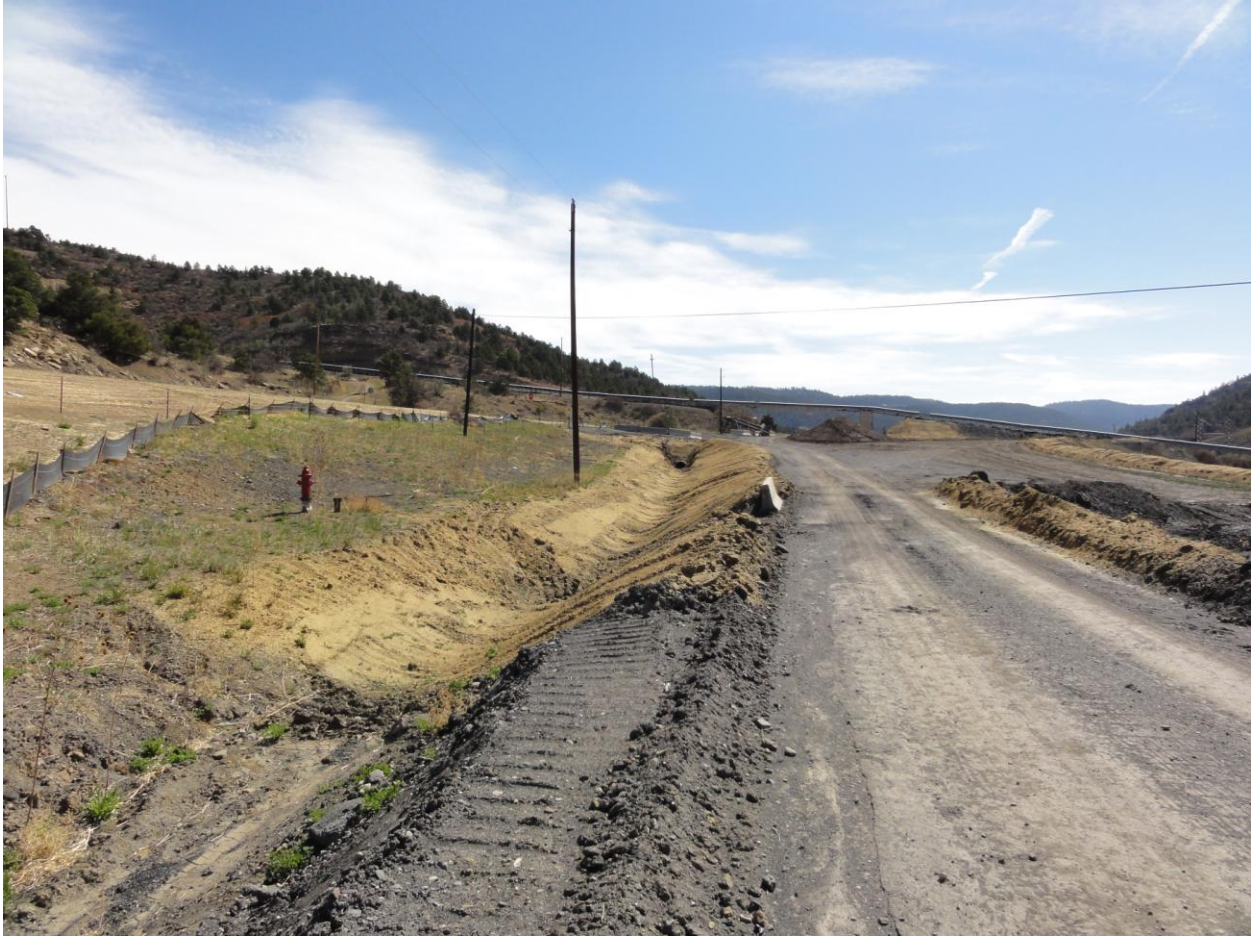
- The ditch along the river by the pump house (ditch D11) was just hydroseeded. The hydroseeding included mulching, which is still in place.
- The east portion of ditch D-19, along the surface disturbance boundary and Colorado Highway 12, was recently hydroseeded and hydromulched. The area remained stable and all of the mulch is still in place.

Hydroseeding at ditch D-19

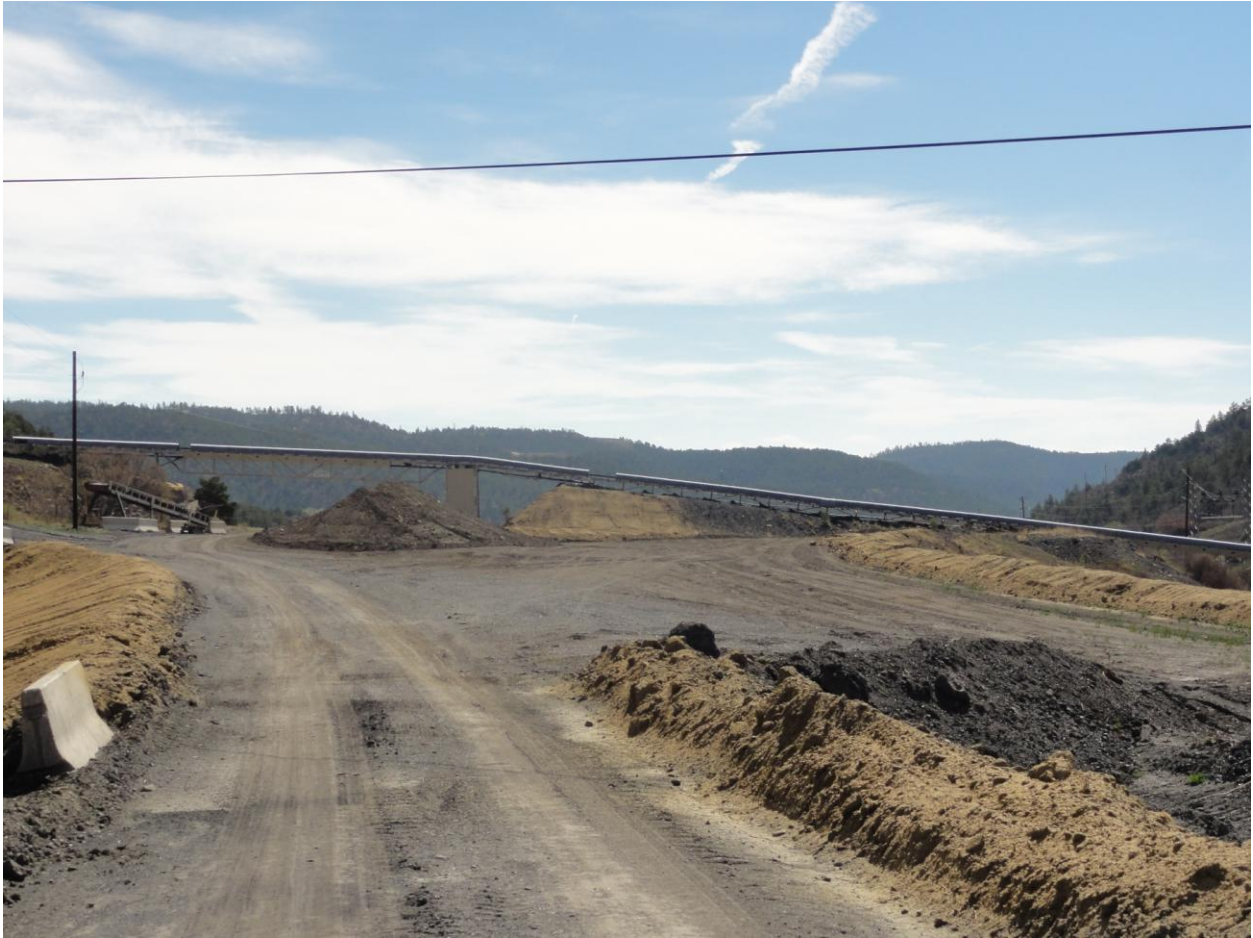
Hydroseeding at area under refuse conveyer
