COLORADO DIVISION OF RECLAMATION, MINING AND SAFETY COAL PROGRAM INSPECTION REPORT

Permit Number: C-1996-084 Mine Name: Lorencito Canyon Mine Operator: New Elk Coal Company, LLC Operator Address: Mr Ron Thompson 12250 Highway 12 Weston, CO 81091	County: Las Animas Operation Type: Surface Permit Status: Permanent Cessation Ownership: Private
	Operator Representative Present: Brian Wilson
Operator Representative Signature: (Field Issuance Only) N/A – Report issued from Denver office

Inspection Start Date: May 23, 2013 Inspection Start Time: 13:30 Inspection End Date: May 23, 2013 Inspection End Time: 16:00	Inspection Type: Coal Partial Inspection Inspection Reason: Normal I&E Program Weather: Clear
Joint Inspection Agency: None	Joint Inspection Contacts: None
Post Inspection Agency: None	Post Inspection Contacts: None
Inspector(s): James R. Stark	Inspector's Signature:

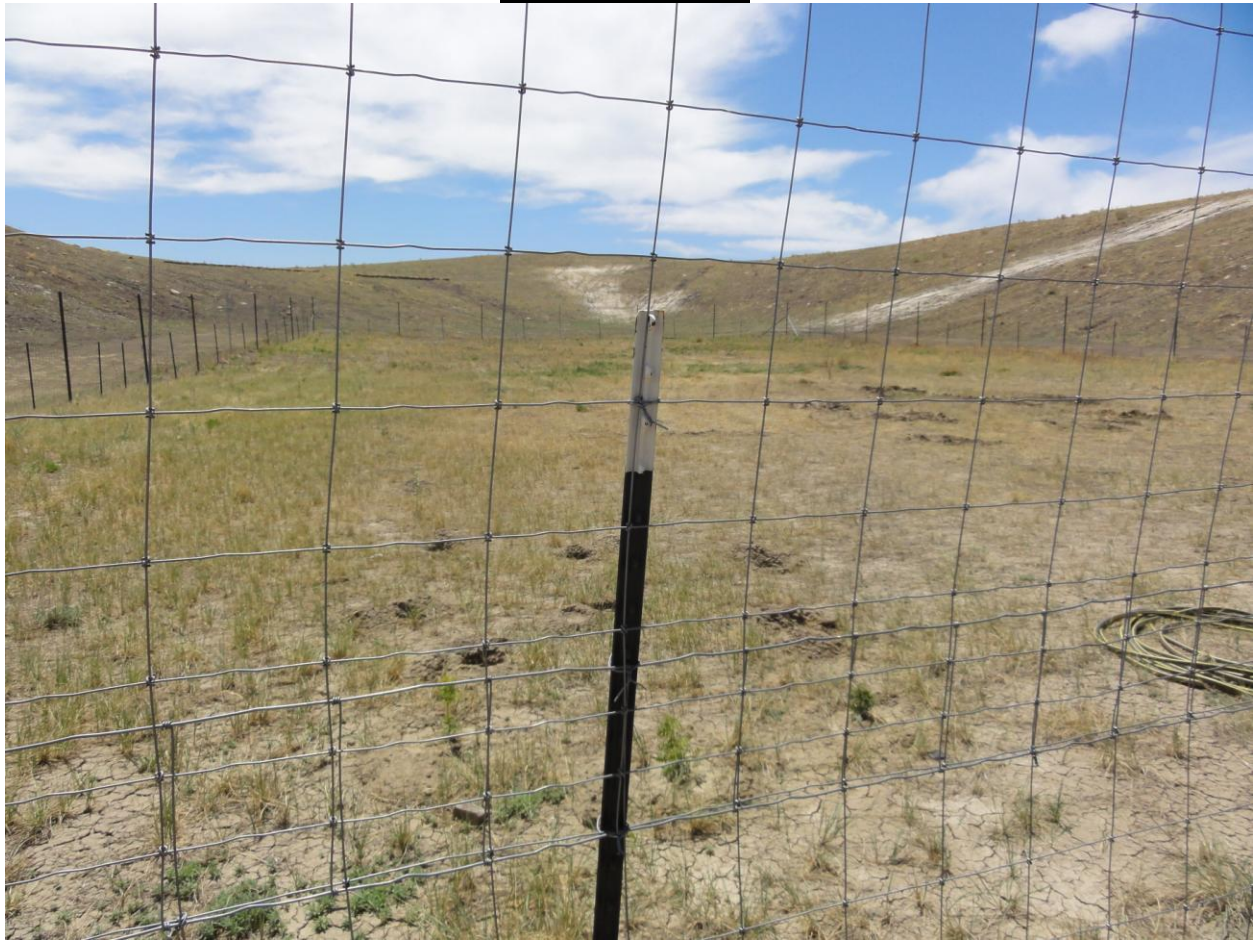
- The operator planted 500 assorted shrubs and trees in an enclosure just south of excess spoil fill 8 (just before the 90° bend in the haul road). The operator is currently watering the shrubs and trees to make sure they survive the relatively dry summer.

Shrub enclosure with 500 various shrubs and trees
