COLORADO DIVISION OF RECLAMATION, MINING AND SAFETY
MINERALS PROGRAM INSPECTION REPORT
PHONE: (303) 866-3567

MINE NAME: McKenna Limestone Quarry	MINE/PROSPECTING ID#: M-2000-039	MINERAL: Limestone (general)	COUNTY: Huerfano
INSPECTION TYPE: Monitoring	INSPECTOR(S): Timothy A. Cazier	INSP. DATE: April 30, 2013	INSP. TIME: 12:30
OPERATOR: Delhur Industries, Inc.	OPERATOR REPRESENTATIVE: James Lott	TYPE OF OPERATION: 110c - Construction Limited Impact

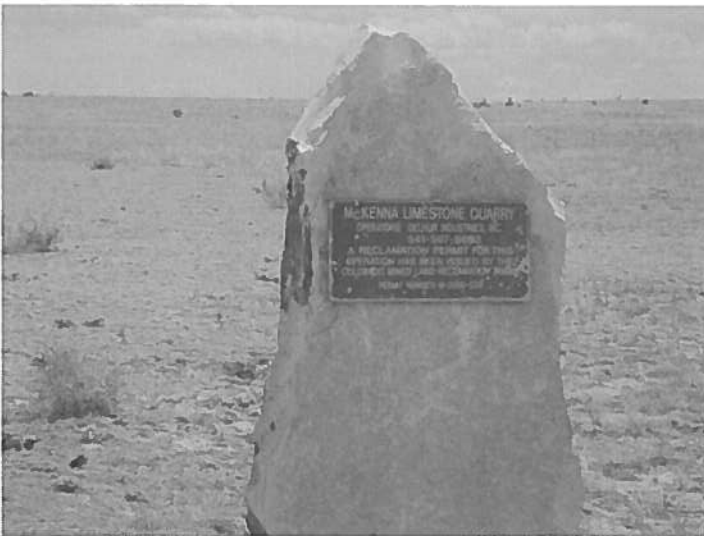
Permit Boundary: A permit sign was posted at the entrance road off CR 211 (see **Photo 1**). Exhibit E.2, Mining Map from the permit application indicates boundary monuments are marked with 5/8" rebar. No boundary markers could be located. **This is cited as a problem on page 1 of this report.** It should be noted that the legal description in Exhibit A of the permit application references a "1921 G.L.O. brass cap" in the "west half of Section 31, Township 27 south, Range 64 west, sixth principal meridian" as a beginning point for the survey. A copy of Exhibit A is included for reference.

Photo 1. Permit sign at entrance.

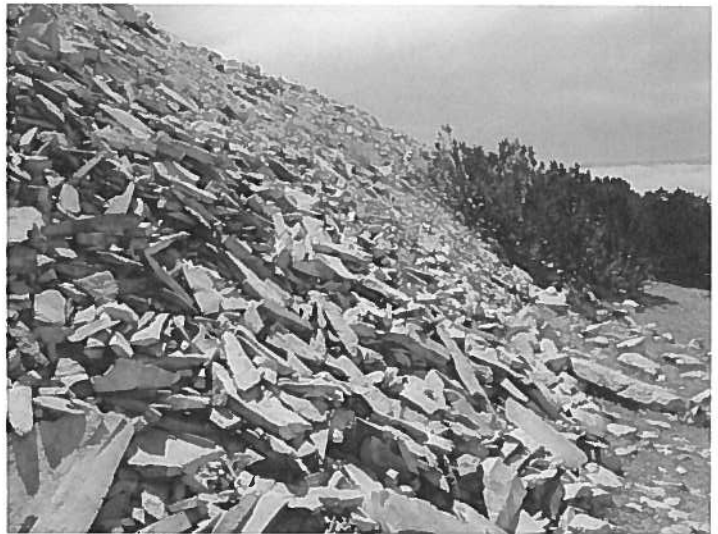
Pit & Permit Area: Two large and one smaller stockpile were observed north of the pit. The largest stockpile on the northern edge of disturbance consists of finer material with long slender angular rock (**Photo 2**). The smaller stockpile contained large dimensional stone (**Photo 3**). The other large stockpile contained medium sized dimensional stone (**Photo 4**). Pit highwall are 6 to 12 feet high exposing limestone and weathered shale (**Photo 5**). The overburden appears to be weathered shale ranges from a few inches to perhaps two feet in thickness.

Photo 2. North stockpile: fines & long slender rock.

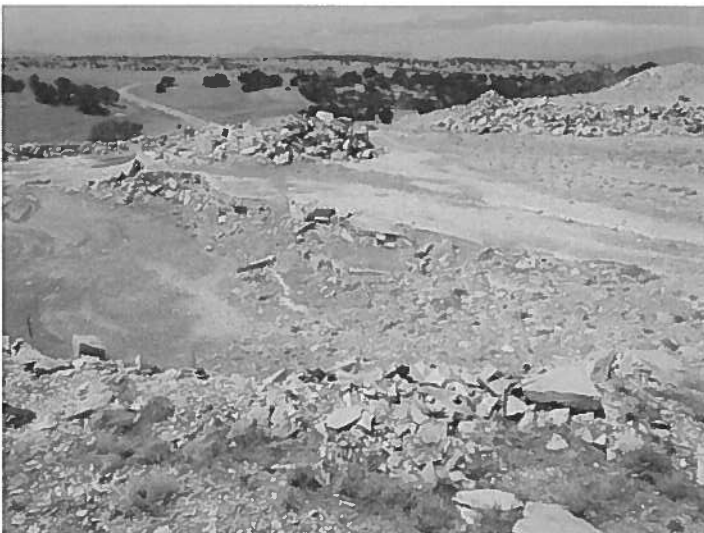
Photo 3. Small stockpile of large rock (looking west).

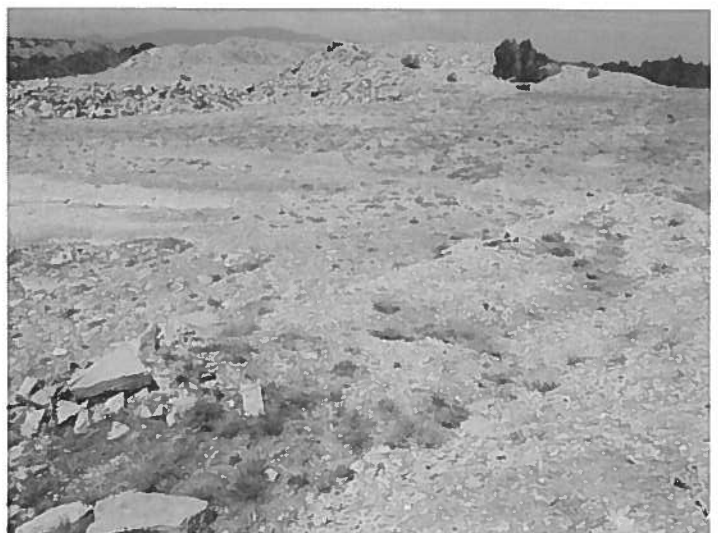
Photo 4. Large medium rock stockpile (looking NW).

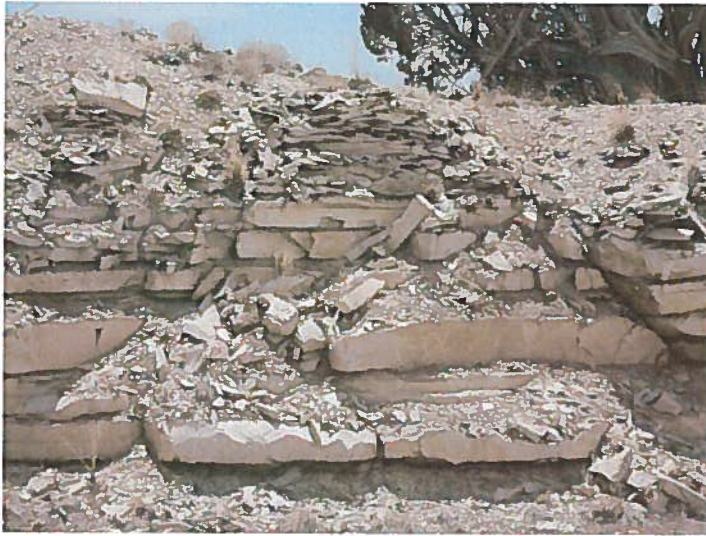
Photo 5. Typical highwall: limestone & weathered shale.

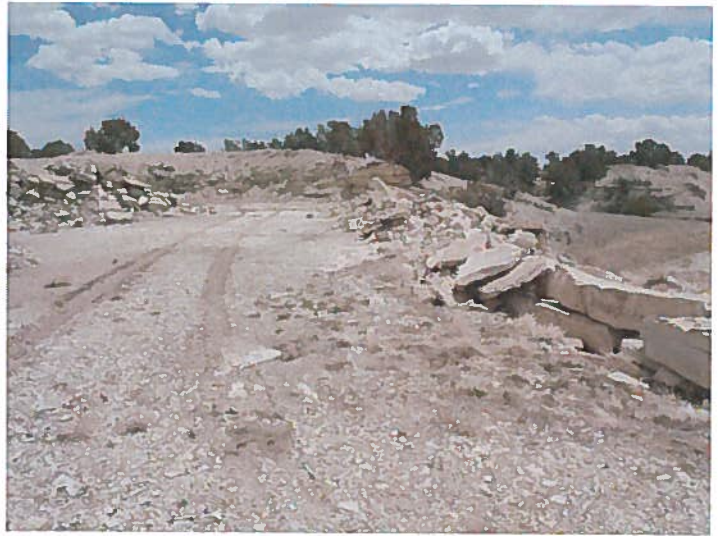
No standing water was observed in the pit which is sloped to drain to the adjacent arroyo (**Photo 6**). No noxious weeds were observed.

Photo 6. Pit sloped to drain (looking east).

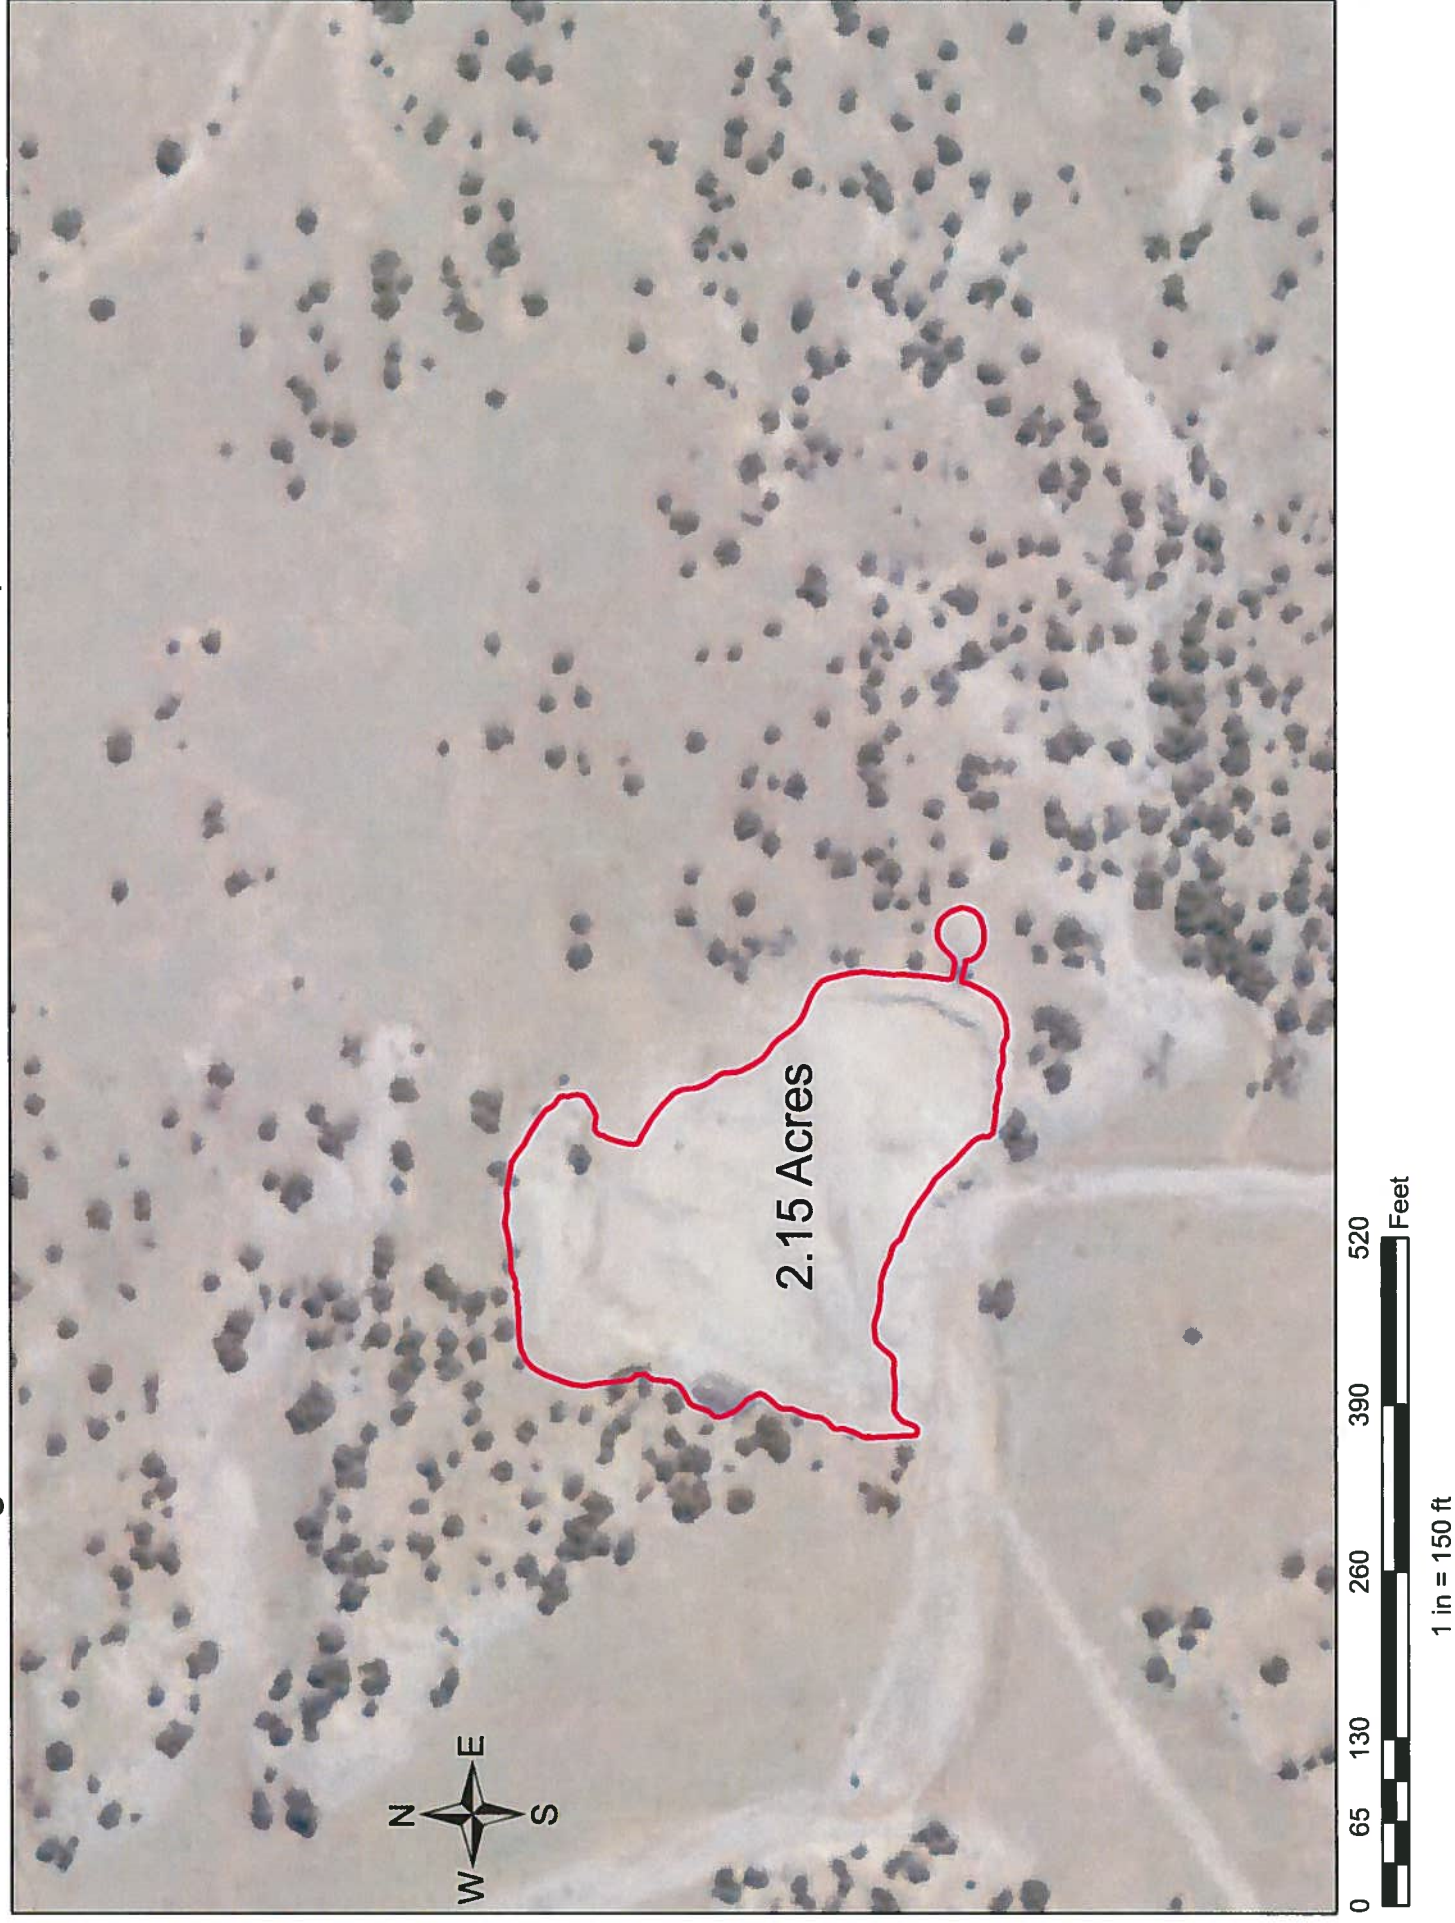
Figure 1. M-2000-039 Disturbed Area Measured April 30, 2013

This inspector used a Trimble Juno GPS receiver for field data collection. The disturbance in the vicinity of the main pit was measured to be 2.15 acres (see **Figure 1**).

Adjacent Lands: The absence of locatable boundary markers made efforts to assess impacts to adjacent properties unreliable. Based on permit maps, the disturbed area may be outside the permit boundary on the west and northwest side. Mr. Lott indicated the Operator could have the site re-surveyed and boundaries marked with more permanent monuments.

1. The Division requires the Operator re-survey the permit boundary and install permanent markers in order for the Division to determine if mine related disturbances are within the permit boundary by the due date stated on page 1 of this report.
2. The Operator shall provide the Division with documentation from a registered land surveyor that the site has been re-surveyed by the due date stated on page 1 of this report.
3. The Operator shall provide the Division with photographic documentation of the visible/locatable boundary markers by the due date stated on page 1 of this report.
