**COLORADO DIVISION OF RECLAMATION, MINING AND SAFETY**  
**MINERALS PROGRAM INSPECTION REPORT**  
**PHONE: (303) 866-3567**

<b>MINE NAME:</b> Norwood Pit	<b>MINE/PROSPECTING ID#:</b> M-1981-154	<b>MINERAL:</b> Sand and gravel	<b>COUNTY:</b> San Miguel
<b>INSPECTION TYPE:</b> Monitoring	<b>INSPECTOR(S):</b> Kate A. Pickford	<b>INSP. DATE:</b> May 29, 2013	<b>INSP. TIME:</b> 11:30
<b>OPERATOR:</b> San Miguel County	<b>OPERATOR REPRESENTATIVE:</b> Bill Wilson	<b>TYPE OF OPERATION:</b> 112c - Construction Regular Operation

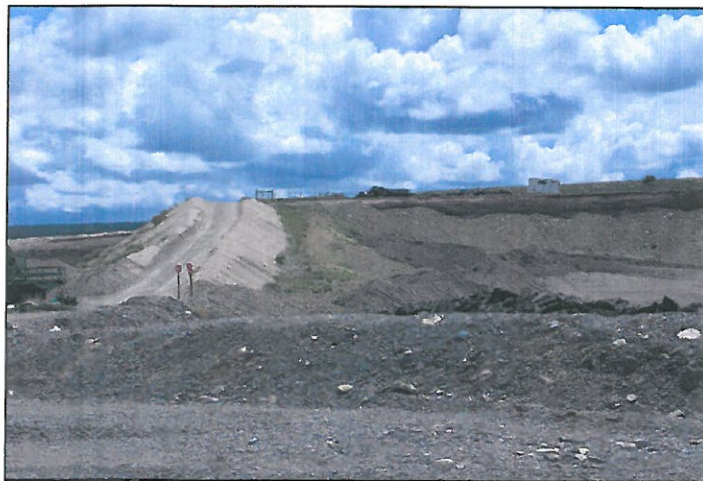
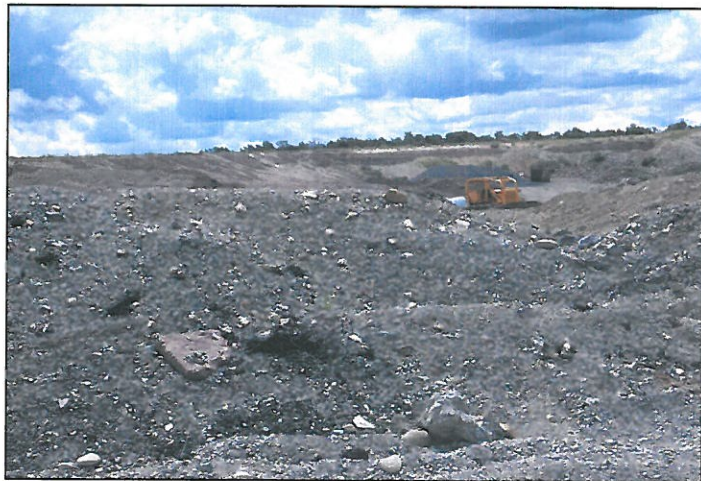
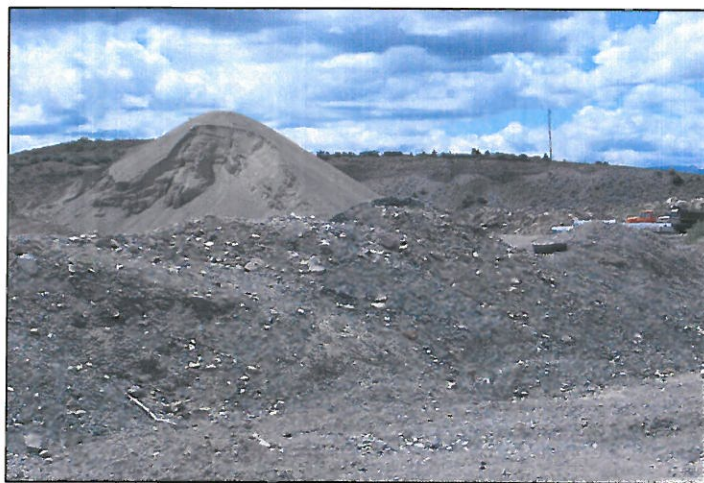
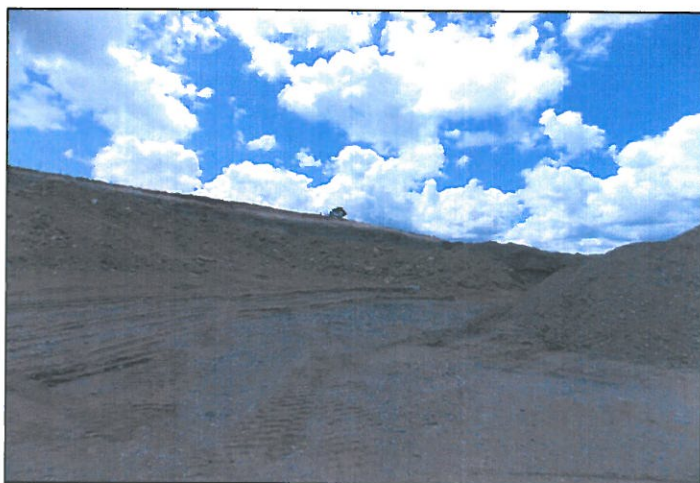
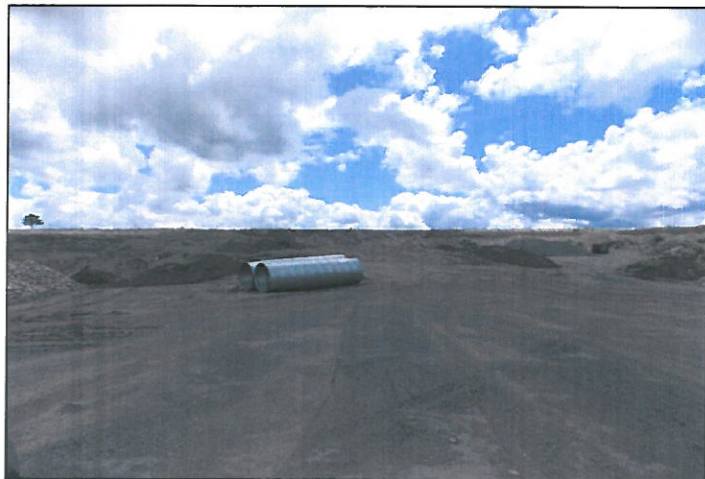
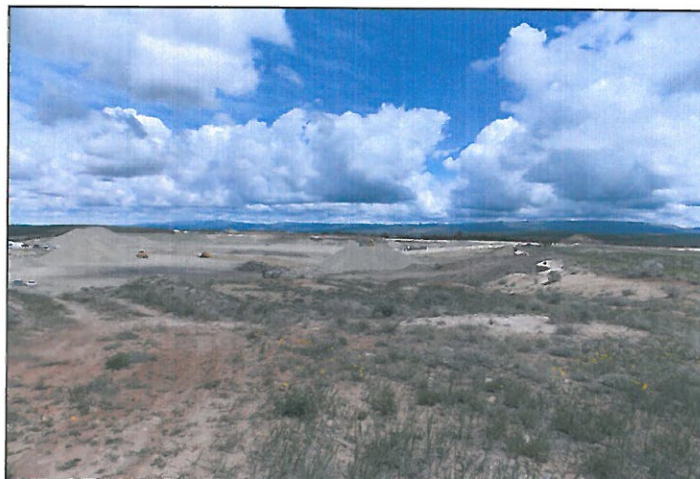
PHOTOGRAPHS

This inspection was conducted as part of the Division of Reclamation, Mining and Safety monitoring program. The condition of the site is similar to that present at the 2008 inspection. A sign is posted at the entrance to the site. The boundaries are easily identified by fences along the edges of the permitted area, with the exception of the center line between this and an adjacent, permitted site. The disturbance at this site consists of a pit covering much of the permitted site, although there is some ground to the west that has not yet been excavated. Large stockpiles of material are contained on the pit floor. Topsoil has been stockpiled and well preserved with vegetation.
