**COLORADO DIVISION OF RECLAMATION, MINING AND SAFETY
COAL PROGRAM INSPECTION REPORT**

Permit Number: C-1992-081 Mine Name: Hayden Gulch Loadout Operator: Hayden Gulch Terminal, LLC Operator Address: Mr. Roy Karo 37796 Routt County Road 53 P.O. Box 670 Hayden, CO 81639	County: Routt Operation Type: Loadout Permit Status: Permanent Cessation Ownership: Private
	Operator Representative Present: Roy Karo
Operator Representative Signature: (Field Issuance Only)

Inspection Start Date: June 3, 2013 Inspection Start Time: 14:22 Inspection End Date: June 3, 2013 Inspection End Time: 16:20		Inspection Type: Coal Partial Inspection Inspection Reason: Normal I&E Program Weather: Clear	
Joint Inspection Agency: None		Joint Inspection Contacts:	
Post Inspection Agency: None		Post Inspection Contacts:	
Inspector(s): Jared L. Ebert	Inspector's Signature:

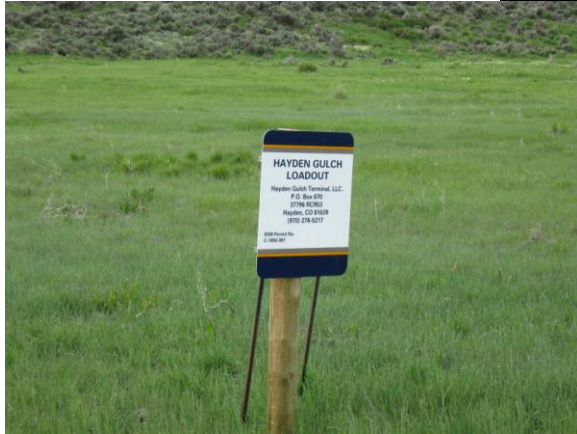
East Entrance Sign

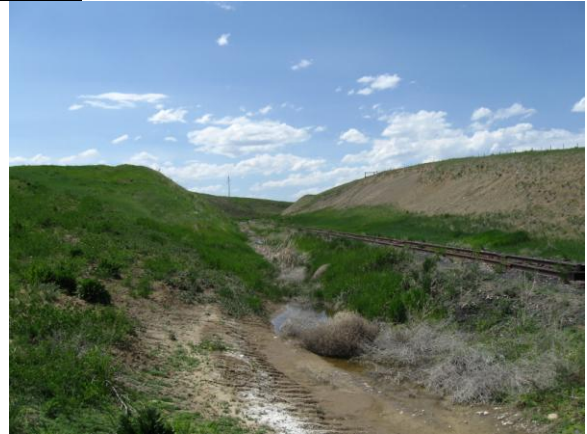
Ditch No. 8 is still holding water and needs to be repaired to restore positive drainage.

Ditch 8 holding water.

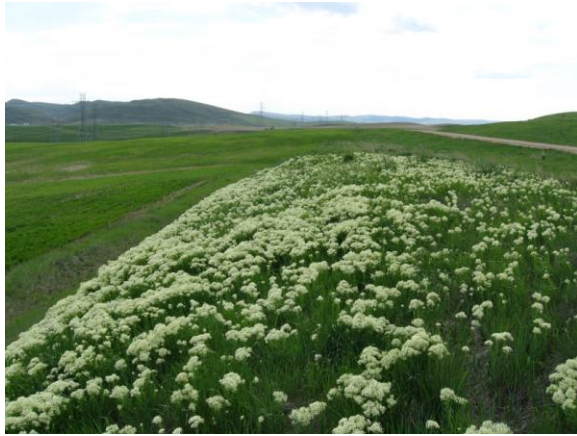
The topsoil stockpiles along the Tie-Across Haul Road were inspected. Each pile was marked with a topsoil identification sign. The piles were stable with dense vegetation cover. A containment berm is in place around each stockpile. Stockpile A, C and G contained several large patches of *Cardaria draba* (Pennycress). Pile G was primarily vegetated with pennycress and *Chorispora tenell*, Blue Mustard.

Topsoil stockpile C. Pennycress

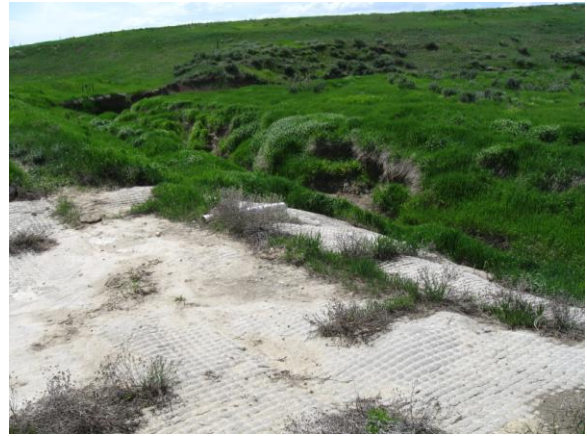
The rail loop pond was holding water but was not discharging. The primary and emergency spillway was stable and functional. The earth berm at the discharge pipe in the spillway needs to be repaired. The pond embankment was stable and vegetated.

Rail loop pond spillway.
