**COLORADO DIVISION OF RECLAMATION, MINING AND SAFETY
COAL PROGRAM INSPECTION REPORT**

Permit Number: C-1994-082 Mine Name: Yoast Mine Operator: Seneca Coal Company, LLC Operator Address: Mr. Roy Karo 37796 Routt County Road 53 P.O. Box 670 Hayden, CO 81639	County: Routt Operation Type: Surface Permit Status: Permanent Cessation Ownership: Federal
	Operator Representative Present: Roy Karo
Operator Representative Signature: (Field Issuance Only)

Inspection Start Date: June 3, 2013 Inspection Start Time: 14:00 Inspection End Date: June 3, 2013 Inspection End Time: 17:30	Inspection Type: Coal Partial Inspection Inspection Reason: Normal I&E Program Weather: Clear
Joint Inspection Agency: None	Joint Inspection Contacts:
Post Inspection Agency: None	Post Inspection Contacts:
Inspector(s): Jared L. Ebert	Inspector's Signature:

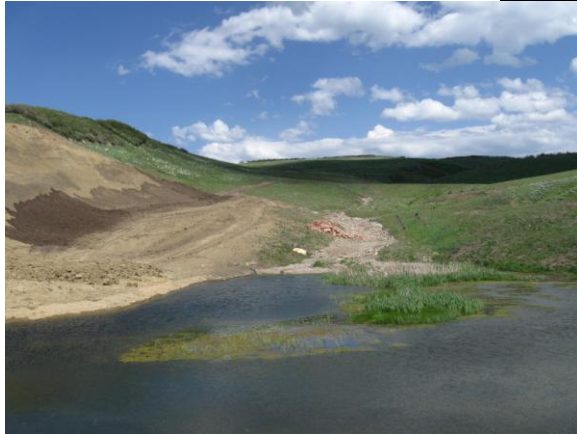
Pond 012 was holding water and discharging. The primary and emergency spillway was clear and functional. The embankment was stable and vegetated.

Pond 012 slide area.

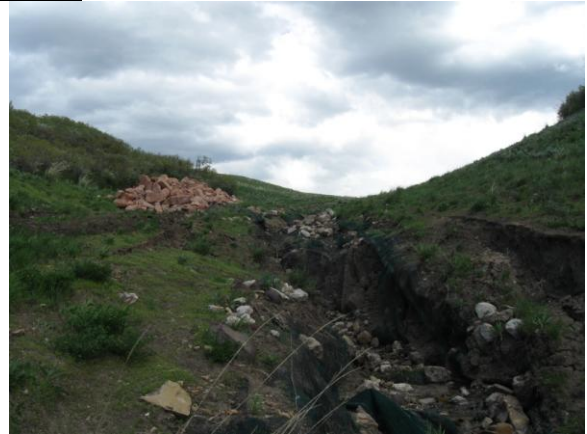
It appears the Operator is conducting several drainage control stabilization measures. New riprap is in place in the upper reaches of YPM-7. A new surge tank has been constructed in the middle of the YPM-7 drainage. It appears additional riprap has been stockpiled at the bottom of YPM-7 for repairs for the lower reaches of this drainage and for the YMP-6-1 drainage. Also, near where YPM-19 intersects YPM-6-1 a stockpile of riprap has been placed for repairs in the YPM-6-1 drainage.

YPM-6-1, riprap stored adjacent to the channel.

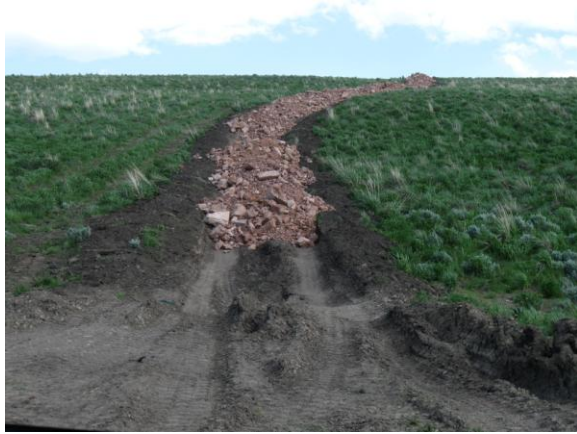
Upper reaches of YPM-7 drainage repair.

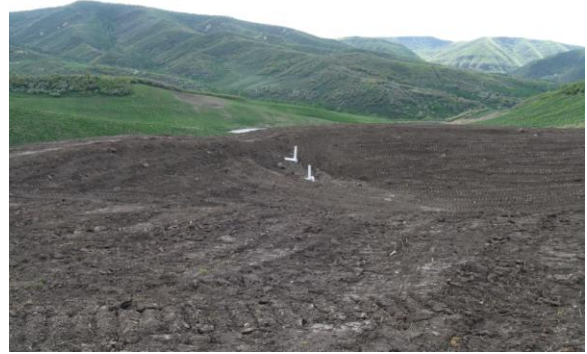
New surge tank in YPM-7 drainage.

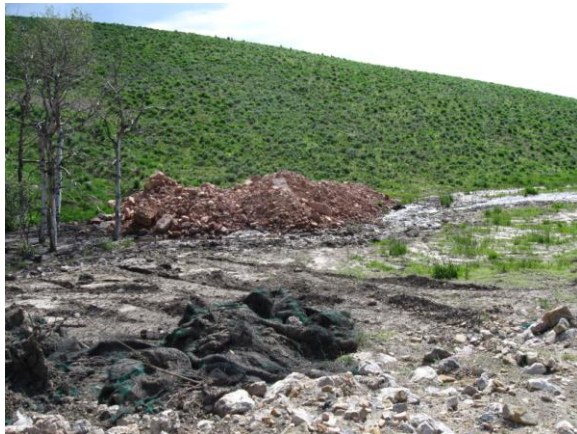
Riprap stockpiled at the base of YPM-7
