# ENGINEER'S INSPECTION REPORT

OFFICE OF THE STATE ENGINEER - DIVISION OF WATER RESOURCES - DAM SAFETY BRANCH

DAM NAME: BATTLE MOUNTAIN SAN LUIS TAILINGS T: 0 R: 0 S: COUNTY: COSTILLA DATE OF INSPECTION: 5/13/2013  
 DAM ID: 240109 YR Compl: 1991 DAM HEIGHT(FT): 140.0 SPILLWAY WIDTH(FT): 4.0 PREVIOUS INSPECTION:  
 CLASS: N hazard DAM LENGTH(FT): 1640.0 SPILLWAY CAPACITY(CFS): 170.0 NORMAL STORAGE (AF): 750.0  
 DIV: 3 WD: 24 CRESTWIDTH(FT): 30.0 FREEBOARD (FT): 10.0 SURFACE AREA(AC): 150.0  
 EAP: Not Required CRESTELEV(FT): 8620.0 DRAINAGE AREA (AC.): 896.0 OUTLET INSPECTED:

## Battle Mountain San Luis Project Tailings Dam: 5/13/13 Dam Safety Inspection Report

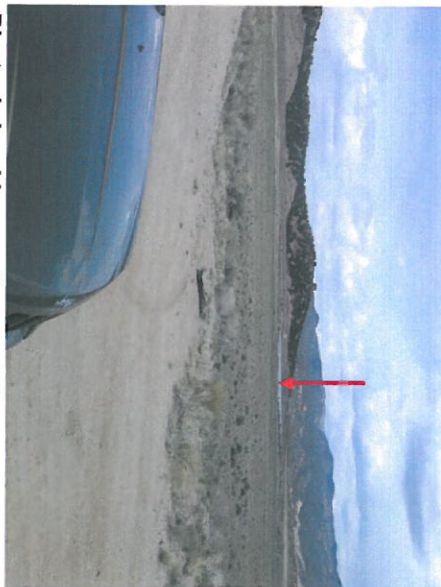
Photo 1- Looking upstream at the tailings containment area from the left abutment of the main dam. During normal operations there is only a small pool of water.

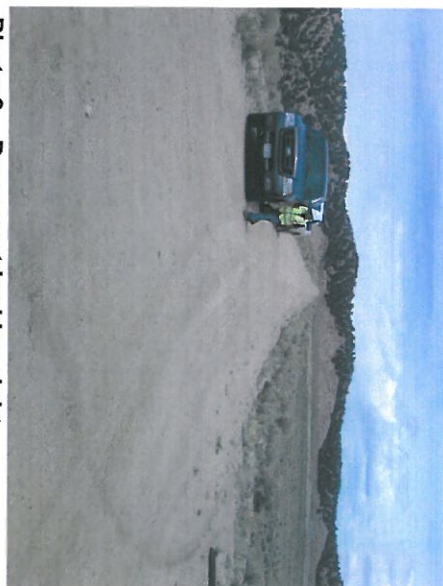
•No signs of distress were observed  
 •The owner recently had a stage capacity and dam crest survey performed. As part of the TR-33 inspection report, we recommend that the dam owner's engineer should verify that the dam crest elevation is maintained for the original design criteria (ex. for PMF storage) around the facility. We specifically discussed that the dam crest profile of the embankment along the 100-YR diversion ditch should be checked.  
 •Maintenance grading has resulted in a windrow of soil along the upstream shoulder, which could inhibit proper surface drainage. We recommend that the crest be graded to drain freely toward the upstream slope to prevent water from ponding on the embankment.  
 •There is a high area on the crest near the right dam abutment where the old seepage recovery pipeline crosses the dam crest. Soil was reportedly added here to provide pipe cover.

Photo 2 – Dam crest looking right from the left abutment.

**- The crest should be graded to promote positive drainage off of the embankment and toward the upstream slope. Remove the windrow along the upstream shoulder.**

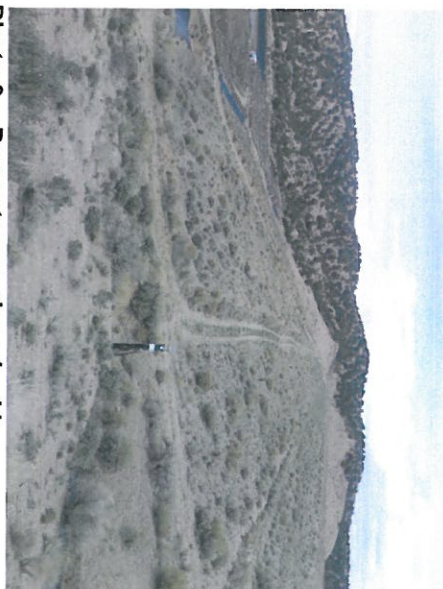
•The Phase I as-built plans show a 3H:1V downstream slope. The existing slope appears to be that or flatter. There are also 2 benches (~10-ft wide each) on top half of the slope.  
 •Vegetation cover is typically sage brush, which is typical for the San Luis Valley climate. No significant surface erosion was observed on the slope. Spot repairs of erosion damage have been made at the right and left groins (see below).  
 •Recent repairs to erosion damage and the liner were made at the right groin on the downstream slope (surface area of repair ~200' x 50'). A small diversion ditch was added on the right abutment to attempt to keep surface water off of the groin and liner. A similar repair was made at the left groin.

Photo 3 – Downstream slope looking right from the left abutment.

**- Control large brush on the embankment in order to allow good routine visual inspection of the slopes**

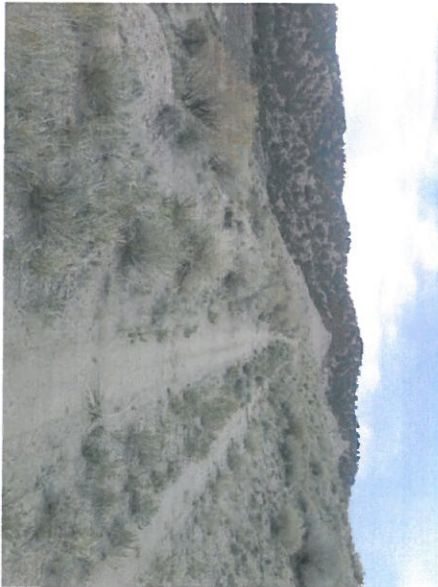
Photo 4 – Looking across one of two benches on the downstream slope.

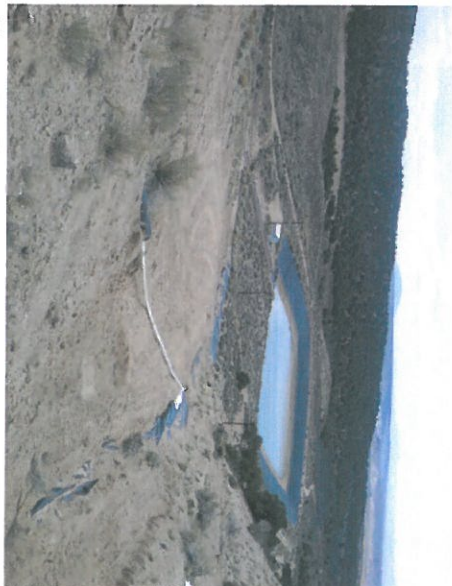
**•The dam owner performs routine maintenance. We observed where they completed recent repairs of erosion damage along the right and left groins of the downstream slope and at the south diversion drop structure outfall.**

Photo 5 – Foreground shows right groin where liner and erosion damage was recently repaired. Background: seepage collection pond at the downstream toe of the main dam.

**According to the Phase I as-built plans, the Seepage Collection Pond, located at the downstream toe of the main tailings dam, has an embankment with a structural height of ~15-ft. We recommend that the Seepage Collection Pond dam should be inspected annually as part of the TR-33 dam safety inspections.**

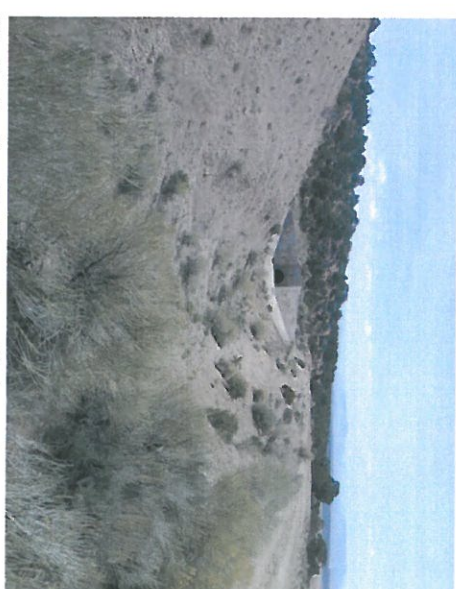
**The facility is reportedly designed to contain the full Probable Maximum Flood (PMF), along with a diversion ditch to bypass surface runoff from the south drainage area around the tailings facility and through a 48-inch diameter CMP culvert drop structure. The Phase I construction plans indicate that the diversion ditch is designed to carry 100-YR frequency flows, which agrees with the owner and DRMS comments during the inspection. It is not clear to us how the ditch and adjacent tailings embankment would perform in larger floods, up to the PMF. In other words, could the drop structure overtop, fail and lead to head-cutting erosion on the south side of the facility? We believe this question should be addressed during the Potential Failure Modes portion of the TR-33 process.**

**We observed that there is no trash rack on the drop structure intake. The SEO typically recommends a self-cleaning type trash rack for the intake of a closed conduit spillway in order to prevent clogging.**

Photo 6 – South diversion ditch and drop structure inlet located on the left side (south) of the main dam.

**We recommend performing an internal inspection (possibly remote video due to steep grade) of the drop structure's 48" diameter CMP.**

- ☒ (97) OTHER: **Consider installing a trash rack at the south diversion drop structure inlet.**
- ☒ (98) OTHER: **Perform an internal inspection of the south diversion drop structure conduit. ALSO we recommend evaluating how the Maximum Normal water level is controlled in both the main tailings dam and the seepage collection pond (See spillway sect. of this report).**

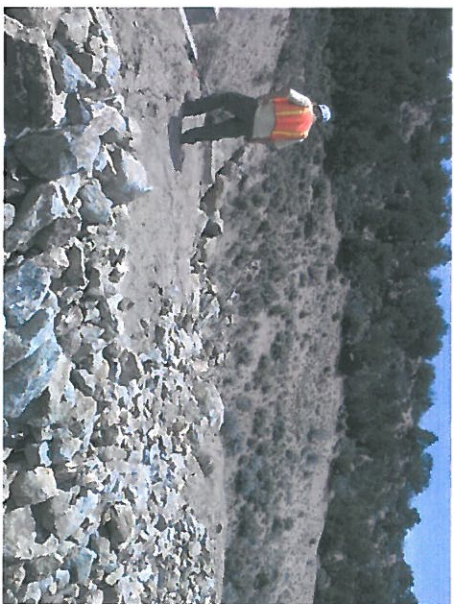
Photo 7 – Recent erosion repairs performed around the south diversion drop structure outfall.

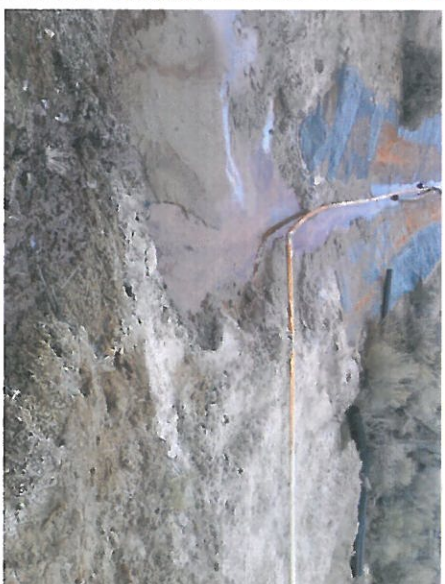
**Uncontrolled seepage was observed exiting ~6-ft above the 12" HDPE drain outfalls on the downstream slope of the main embankment.**

Photo 8 – Seepage at toe of the main dam. Majority of seepage comes through collection drain, but some seepage appears to be uncontrolled (see Photo 9).

**(1) research to determine the design of the seepage collection pipe system under the embankment, and (2) after determining the design of the pipe collection system, determine if it is feasible to video inspect the pipes. The SEO recommends that internal outlet conduit video inspections be performed at least every 10 years for SEO-regulated High and Significant Hazard dams.**

- ☐ (93) PERFORM A HYDROLOGIC STUDY TO DETERMINE REQUIRED SPILLWAY SIZE:
- ☐ (94) PREPARE PLANS AND SPECIFICATIONS FOR AN ADEQUATE SPILLWAY:
- ☒ (96) PERFORM AN INTERNAL INSPECTION OF THE OUTLET: **Determine the design of the seepage collection pipe system under the embankment. If possible video inspect the pipes. Determine source of uncontrolled seepage exiting on downstream slope above collection drain outfalls**

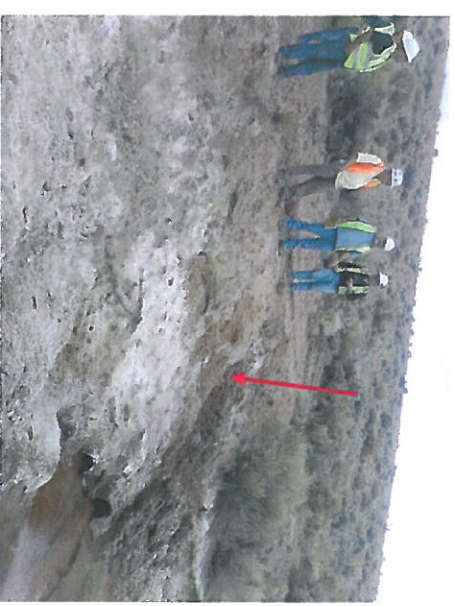
**Three 12" diameter HDPE pipes outfall at the downstream toe of the main embankment into an open channel to the seepage collection pond. The owner reports that the three pipes may be short extensions of what they believe is a larger (36"-48" dia.) HDPE seepage collection pipe under the main embankment. Again, no details of the collection pipe system were found by us on the Phase I as-built plans.**

Photo 9 – Seepage drain outfall at the downstream toe (3x12" HDPE pipes). There is reportedly a large seepage collection pipe under the dam. NOTE: Uncontrolled seepage exiting higher on the slope above the drain outfalls (red arrow).
