COLORADO DIVISION OF RECLAMATION, MINING AND SAFETY
MINERALS PROGRAM INSPECTION REPORT
PHONE: (303) 866-3567 ext. 8186

MINE NAME: Pit No 1	MINE/PROSPECTING ID#: M-1977-020	MINERAL: Sand and gravel	COUNTY: Delta
INSPECTION TYPE: Monitoring	INSPECTOR(S): Travis H. Marshall	INSP. DATE: January 24, 2013	INSP. TIME: 12:00
OPERATOR: Oldcastle SW Group, Inc. dba United Compai County	OPERATOR REPRESENTATIVE: Peter J. Siegmund	TYPE OF OPERATION: 112c - Construction Regular Operation

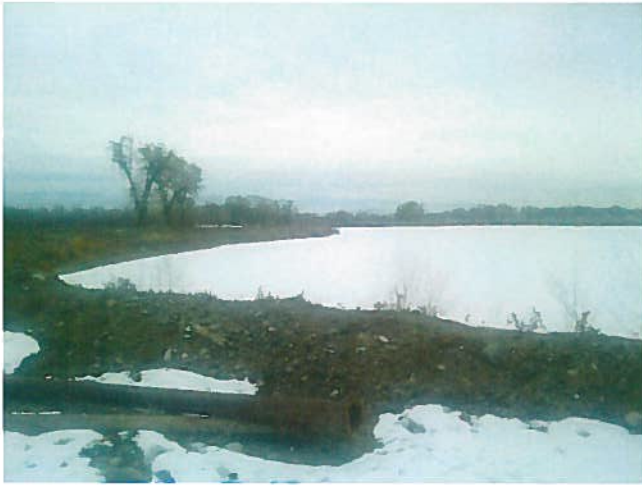
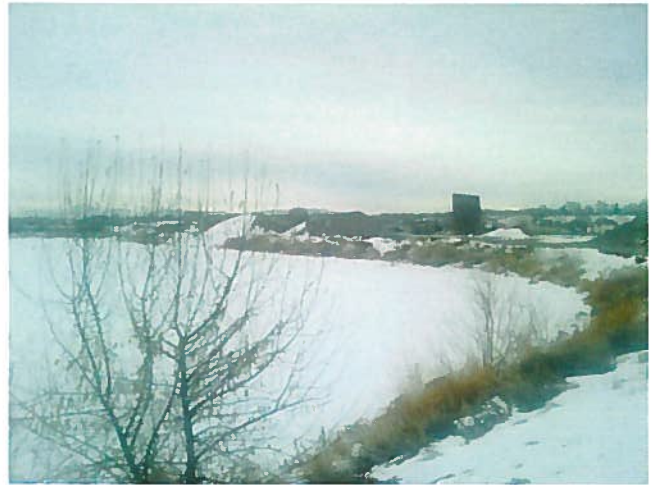
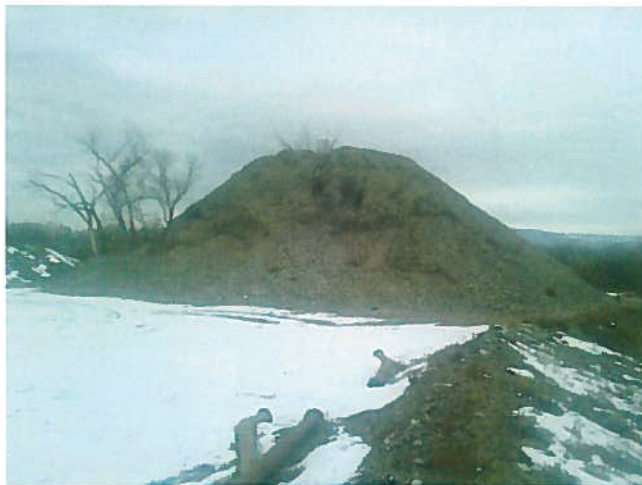
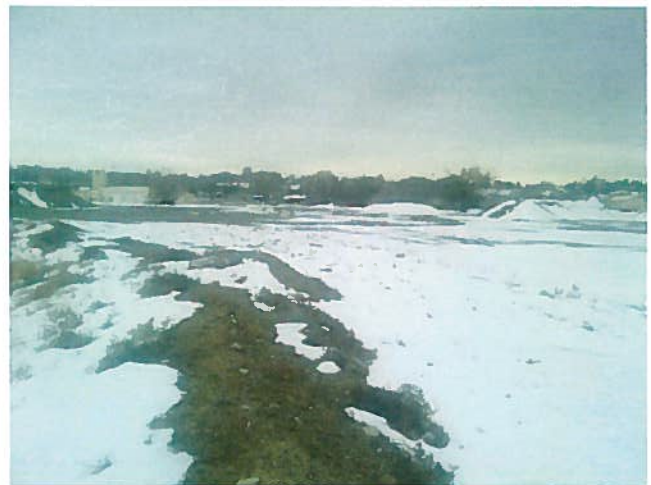
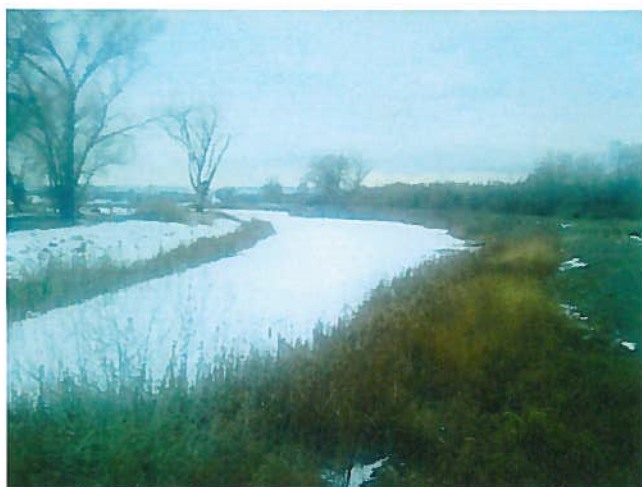
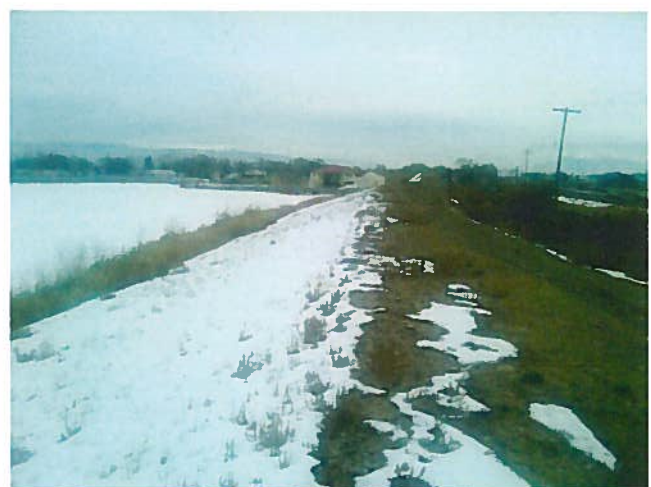
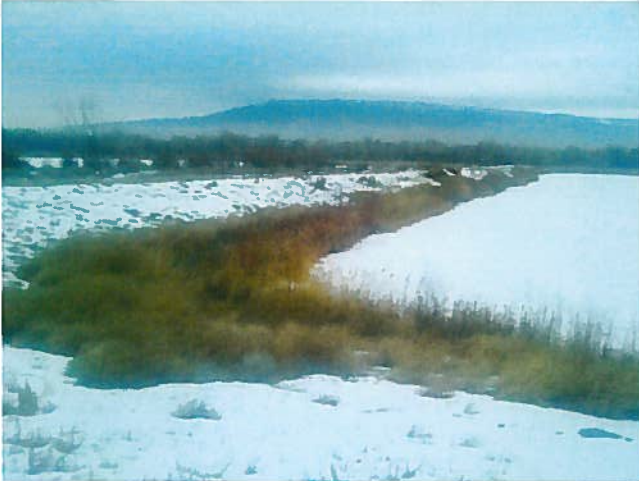
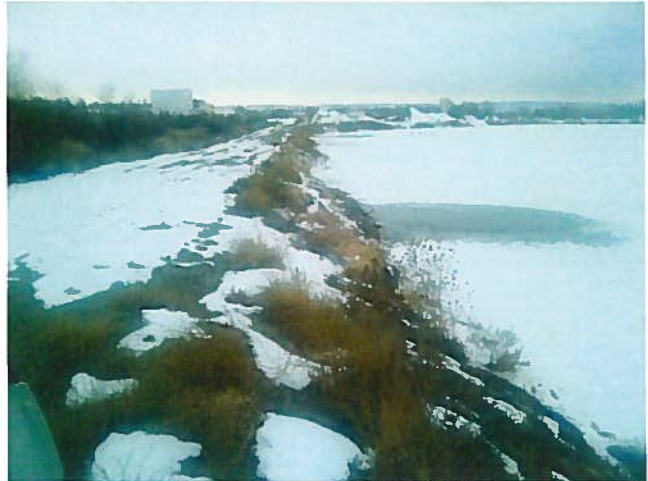
No active mining was observed during the inspection. Various large stockpiles of material were observed within the permit boundary and an area to the south of the permit boundary that is used to stockpile material for sale.

The majority of the slopes appeared to be no steeper than the required 3H:1V described in the mining and reclamation plan. Steep slopes were observed along the southern shore of the Delta Sand & Gravel lake. The slopes must be repaired in order to meet the requirements of the reclamation plan. A berm along the upper rim of the lake shore of the Delta Sand & Gravel lake was observed. This berm is likely a safety requirement and must be removed in order to meet the approved reclamation requirements.

Tamarisk and Russian Olive were observed within the permit area; Tamarisk is listed as a noxious weed and will hinder the ability of desirable plant species to get established. Per Rule 3.1.10 (6), Methods of weed control shall be employed for all prohibited noxious weed species, and whenever invasion of a reclaimed area by other weed species seriously threatens the continued development of the desired vegetation. Weed control methods shall be used whenever the inhabitation of the reclaimed area by weeds threatens further spread of serious weed pests to nearby areas. The infestation is seen as a problem due to lack of performance of the Russian Olive and Tamarisk controls specified in the weed management plan. The operator is aware that control measures for the Tamarisk and Russian Olive need to be implemented and documented before the site can be considered reclaimed. Failure to implement these control measures during the 2013 field season may result in an enforcement action. All portions of the permit are subject to the DRMS tamarisk policy due to the March 30, 2012 Annual Report indicating that the mine is not in final reclamation. A copy of the annual report is attached.

No evidence of on or off site erosion was observed during the inspection.
