COLORADO DIVISION OF RECLAMATION, MINING AND SAFETY
MINERALS PROGRAM INSPECTION REPORT
PHONE: (303) 866-3567

MINE NAME: Buena Vista Pit	MINE/PROSPECTING ID#: M-1977-196	MINERAL: Sand and gravel	COUNTY: Chaffee
INSPECTION TYPE: Monitoring	INSPECTOR(S): Dustin Czaplá	INSP. DATE: May 22, 2013	INSP. TIME: 09:30
OPERATOR: Hard Rock Paving and Redi-Mix, Inc.	OPERATOR REPRESENTATIVE: None	TYPE OF OPERATION: 112c - Construction Regular Operation

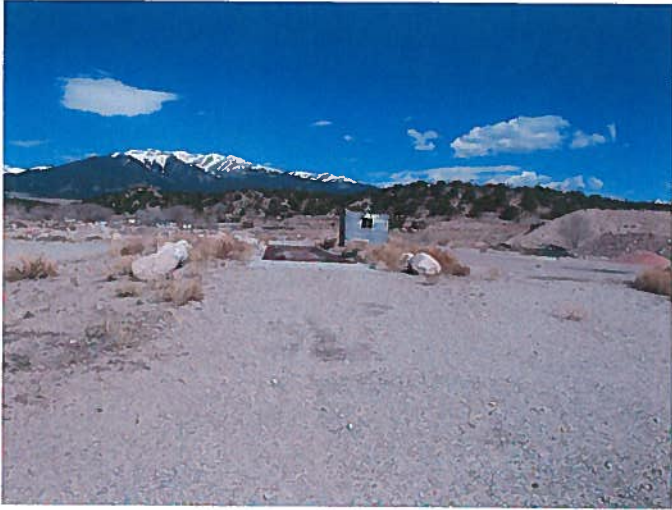
Figure 1: Scale and scale house. The asphalt pad is located on the right side of the scale house.

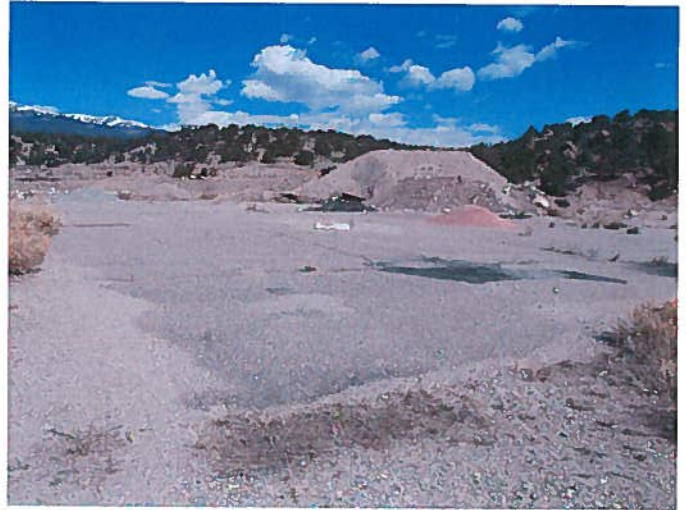
Figure 2: Asphalt pad. Topsoil stockpile is shown just beyond the pad.

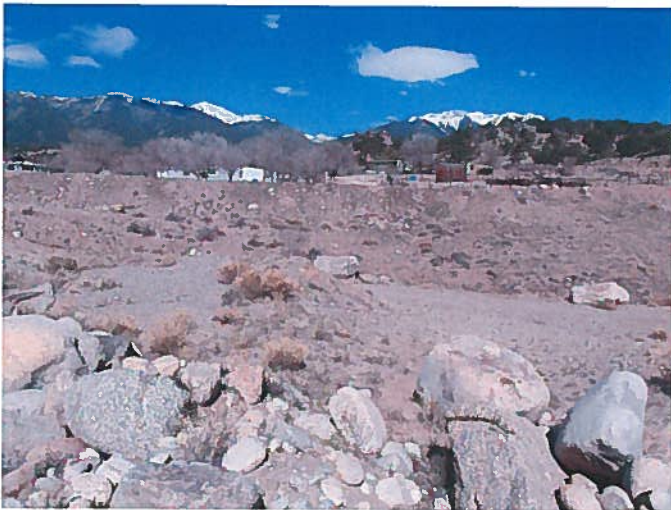
Figure 3: View toward the northwest slope in the northwest pit area. The slope appeared stable and vegetation was becoming established.

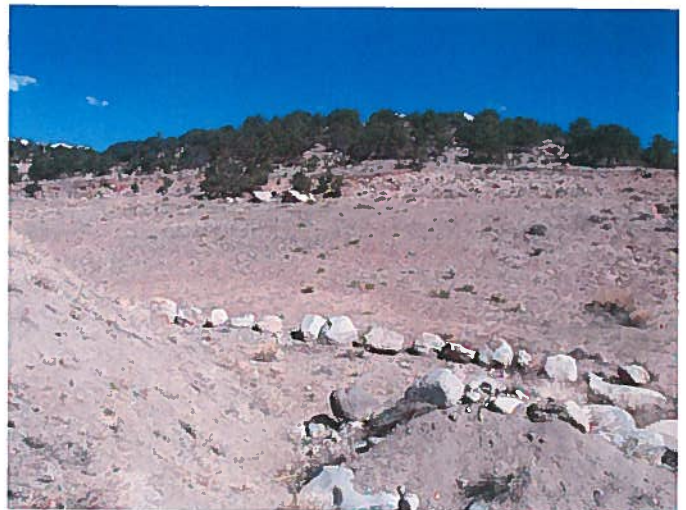
Figure 4: View toward the north slope in the northwest pit area. This part of the slope appeared stable and vegetation was becoming established.

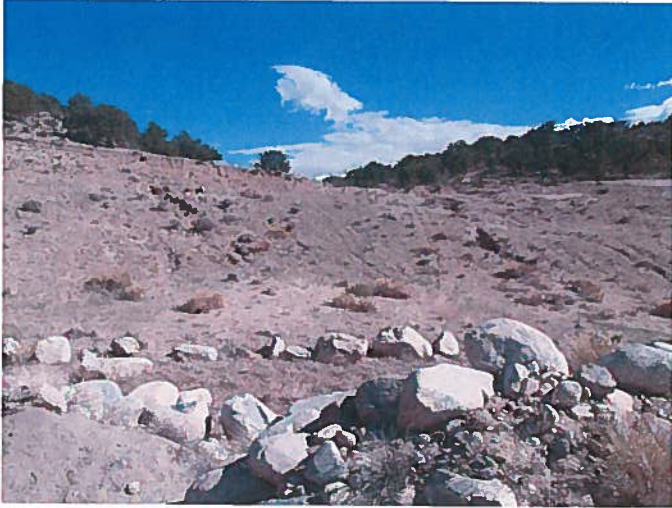
PROBLEM/POSSIBLE VIOLATION: Problem: Erosion gullies and ruts were observed on-site. This is a problem at this time for failure to protect the affected land from erosion pursuant to C.R.S. 34-32.5-116 (4) (j).

Figure 5: View toward the northeast part of the north slope in the northwest pit area. Significant gullies are forming on this part of the slope.

CORRECTIVE ACTIONS: The operator shall provide photo documentation to the Division verifying the erosion gullies and ruts in the north part of the site have been repaired, and that the site has been reconstructed and stabilized to minimize erosion damage by the corrective action date.

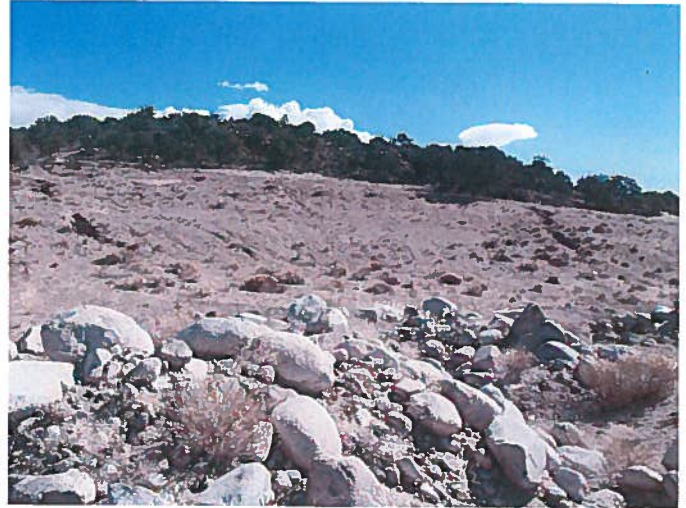
Figure 6: View toward the northeast part of the north slope in the northwest pit area. Significant gullies are forming on this part of the slope.

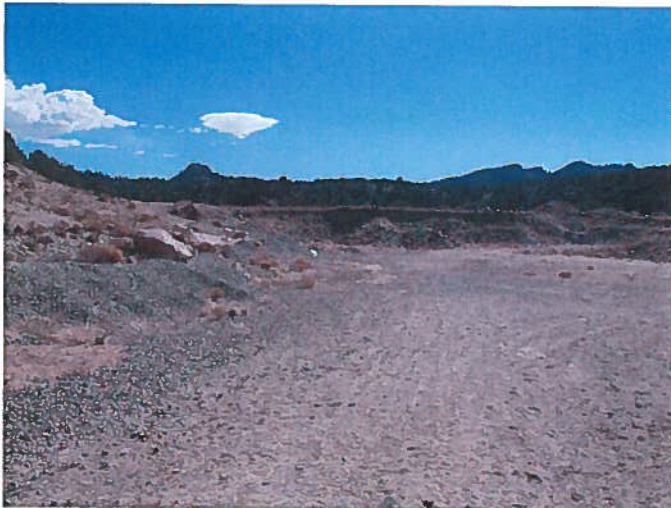
Figure 7: View, facing east toward the northeast pit, from the access road that leads from the northwest pit.

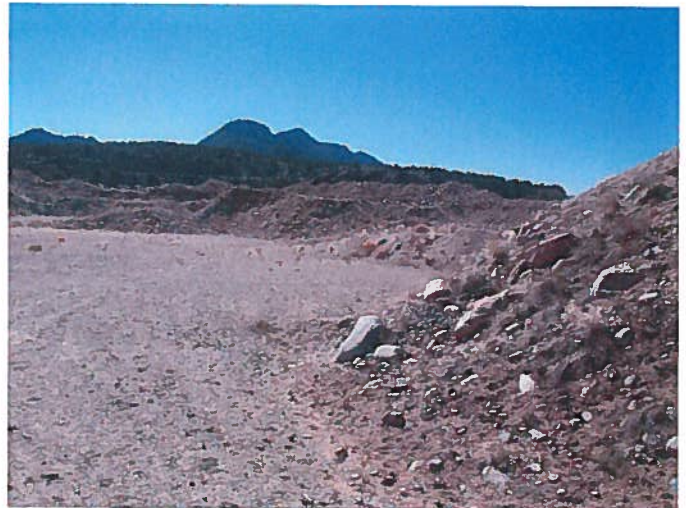
Figure 8: View, facing south, toward the south highwall of the northeast pit.

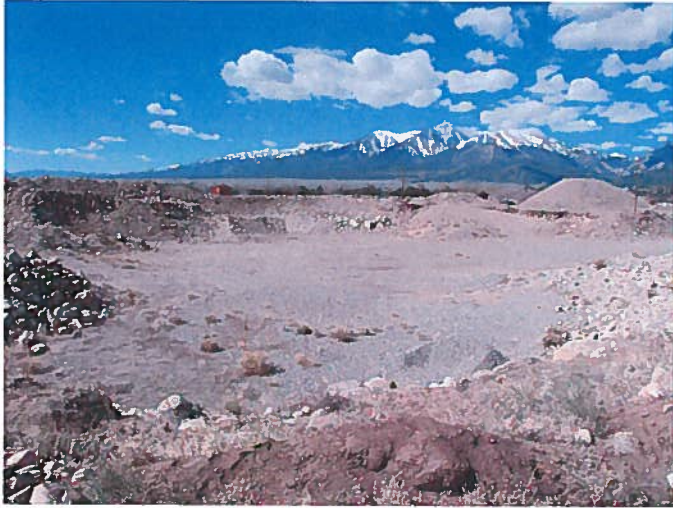
Figure 9: View, from east rim of the northeast pit, facing west.

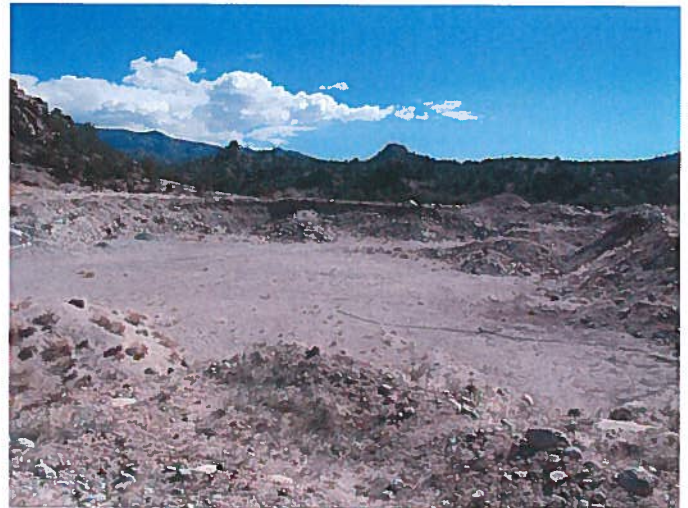
Figure 10: View, from the west rim of the northeast pit, facing east.

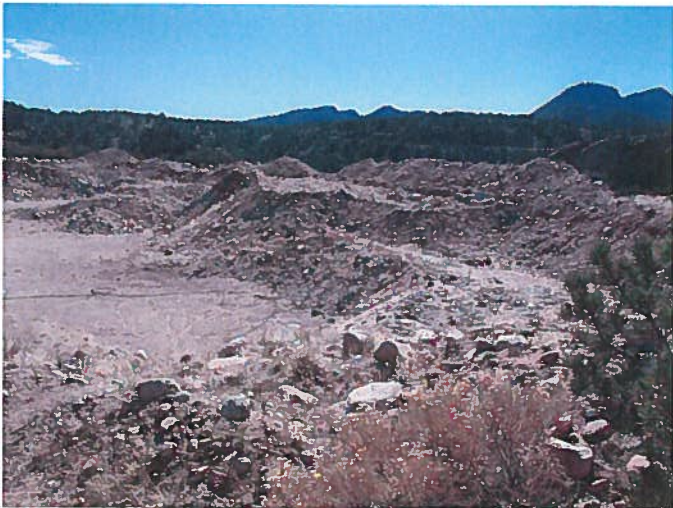
Figure 11: View, from the west rim of the northeast pit, facing east.

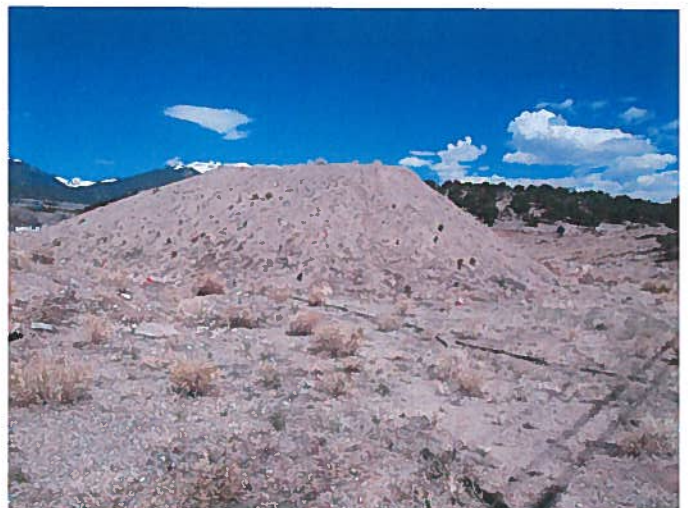
Figure 12: Topsoil stockpile located at the north side of the asphalt pad.
