**COLORADO DIVISION OF RECLAMATION, MINING AND SAFETY**  
**MINERALS PROGRAM INSPECTION REPORT**  
**PHONE: (303) 866-3567**

<b>MINE NAME:</b> Cross Creek	<b>MINE/PROSPECTING ID#:</b> M-2013-031	<b>MINERAL:</b> Gravel	<b>COUNTY:</b> La Plata
<b>INSPECTION TYPE:</b> Illegal(Unpermitted Operation)	<b>INSPECTOR(S):</b> Kate A. Pickford	<b>INSP. DATE:</b> June 5, 2013	<b>INSP. TIME:</b> 11:00
<b>OPERATOR:</b> John Avery	<b>OPERATOR REPRESENTATIVE:</b>	<b>TYPE OF OPERATION:</b> IM - Is it Mining

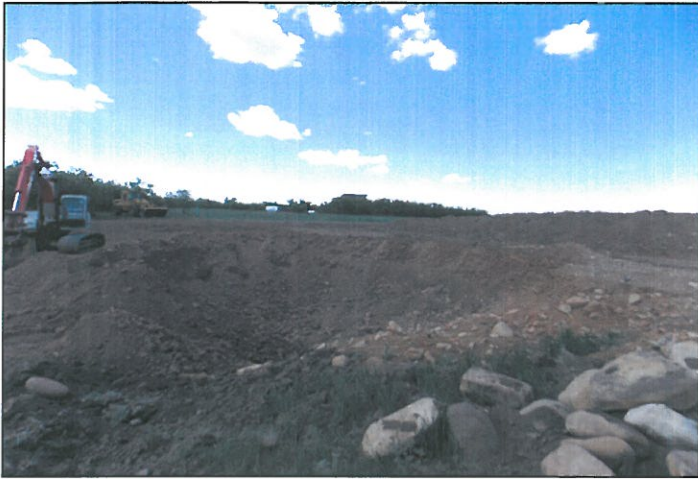
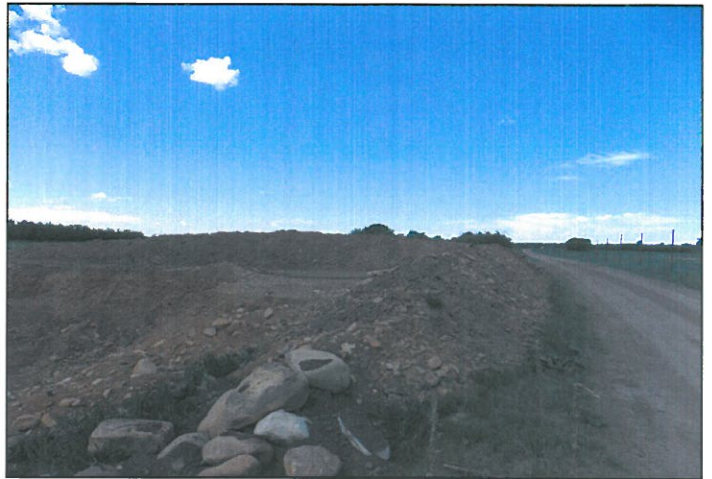
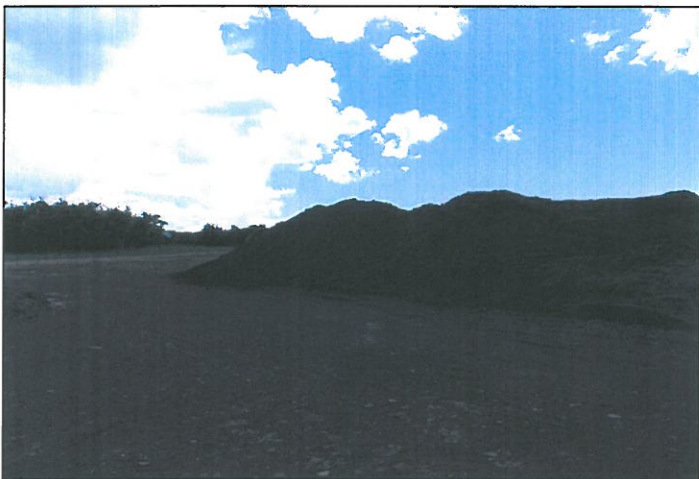
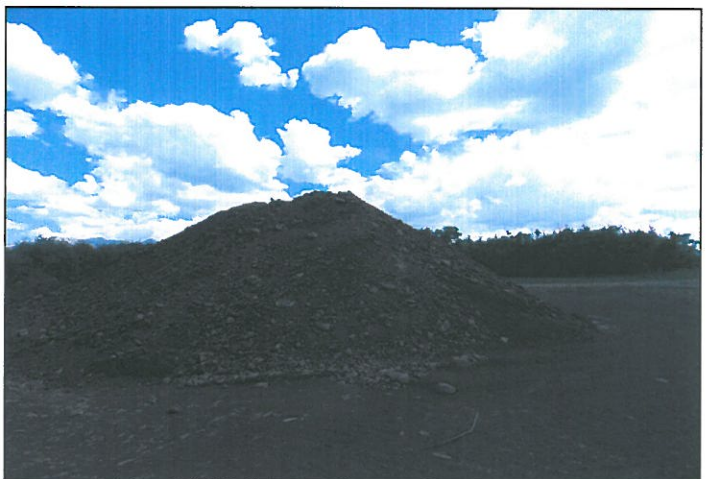
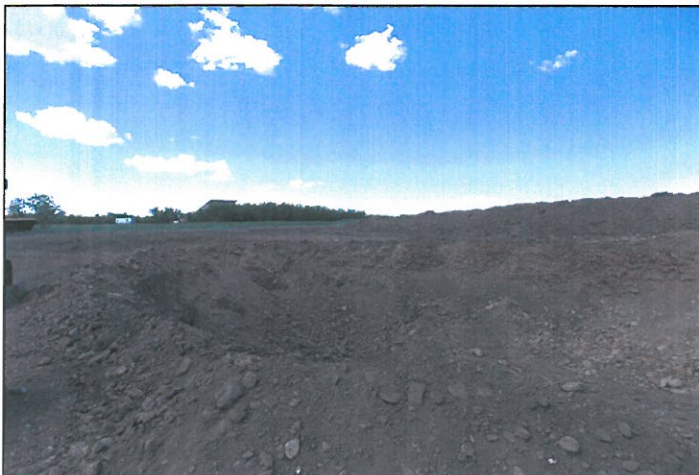
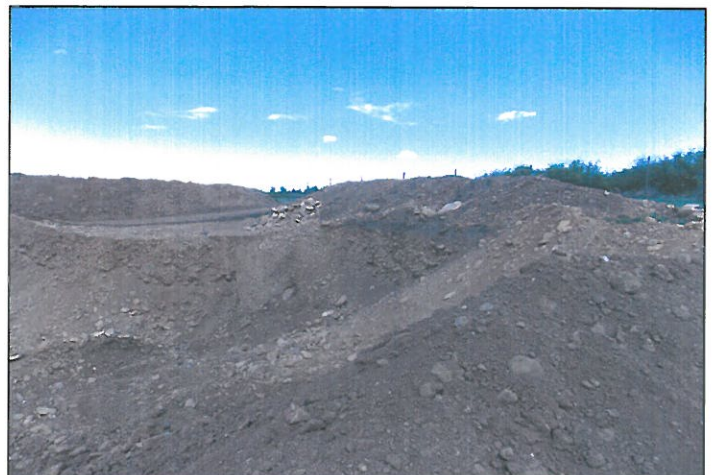
PHOTOGRAPHS

Two areas of activity were observed on the property. One is located approximately 150 feet off of CR120, the other is at the back of the property off of Equestrian Trail Rd. Roads being installed on other properties were also observed.
