COLORADO DIVISION OF RECLAMATION, MINING AND SAFETY
MINERALS PROGRAM INSPECTION REPORT
PHONE: (303) 866-3567

MINE NAME: Spor Pit	MINE/PROSPECTING ID#: M-1995-038	MINERAL: Gravel	COUNTY: San Miguel
INSPECTION TYPE: Monitoring	INSPECTOR(S): Kate A. Pickford	INSP. DATE: May 29, 2013	INSP. TIME: 10:30
OPERATOR: Haldorson and Sons, Inc.	OPERATOR REPRESENTATIVE: Jerry Spor	TYPE OF OPERATION: 110c - Construction Limited Impact

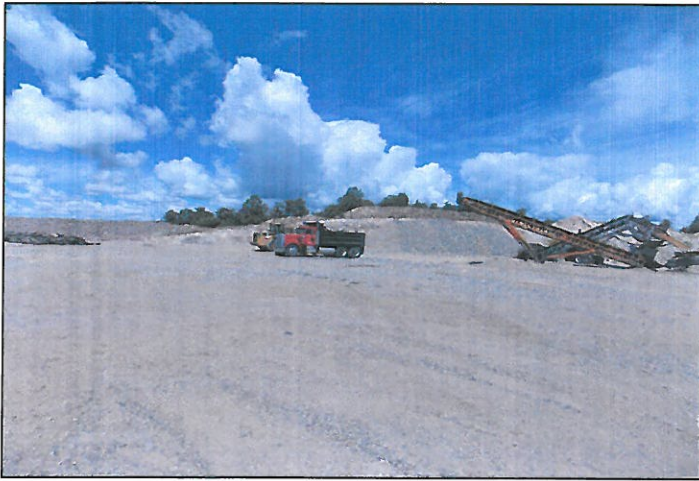
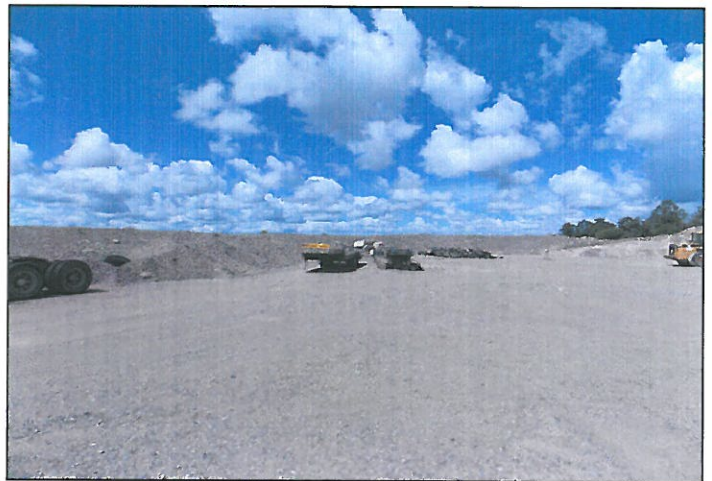
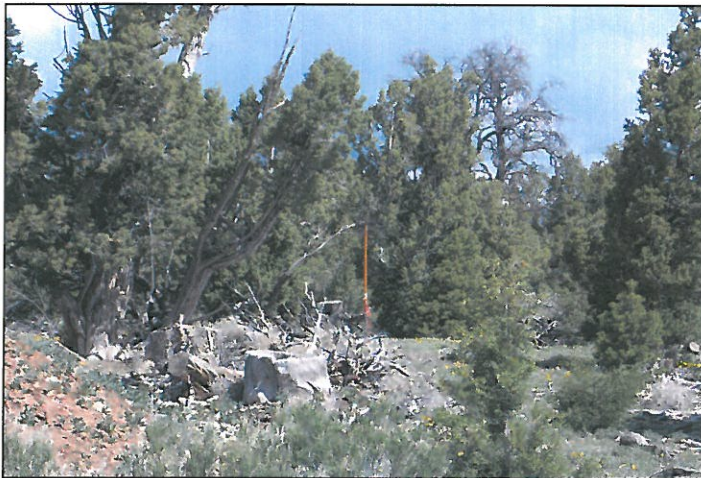
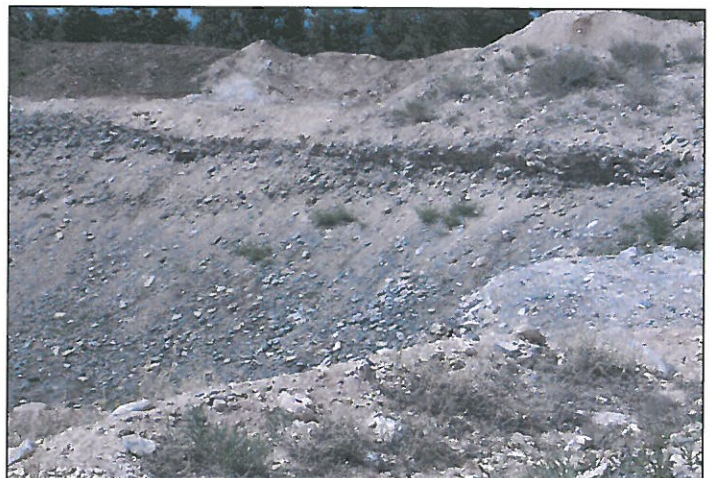
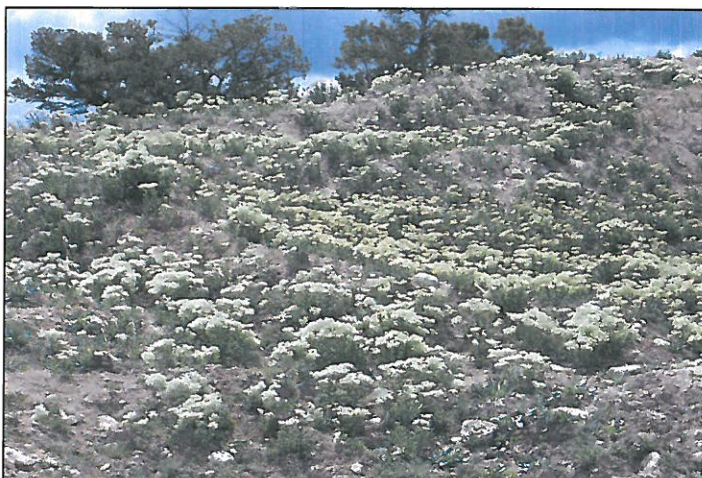
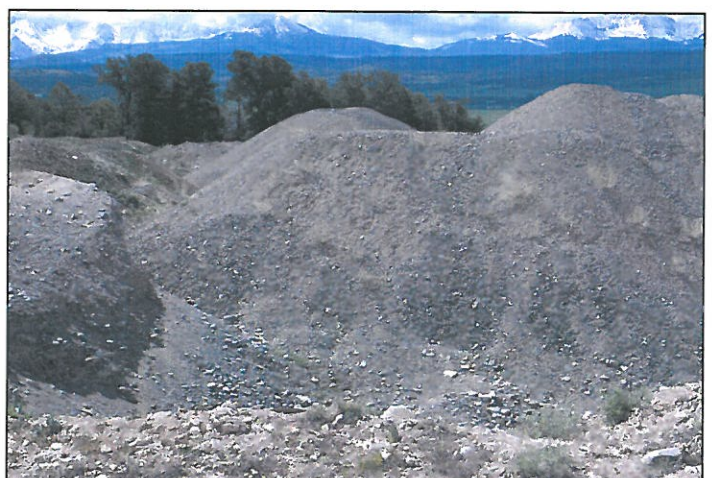
PHOTOGRAPHS

PROBLEM/POSSIBLE VIOLATION: Problem: There are state-listed noxious weeds present on site. This is a problem for failure to employ weed control methods for state listed noxious weed species within the permitted area, and to reduce the spread of weeds to nearby areas as required by Section 3.1.10 (6) of the rule.

PROBLEM/POSSIBLE VIOLATION: Problem: The topsoil stockpiles do not have established vegetation on them and are therefore susceptible to erosion. Rule 3.1.9(1) states if topsoil is not replaced into the backfill area within a time short enough to avoid deterioration of the topsoil, vegetative cover or other means shall be employed so that the topsoil is protected from erosion.

The topsoil stockpile has not been seeded. This is a problem and is cited in the problem section of this report. The site has a large amount of Whitetop. The operator must take measures to control this noxious weed. This issue is also noted in the problem section of this report.

CORRECTIVE ACTIONS: Implement approved weed control plan and provide proof to the Division that this has been done. If a weed control plan is not already in place, the operator shall develop a weed control and management plan in accordance with Section 3.1.10 (6) of the Rule. This plan should be developed in consultation with the county extension agency, or weed control district office and should include specific control measures to be applied, a schedule for when control measures will be applied and a post-treatment monitoring plan. This weed control plan shall be submitted to the Division as a Technical Revision to the approved plan with the appropriate Technical Revision fee of \$216.00 by the corrective action date.

CORRECTIVE ACTIONS: The operator shall seed the stockpiles with the seed mix that was submitted as part of the approved Reclamation Plan. If no seed mix has been provided, the operator shall submit a seed mix for approval as a technical revision to the permit along with the appropriate \$216 revision fee to the Division by the
