COLORADO DIVISION OF RECLAMATION, MINING AND SAFETY COAL PROGRAM INSPECTION REPORT

| Permit Number: C-1980-006 Mine Name: Marr Mine Operator: Kerr Coal Company Operator Address: Mr George Patterson C/O Energy Fuels Coal, Inc. P.O. Box 459 Florence, CO 81226 | County: Jackson Operation Type: Surface Permit Status: Permanent Cessation Ownership: Federal |

| Inspection Start Date: June 10, 2013 Inspection Start Time: 11:00 Inspection End Date: June 10, 2013 Inspection End Time: 14:00 | Inspection Type: Coal Partial Inspection Inspection Reason: Normal I&E Program Weather: Clear |

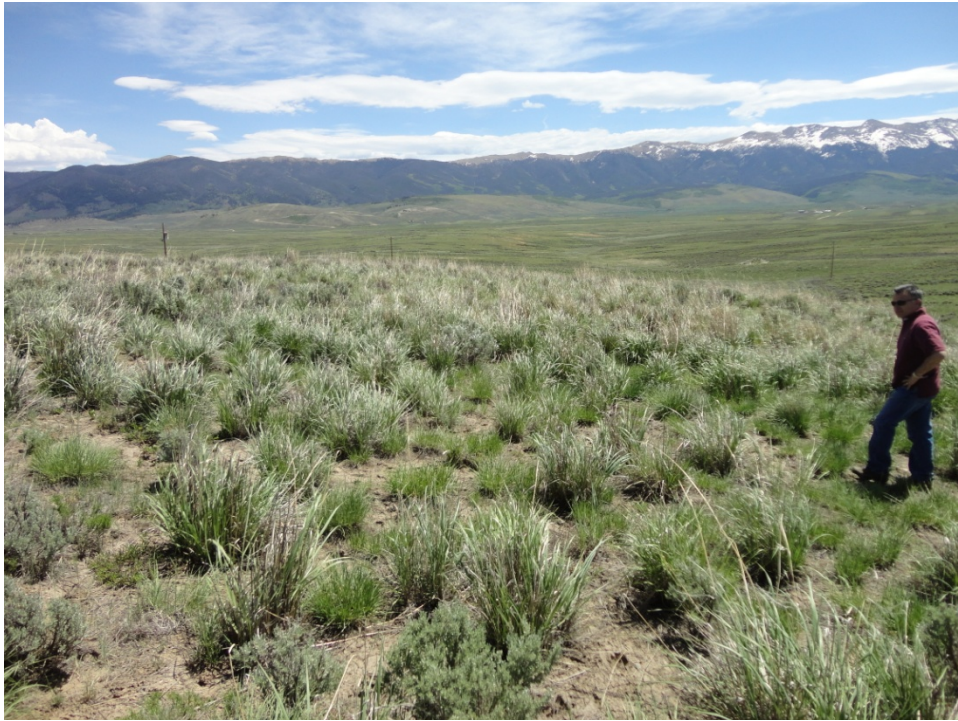
Of the two remaining unreleased parcels at the mine site, the northerly was well vegetated, with basin wildrye (*Leymus cinereus*), sagebrush and western wheatgrass (*Pascopyrum smithii*) the dominant species. The parcel to the south appeared to be more diverse, with species of bluegrass and fescue also evident.

No recent disturbance was observed at either parcel, nor was there any significant erosion.

Photo 1: Vegetation at mine site (north parcel)

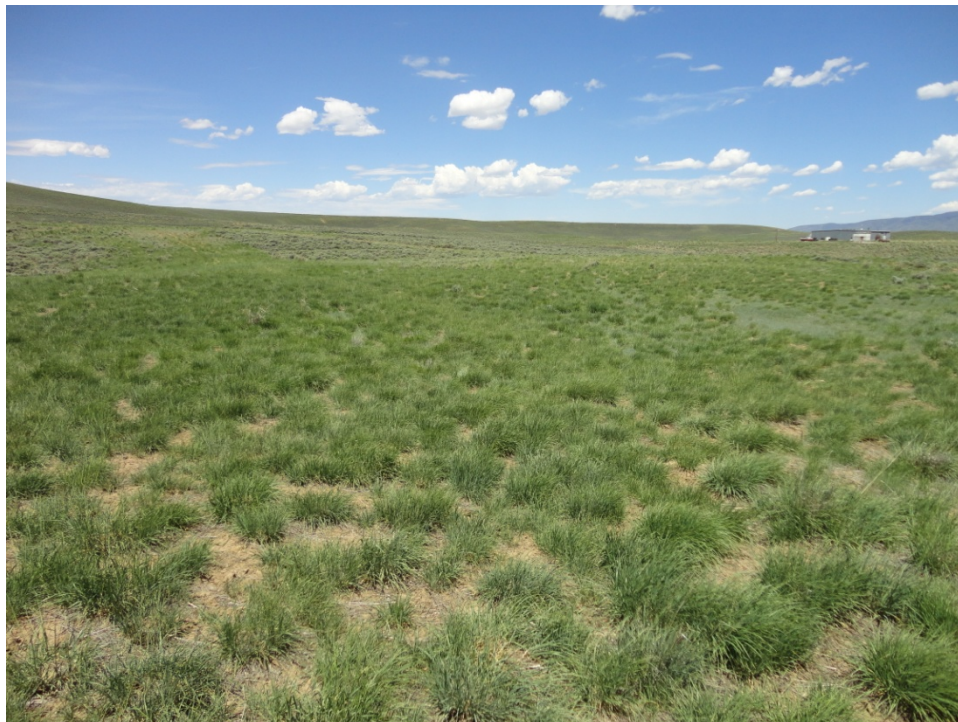
Photo 2: Vegetation at mine site (south parcel)

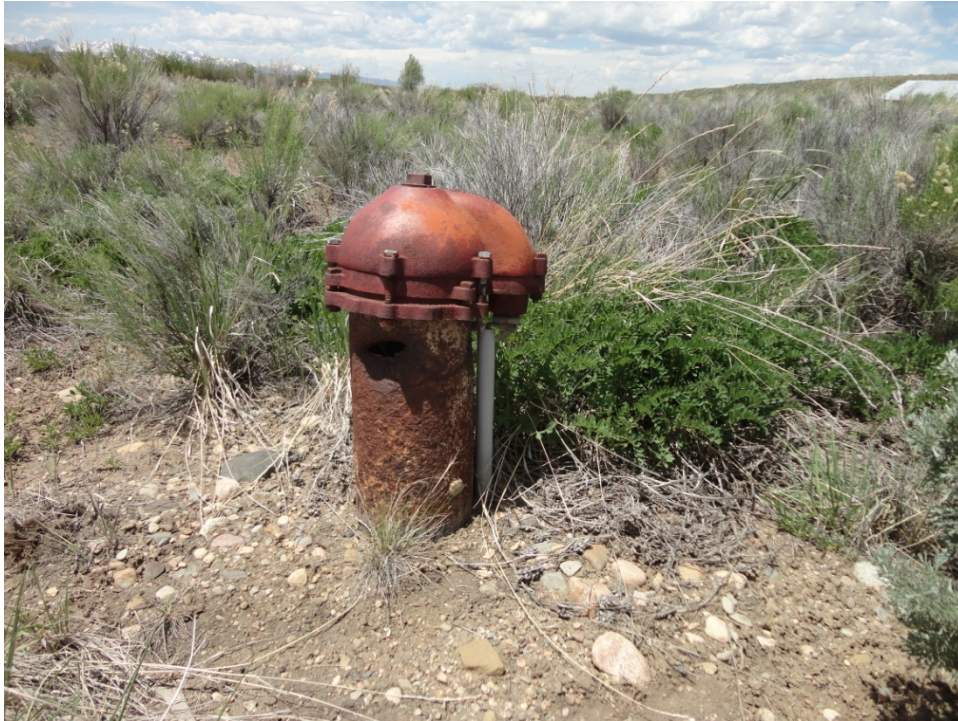
Non-coal waste was collected in a rough pile behind the building. A hydrant on the site was still connected to an electrical cable, but a hole had been punched in the side of the hydrant itself. Two power poles were left standing, with bare electrical cables protruding from the ground nearby.

Photo 3: Hydrant at the loadout

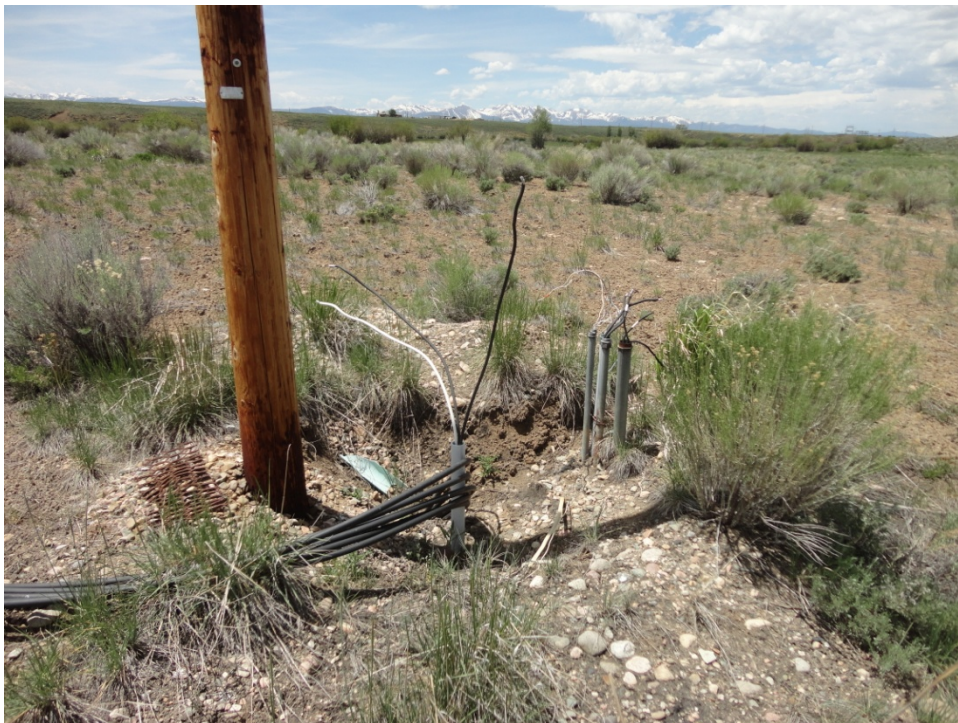
Photo 4: Bare cables at the loadout

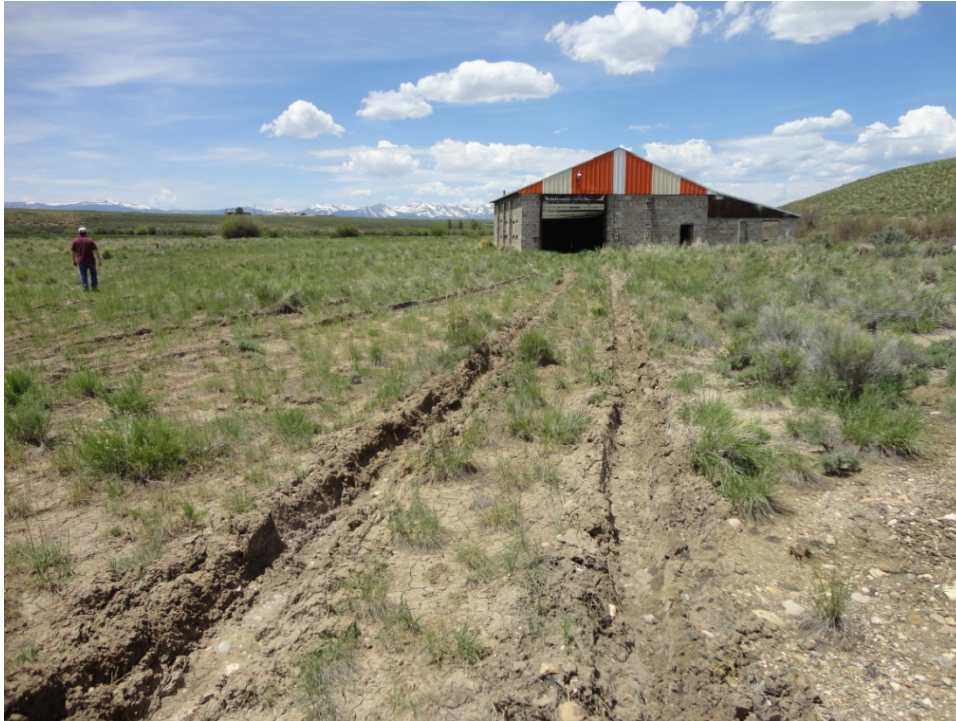
The loadout was secured by a locked gate, which had been repaired following recent vandalism. Multiple ruts >12" deep were very evident from that vandalism, although the ground was hard and dry.

Photo 5: Ruts at the loadout

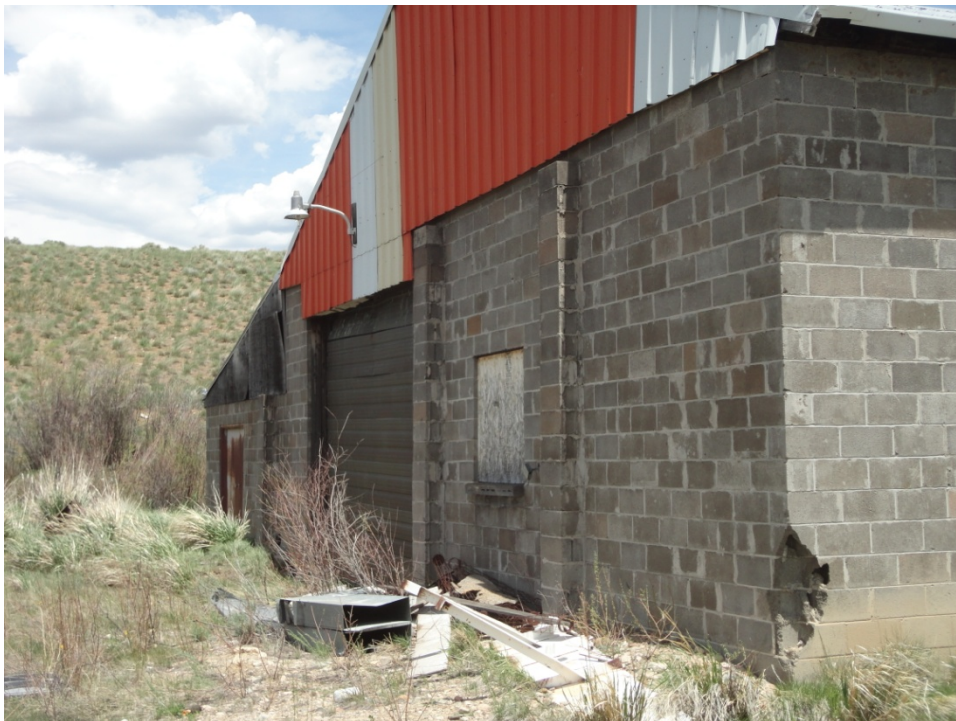
Photo 6: Non-coal waste at the loadout
