## COLORADO DIVISION OF RECLAMATION, MINING AND SAFETY COAL PROGRAM INSPECTION REPORT

<b>Permit Number:</b> C-1981-019 <b>Mine Name:</b> Colowyo Coal Mine <b>Operator:</b> Colowyo Coal Company L.P. <b>Operator Address:</b> Mr. Tony Tennyson 5731 State Highway 13 Meeker, CO 81641	<b>County:</b> Moffat, Rio Blanco <b>Operation Type:</b> Surface <b>Permit Status:</b> Active <b>Ownership:</b> Federal
	<b>Operator Representative Present:</b>  Tony Tennyson
<b>Operator Representative Signature: (Field Issuance Only)</b>

<b>Inspection Start Date:</b> June 11, 2013 <b>Inspection Start Time:</b> 08:30 <b>Inspection End Date:</b> June 11, 2013 <b>Inspection End Time:</b> 12:00		<b>Inspection Type:</b> Coal Partial Inspection <b>Inspection Reason:</b> Normal I&E Program <b>Weather:</b> Windy	
<b>Joint Inspection Agency:</b>  None		<b>Joint Inspection Contacts:</b>  	
<b>Post Inspection Agency:</b>  None		<b>Post Inspection Contacts:</b>  	
<b>Inspector(s):</b>  Leigh D. Simmons  Daniel I. Hernandez	<b>Inspector's Signature:</b>

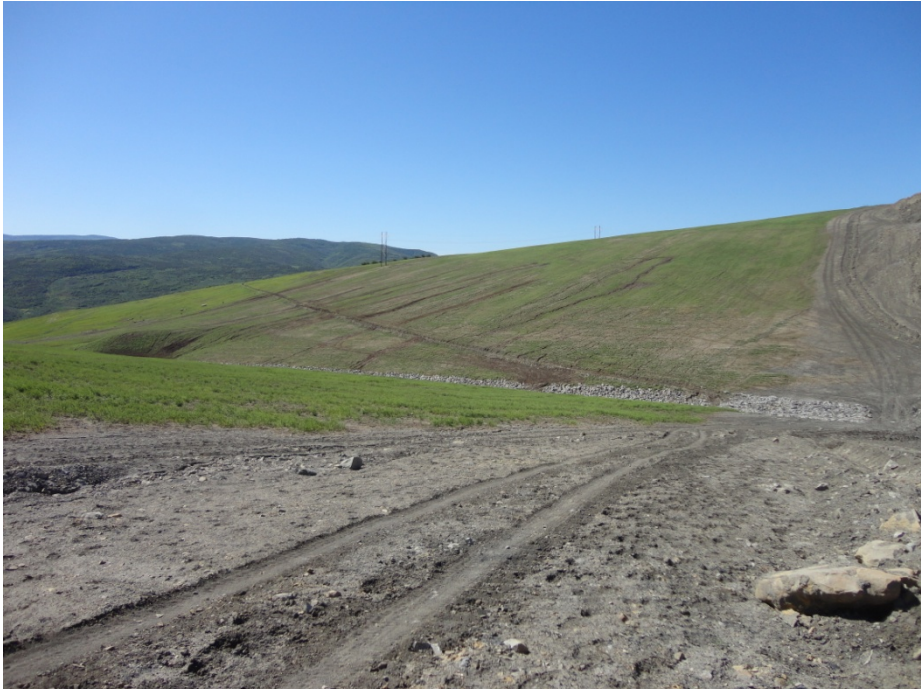
The recently reclaimed area at the southern end of the East Pit showed some erosion on the slope above the contour ditch (see photo 1). Mr Tennyson plans to repair this when the ground is sufficiently dry. From a distance there appeared to be plenty of green cover on the slope. Moving north from there, through successively older reclamation, showed excellent revegetation.

Photo 1: Erosion at south end of East Pit reclaimed area

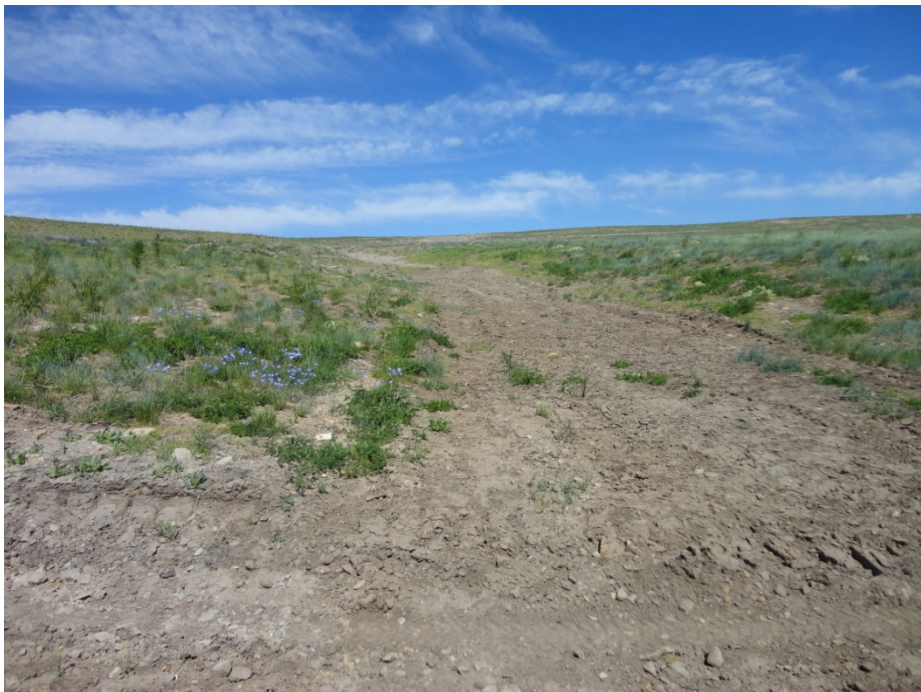
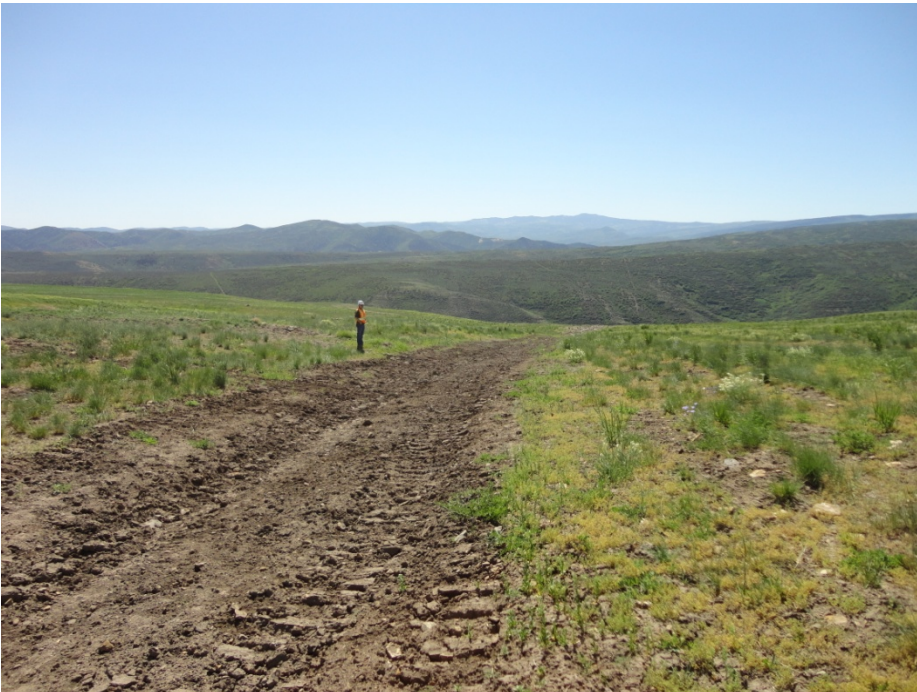
The erosion in the prospect ditch, noted in a previous inspection report, had been repaired.

Photo 2: Prospect ditch (1)

Photo 3: Prospect ditch (2)

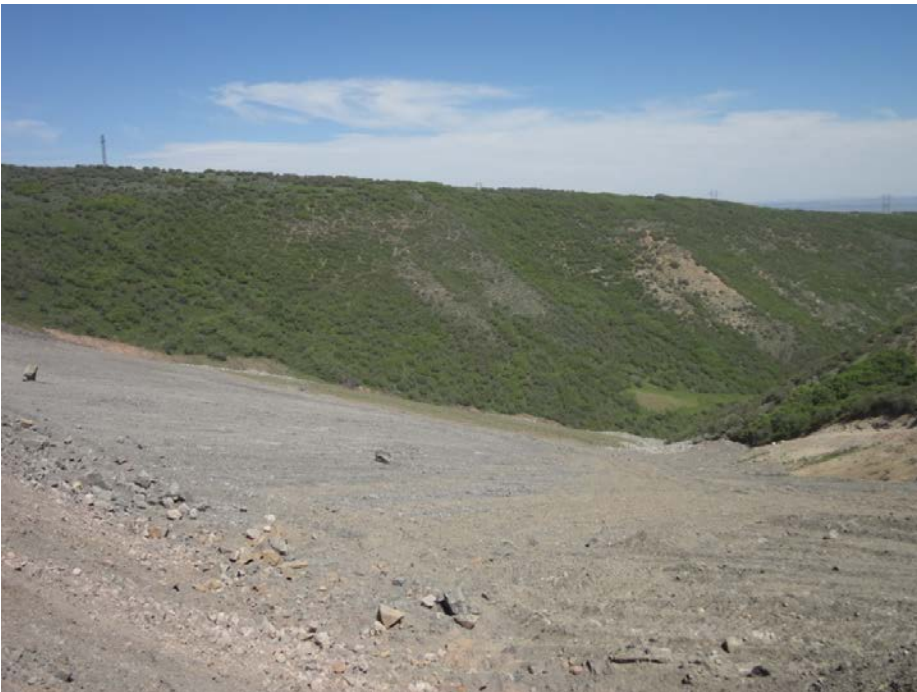
The West Taylor Valley fill was inspected from above. The bottom of the fill has already been reclaimed. Mr Tennyson plans to grade the upper slope, as far as the road, to its final contour this year.

Photo 4: West Taylor Valley fill

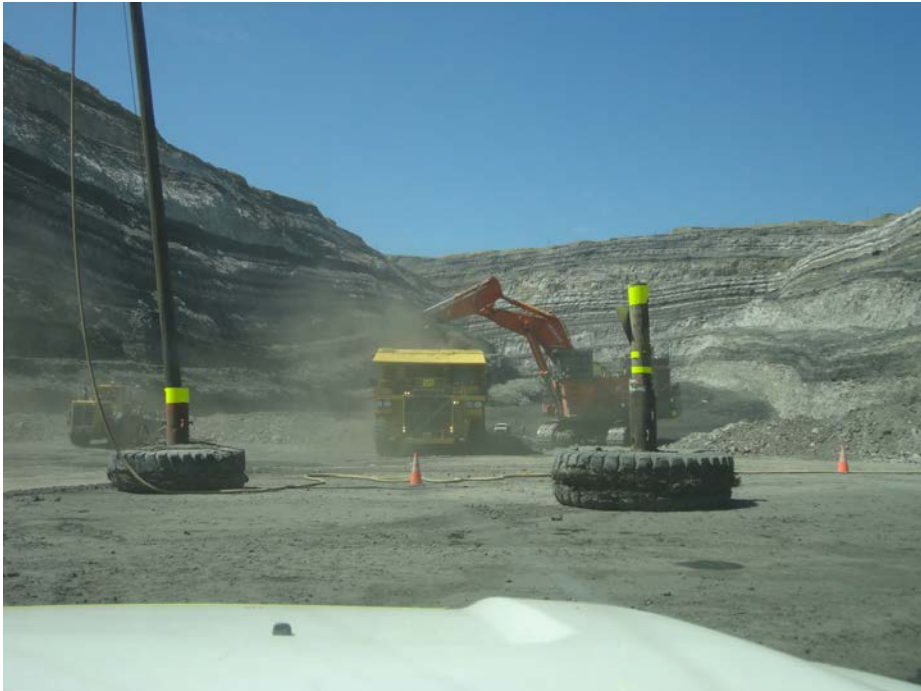
Colowyo is an active surface mine which employs ~250 people in 4 crews, and operates on 2x12 hour shifts. The mine was in active production at the time of the inspection. Work was ongoing to complete the box cut in the South Taylor pit. The large excavator was cutting the G7 seam using a 29 cubic yard bucket. One more seam remains before the box cut is complete. The larger shovel with the 50 cubic yard bucket was not active. The geology of the coal seams has been more rolling than was expected from the exploration data. The steeper dipping seams have made mining using the shovel more difficult since it is unable to operate on grades steeper than 6% without risk of shearing the center pin.

Photo 5: Excavator loading truck in South Taylor pit

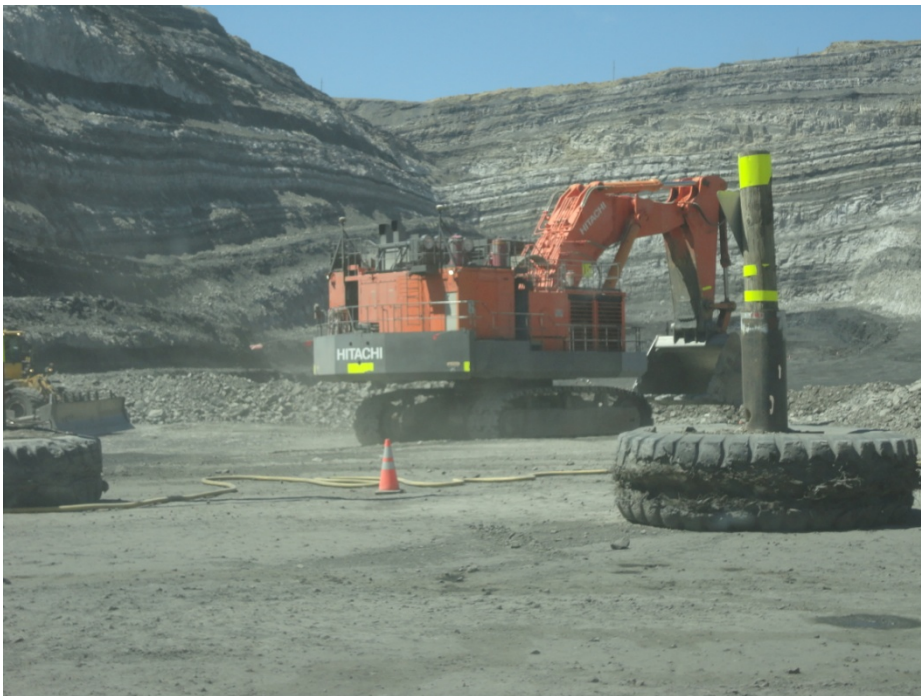
During the inspection operations were shut down due to exceedence of the 100 µg/L air quality standard, caused by very strong winds. This is an internal standard; compliance with the air quality permit is based on a 24 hour average. Dust is controlled around the site by two water trucks which run continuously and were operating throughout the inspection.

Photo 6: Excavator shut down to protect air quality

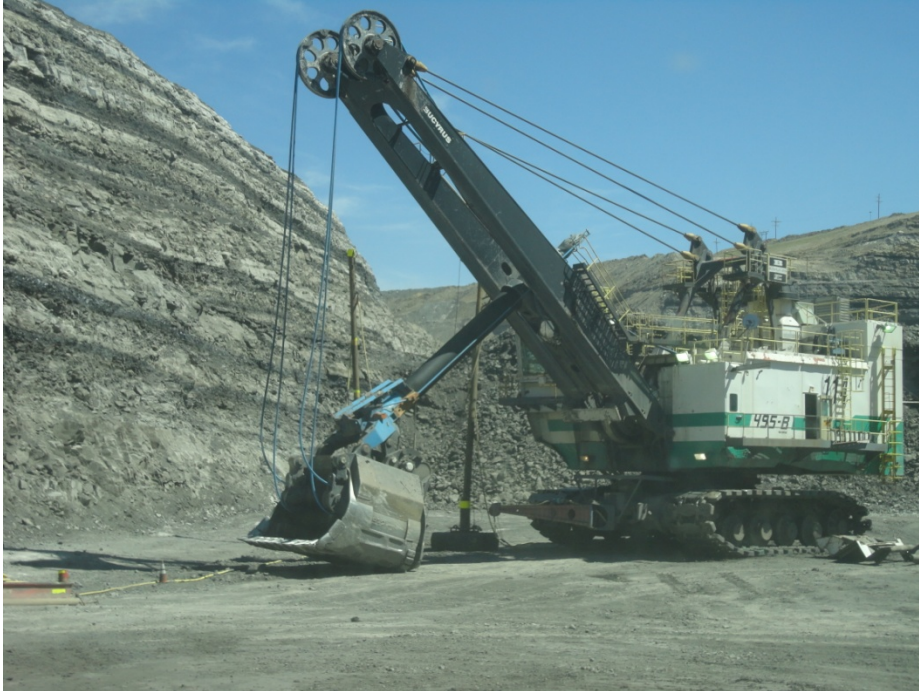
Photo 7: Idle shovel

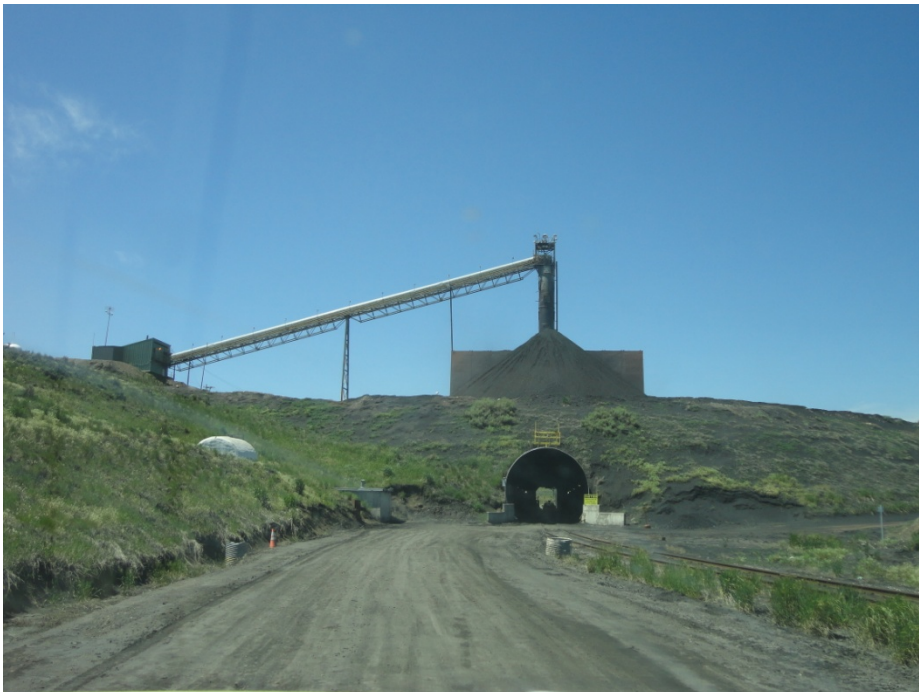
Photo 8: Loadout
