COLORADO DIVISION OF RECLAMATION, MINING AND SAFETY MINERALS PROGRAM INSPECTION REPORT

MINE NAME:	MINE/PROSPECTING ID#:	MINERAL:	COUNTY:
Iris Project	P-2012-003	Au,Ag,Pb,Zn,Cu	Saguache
INSPECTION TYPE:	INSPECTOR(S):	INSP. DATE:	INSP. TIME:
Mineral Prospect Inspection	Bob Oswald	June 12, 2013	16:00
OPERATOR:	OPERATOR REPRESENTATIVE:	TYPE OF OPERATION:	
Garth Cooke	Garth Cooke	MP - Mineral Prospecting

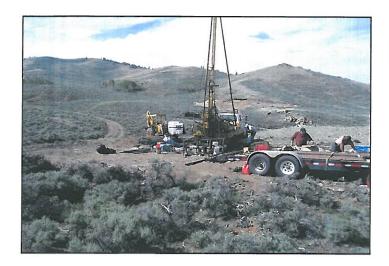
This was a minerals prospecting inspection performed by the Division to monitor the operator's drilling activity. The operator (named on page one) and three other personnel were at the site at the time of the inspection. The drilling equipment was deployed and active, and the drill hole at Site 2 was about 270 feet deep. The operator is extracting 1.5-inch diameter core. The bore hole was dry at that depth during the inspection.

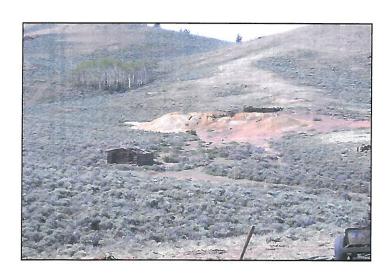
The disturbance observed was minimal, and in conformance with the approved plan. There were no problems observed.
