COLORADO DIVISION OF RECLAMATION, MINING AND SAFETY
MINERALS PROGRAM INSPECTION REPORT
PHONE: (303) 866-3567

MINE NAME: Logan Wash	MINE/PROSPECTING ID#: M-1977-424	MINERAL: Oil shale	COUNTY: Garfield
INSPECTION TYPE: Monitoring	INSPECTOR(S): Travis H. Marshall	INSP. DATE: June 7, 2013	INSP. TIME: 10:00
OPERATOR: Occidental Oil Shale, Inc.	OPERATOR REPRESENTATIVE: Bruce Smith	TYPE OF OPERATION: 112 - Hard Rock Regular Operation	
REASON FOR INSPECTION: Normal I&E Program	BOND CALCULATION TYPE: None	BOND AMOUNT: \$570,428.00	
DATE OF COMPLAINT: NA	POST INSP. CONTACTS: None	JOINT INSP. AGENCY: None	
WEATHER: Clear	INSPECTOR'S SIGNATURE:

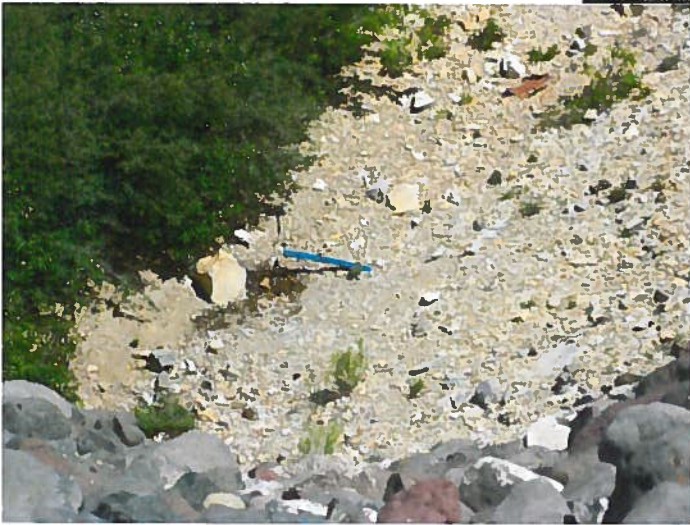
This was a partial inspection with the primary focus to observe the outfall LW-001 that is currently regulated by the CDPHE under a discharge permit. The discharge point is currently located in the drainage that is located to the west of the mine bench. The estimated discharge rate is 2.5 gallons per minute. During observation of the discharge point a damp area around it was observed. It appears that the water is only on the surface for a short amount of time and then it infiltrates into the crushed shale and becomes subsurface water.

The fate of the discharge point LW-001 is under review and the operator may propose to remove the discharge point from the drainage it is currently located in. The point of discharge may be relocated to the mine bench where an infiltration pit may be constructed. The relocation of the discharge point from the channel would eliminate the need for a discharge permit due to no longer being in the channel.

Prior to a relocation of the discharge point LW-001 and construction of an infiltration pit a technical revision must be submitted for review by DRMS staff.

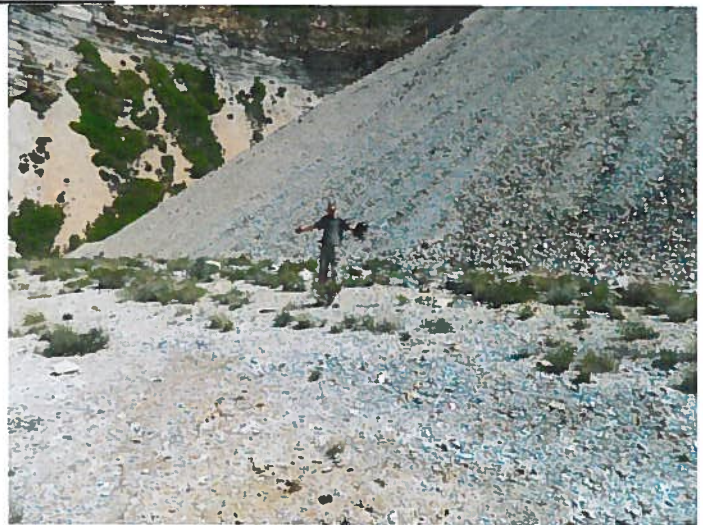
Potential location of infiltration pit

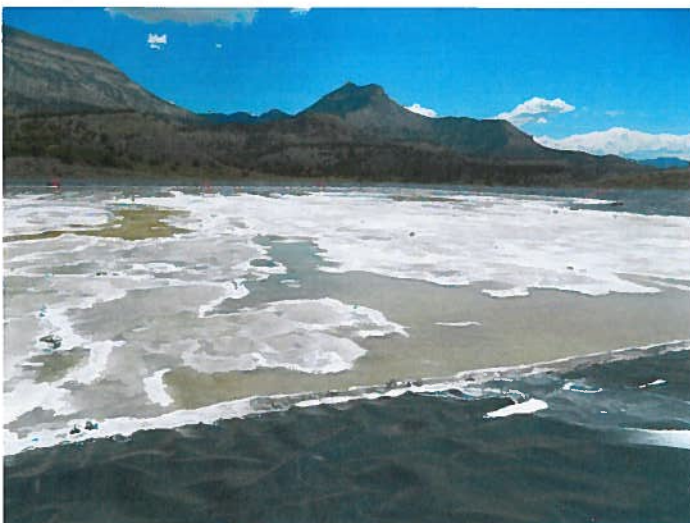
Evaporation pond

The condition of the evaporation pond liner was observed and found to be properly functioning. As stated in previous inspection reports the liner has been repaired many times and is very near the end of its lifespan. This is not a problem at this time due to the operator being required to have the evaporation ponds and mine facility fully reclaimed by September 5, 2018. The condition of the pond liner is monitored on a weekly basis and is continuously monitored for leaks with a transducer located in the leachate collection system vault. If a leak occurs the water is immediately pumped back into the pond via submersible pump.
