COLORADO DIVISION OF RECLAMATION, MINING AND SAFETY COAL PROGRAM INSPECTION REPORT

Permit Number: C-1981-037 Mine Name: GEC Strip Mine Operator: GEC Minerals Operator Address: Dr W Corley 2605 Constellation Drive Colorado Springs, CO 80906	County: Fremont Operation Type: Surface Permit Status: Revoked Ownership: Private
	Operator Representative Present: NA
Operator Representative Signature: (Field Issuance Only)

This was a complete inspection. The Division is conducting a final inspection prior to terminating DRMS jurisdiction on the GEC mine site.

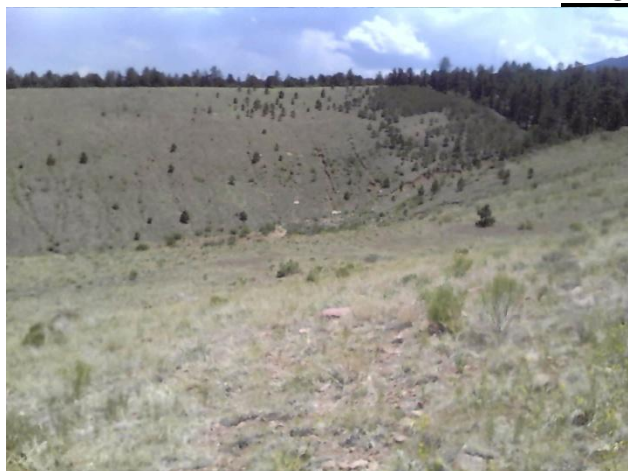
Photo 1: East pit looking towards south

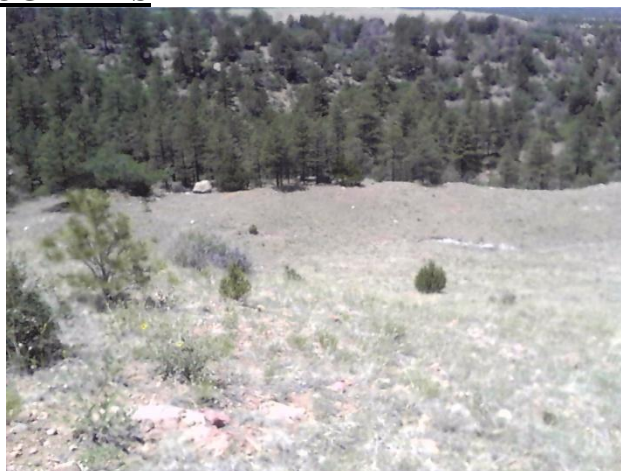
vegetation looks fairly stable. Some gullies still exist on these steeper slopes.

Photo 2: South end of West Pit

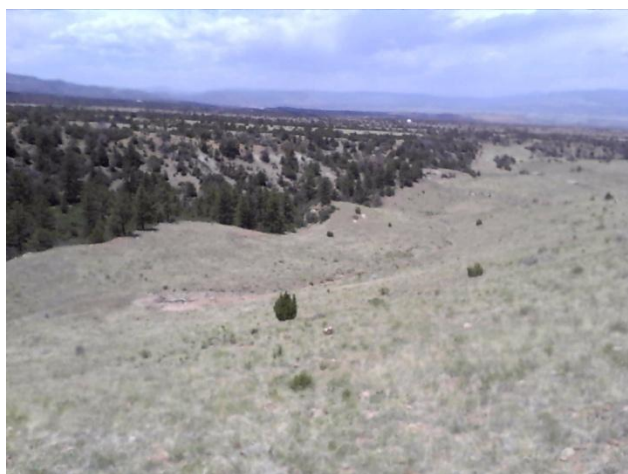
Photo 3: West pit looking northwards

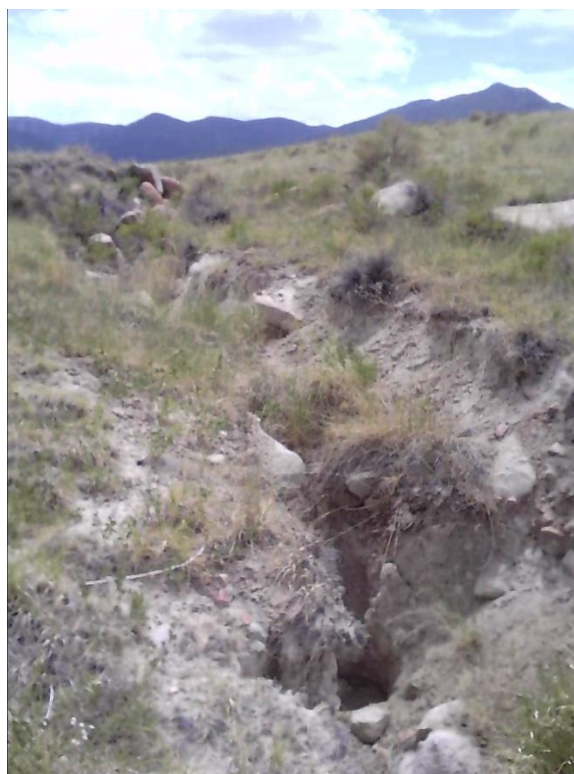
The drainage between the northern ends of the east and west pit remains large. The gully on the west side of Chen's hill remains large as well. Drainage from the south and west sides of Chen's hill flow to this area. Runoff from the East Pit, West Pit and east side of Chen's hill drain to the Magpie drainage.

The large gully between the East Pit and West Pit does not appear to have stabilized based upon recent sedimentation on the road and in the bottom of this feature.

Photo 4: Gully between West Pit and East pit at north Extent (south of access road)

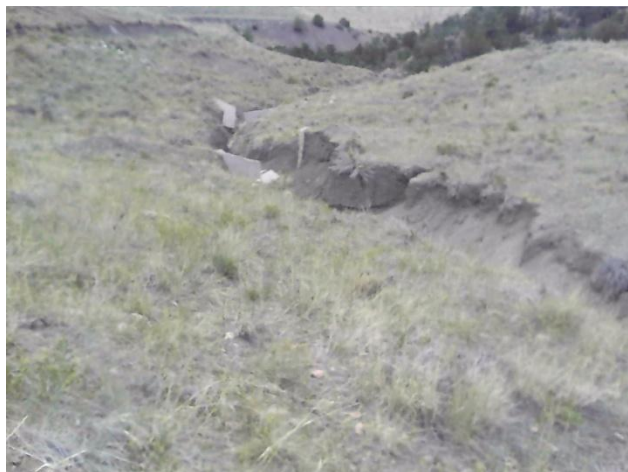
The gully on the north extent of the East and West pits with the damaged concrete check dams does not appear to have deepened or enlarged. The large gully on the west side of Chen's Hill and east of Fremont County Road 92 does not appear to have gotten any deeper.

Photo 5: gully located north of access road with broken concrete check dams

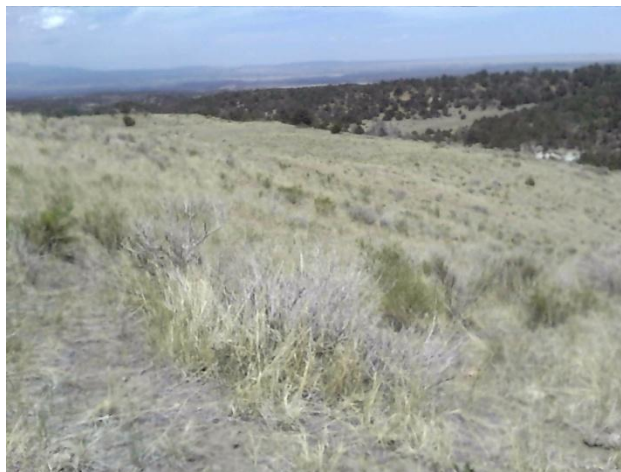
Photo 6: East side of Chen's Hill looking northward

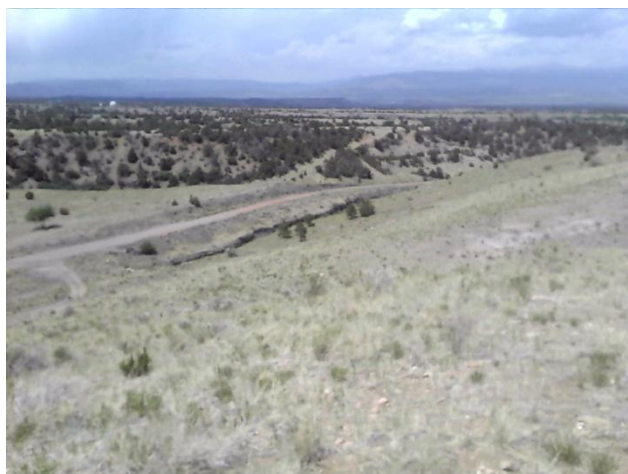
Photo 7: West side of Chen's Hill looking northward

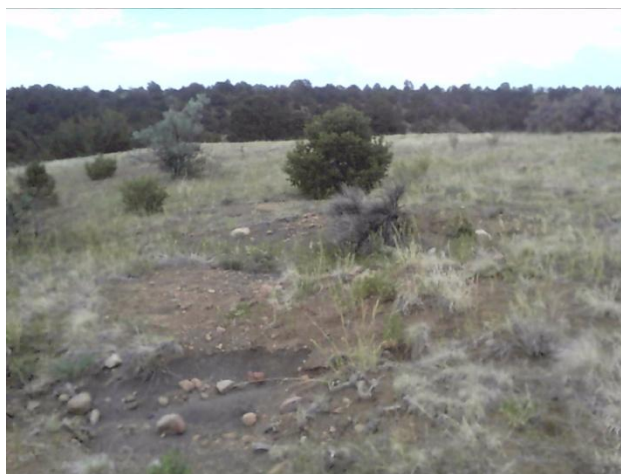
There are occasional bare patches within the reclamation. These patches are limited in size and generally not eroding. The bare patches are more commonly observed on Chen's Hill just below the crest of the ridge at the top of the slopes. Some bare patches are located on the flat areas of the reclaimed ridges.

Photo 8: North end of Chen's Hill. Bare spot below crest

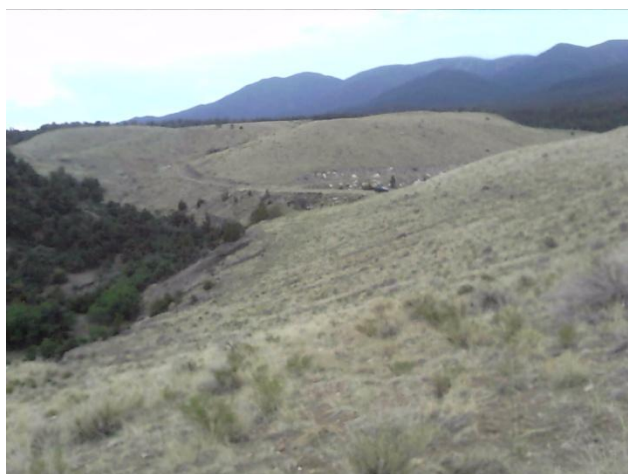
Photo 9: East side of Chen's Hill looking southwest

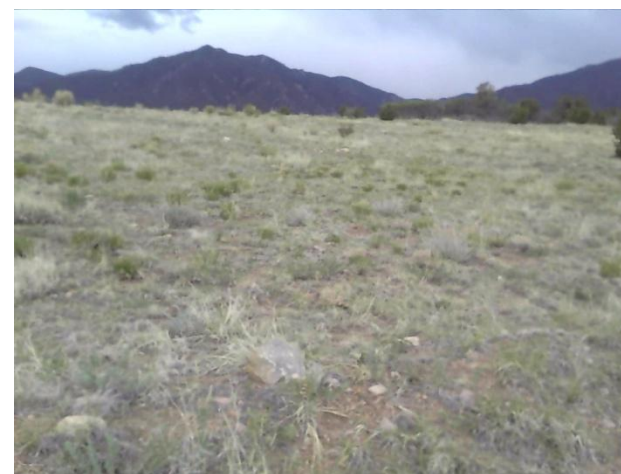
The reclaimed Duckpond area has held up well. There was no evidence of gully formation in the reclaimed Duckpond location. Contour furrows were still intact and effective in this area.

Photo 10: Reclaimed "Duckpond" slope looking westward

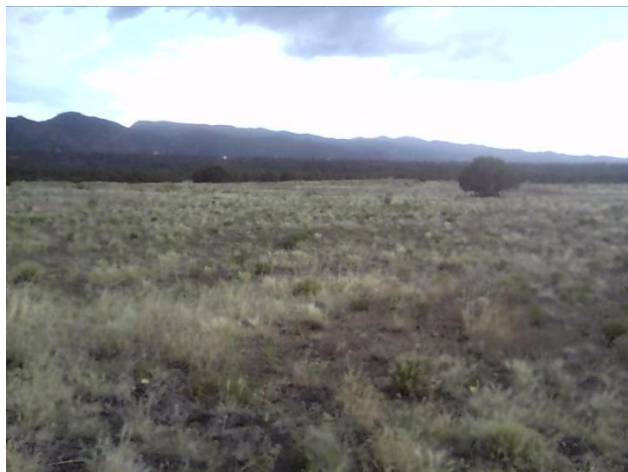
The reclaimed tipple area is relatively flat and grazed by livestock. No gully formation was noted in the reclaimed tipple area. There are no ponds remaining in the tipple area.

More annuals were noted in the tipple area. The tipple area has been grazed by cattle. Cattle were in the tipple area pasture at the time of the inspection.

Photo 11: Reclaimed & grazed tibble

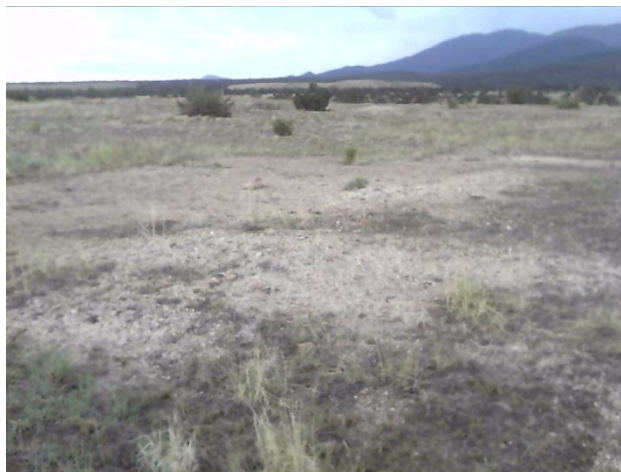
Photo 12: Gravel patch at tibble area
