COLORADO DIVISION OF RECLAMATION, MINING AND SAFETY
MINERALS PROGRAM INSPECTION REPORT
PHONE: (303) 866-3567

MINE NAME: Trout Creek Pit	MINE/PROSPECTING ID#: M-2001-035	MINERAL: Borrow material	COUNTY: Chaffee
INSPECTION TYPE: Monitoring	INSPECTOR(S): Dustin M. Czaplá	INSP. DATE: May 22, 2013	INSP. TIME: 12:00
OPERATOR: ACA Products, Inc.	OPERATOR REPRESENTATIVE: Mike Coleman	TYPE OF OPERATION: 112c - Construction Regular Operation

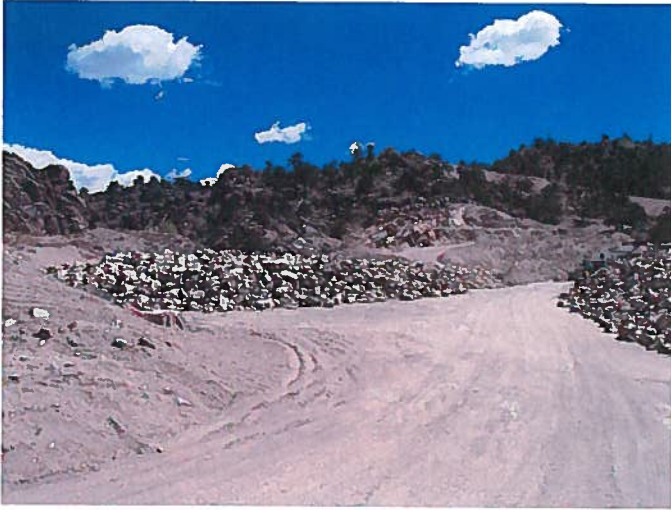
Figure 1: View of storage pad and lower quarry area, facing east.

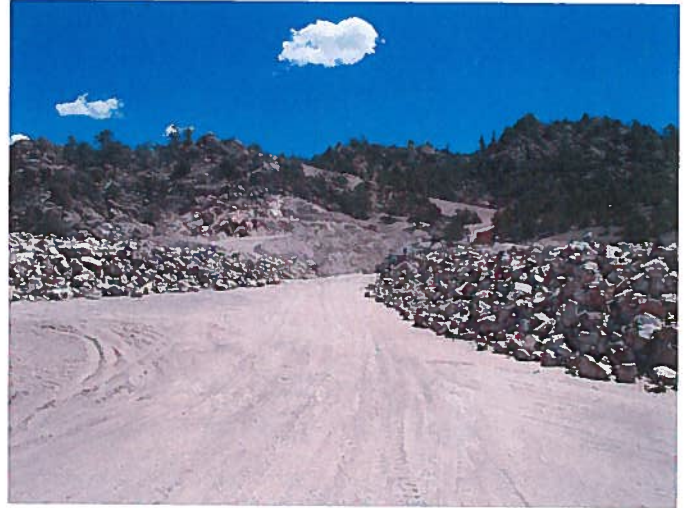
Figure 2: View of storage pad and lower quarry area, facing east.

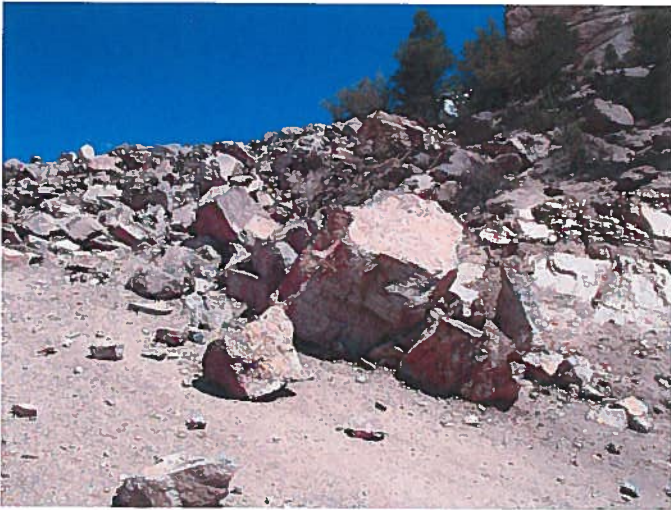
Figure 3: View of upper quarry area, facing east.

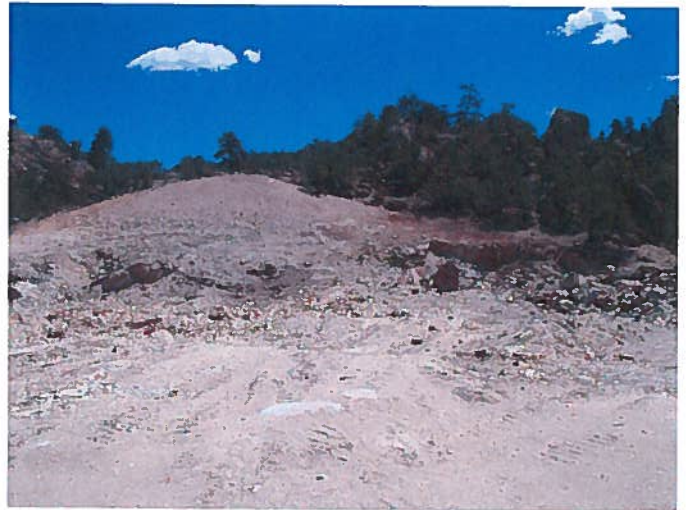
Figure 4: View of upper quarry area, facing east.
