COLORADO DIVISION OF RECLAMATION, MINING AND SAFETY
MINERALS PROGRAM INSPECTION REPORT
PHONE: (303) 866-3567

MINE NAME: River Park Recreation Access	MINE/PROSPECTING ID#: M-2005-051	MINERAL: Gravel	COUNTY: Chaffee
INSPECTION TYPE: Monitoring	INSPECTOR(S): Dustin M. Czapla	INSP. DATE: May 22, 2013	INSP. TIME: 11:30
OPERATOR: ACA Products, Inc.	OPERATOR REPRESENTATIVE: Mike Coleman	TYPE OF OPERATION: 110c - Construction Limited Impact

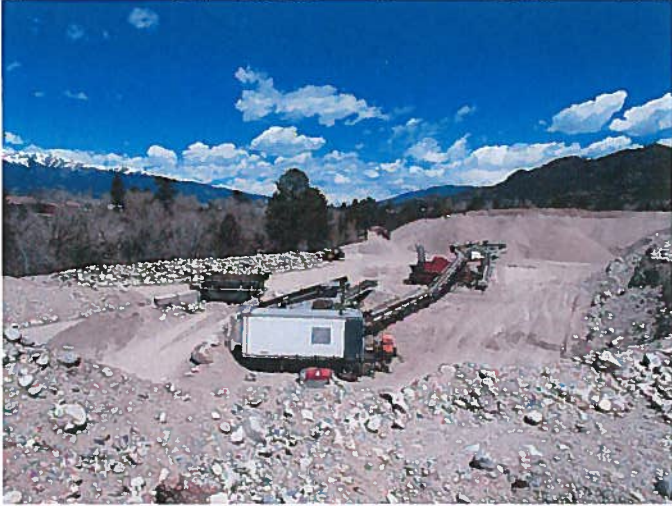
Figure 1: View from the south side of the pit, facing north.

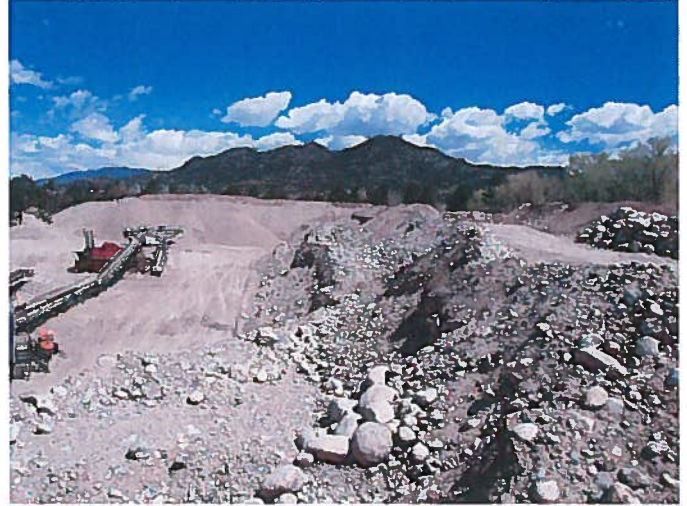
Figure 2: View from the south side of the pit, facing north.

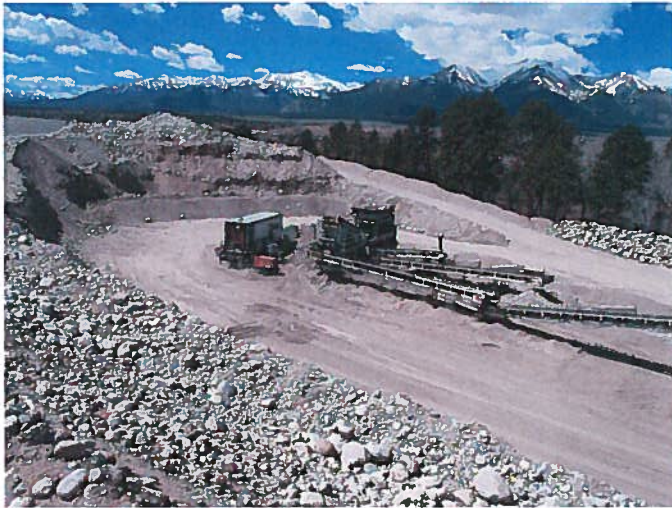
Figure 3: View toward the south end of the pit, from the east rim of the pit.

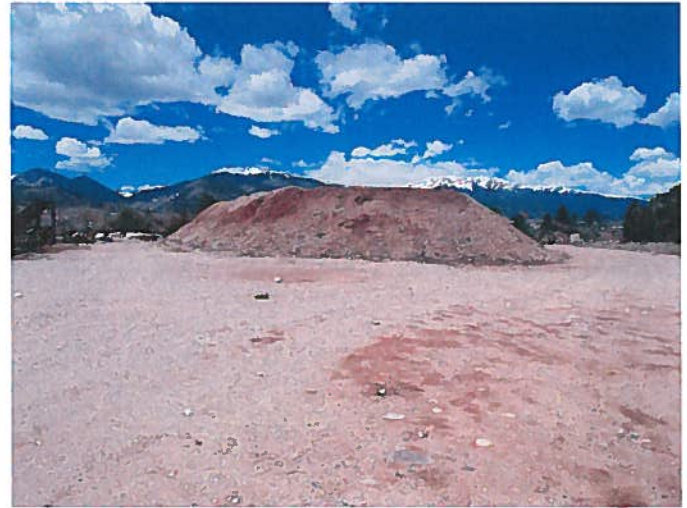
Figure 4: Topsoil stockpile located on the north side of the pit.
