COLORADO DIVISION OF RECLAMATION, MINING AND SAFETY
MINERALS PROGRAM INSPECTION REPORT
PHONE: (303) 866-3567

MINE NAME: Avery Construction Pit	MINE/PROSPECTING ID#: M-1979-010	MINERAL: Sand and gravel	COUNTY: Chaffee
INSPECTION TYPE: Monitoring	INSPECTOR(S): Dustin M. Czapla	INSP. DATE: May 22, 2013	INSP. TIME: 10:30
OPERATOR: ACA Products, Inc.	OPERATOR REPRESENTATIVE: Mike Coleman	TYPE OF OPERATION: 112c - Construction Regular Operation

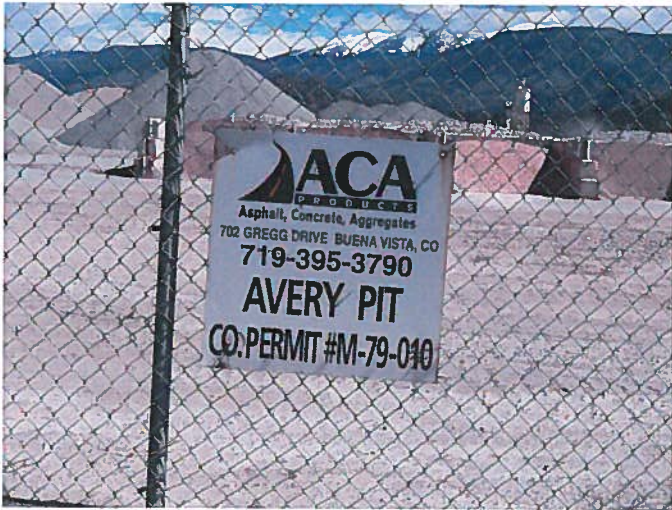
Adequate mine identification signage was noted at the entrance to the site.

Figure 1: Mine sign located near the east entrance to the site.

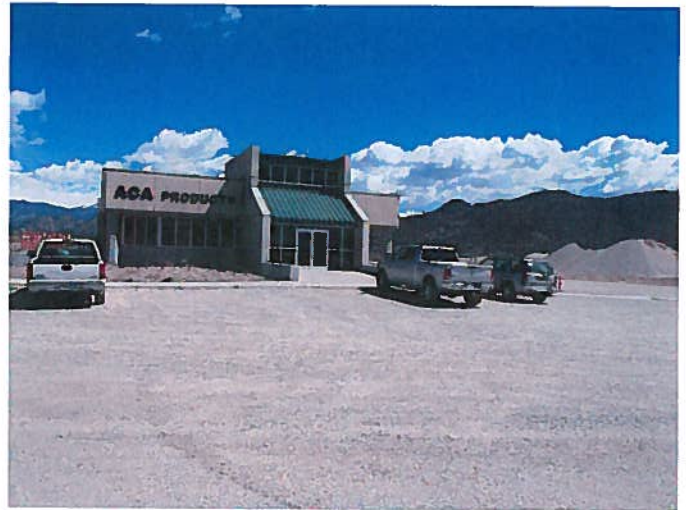
Figure 2: Office building located on south side of pit.

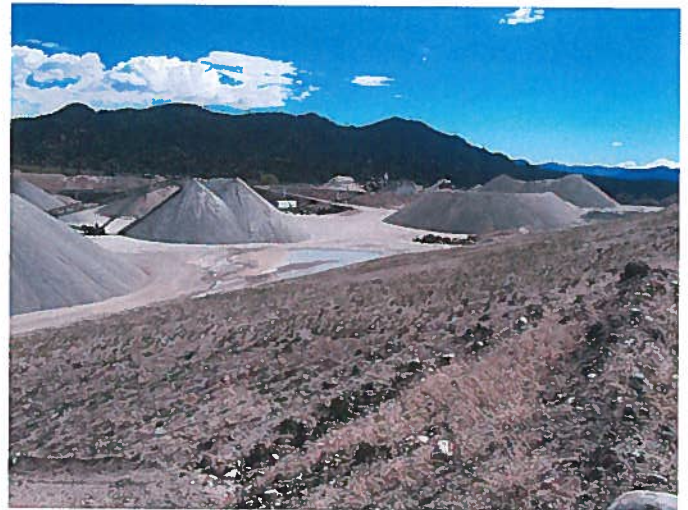
Approximately 300 linear feet highwall on the north side of the office building has been graded to 4H:1V and seeded. The slope appeared stable and no rills or gullies were noted. The vegetation on the slope appeared sparse though. Some further backfilling of the highwall has commenced along the south side of the pit. Much of the southeast and east highwall were near vertical. The north highwall has been graded to approximately 2.5H:1V.

Figure 6: View from the south side of the pit, facing east.
4H:1V slope shown is on north side of office building.

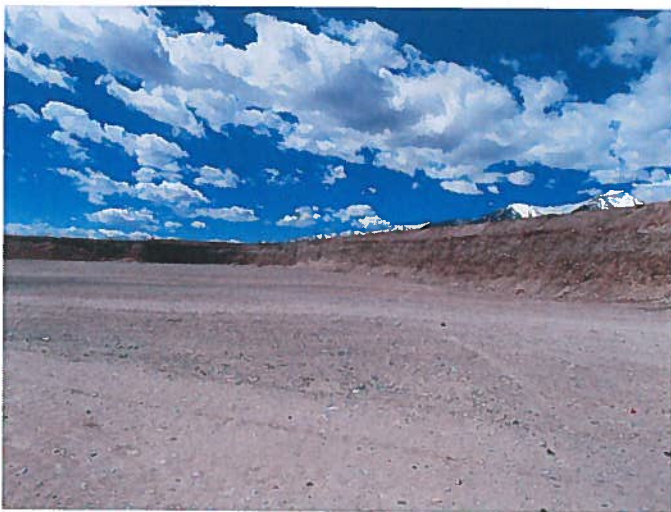
Figure 7: Highwall on the west side of the pit.

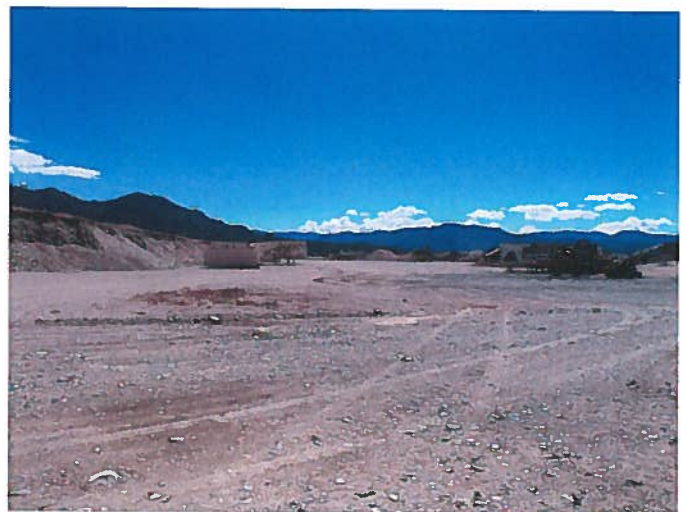
Figure 8: Highwall on the west side of the pit.

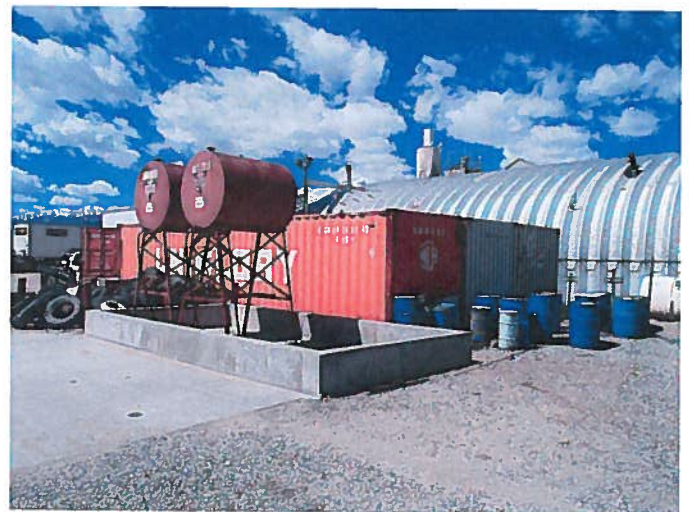
Figure 12: Fuel adequately contained behind the shop area.

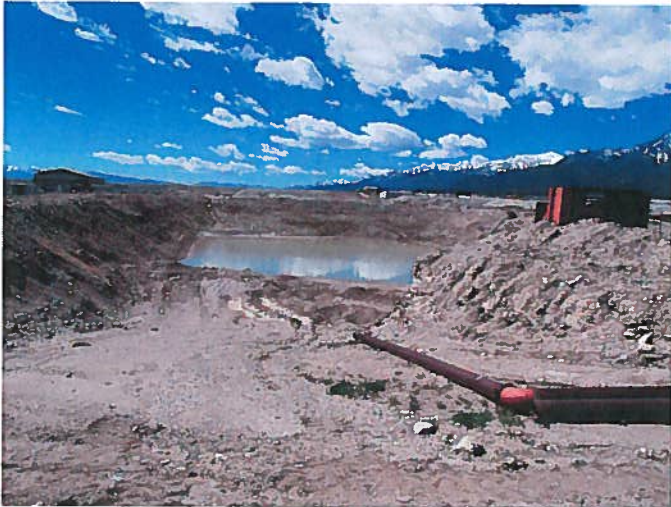
Figure 13: Northeast wash pond.

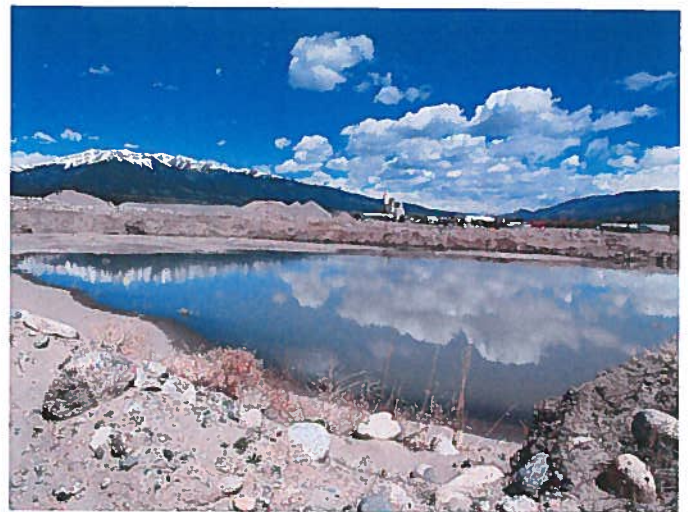
Figure 14: Southeast wash pond.

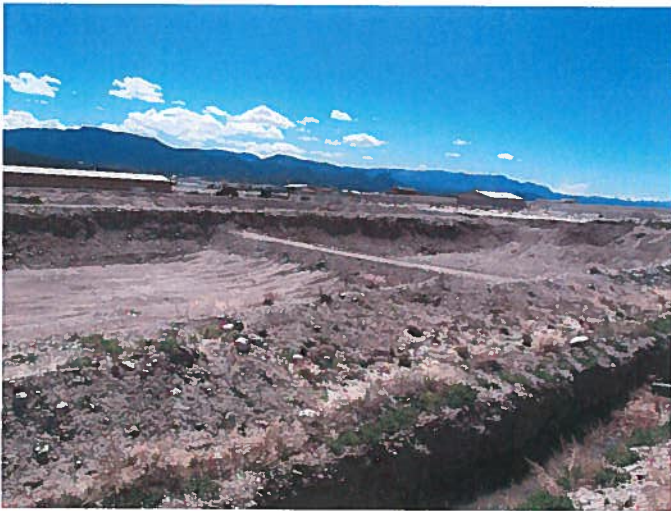
Figure 15: West wash ponds.

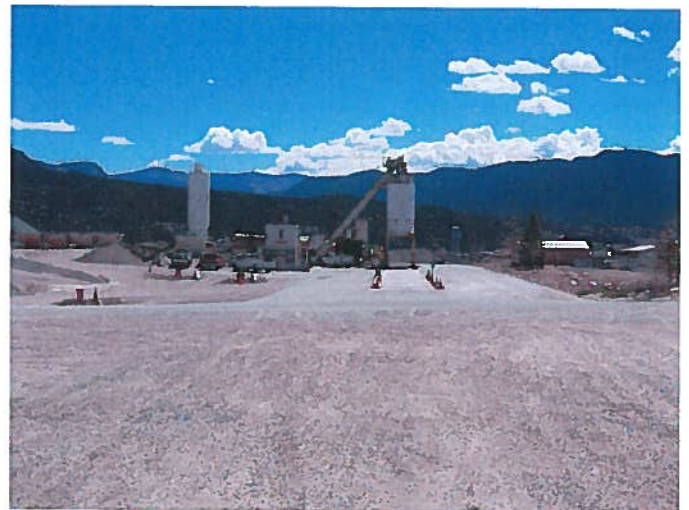
Figure 16: Batch plant.
