COLORADO DIVISION OF RECLAMATION, MINING AND SAFETY
MINERALS PROGRAM INSPECTION REPORT
PHONE: (303) 866-3567

MINE NAME: Newett Quarry	MINE/PROSPECTING ID#: M-1978-093	MINERAL: Limestone	COUNTY: Chaffee
INSPECTION TYPE: Monitoring	INSPECTOR(S): Dustin M. Czapla	INSP. DATE: May 22, 2013	INSP. TIME: 14:00
OPERATOR: Colorado Lien Company	OPERATOR REPRESENTATIVE: Mike Golliher	TYPE OF OPERATION: 112c - Construction Regular Operation

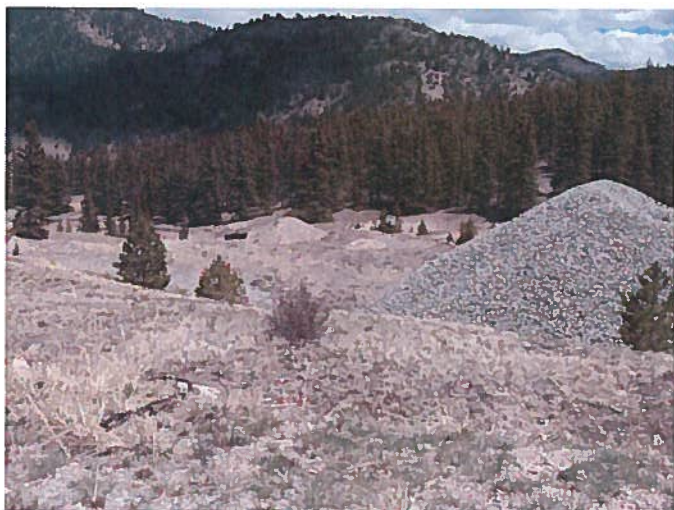
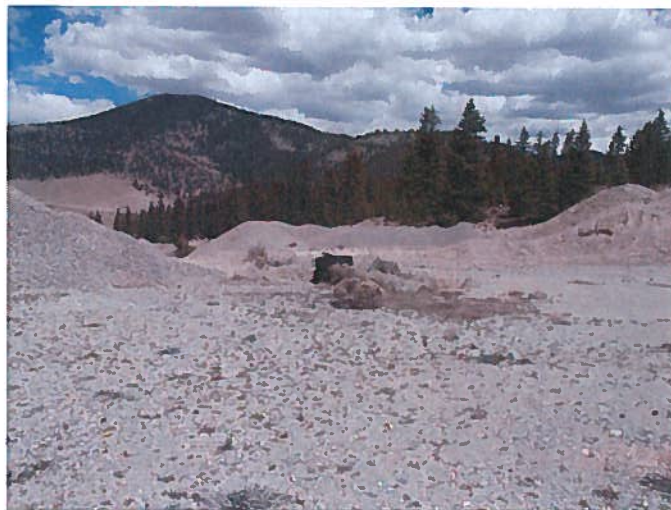
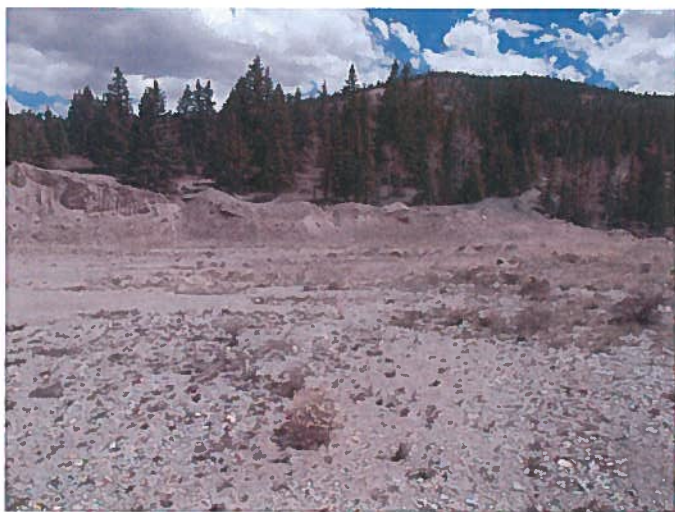
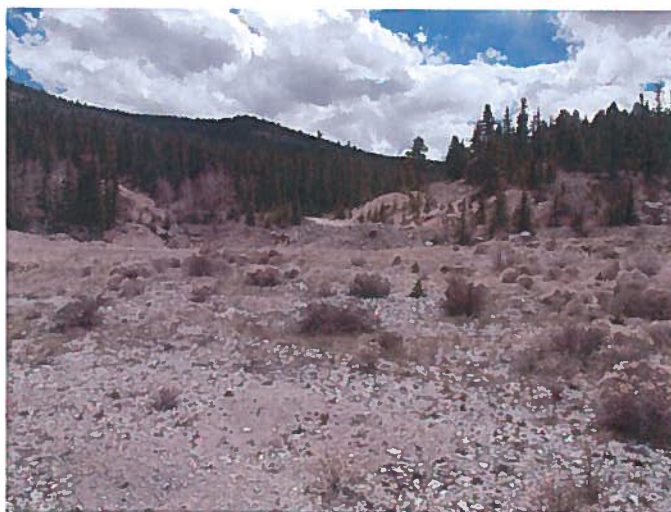
Mining was not occurring at the site during this inspection. According to the operator's annual reports, mining activity last occurred here in October, 2010. Some remaining stockpiles of processed material were located in the stockpile area. Except for several used tires, the stockpile area appeared free of debris and/or refuse. Silt fence, which appeared in good working order, was placed at the east end of the stockpile area, above the drainage, in order to detain run-off sediment on-site.

Figure 1: Stockpile Area

Figure 2: Stockpile Area

Figure 3: Stockpile Area

Figure 4: Stockpile Area

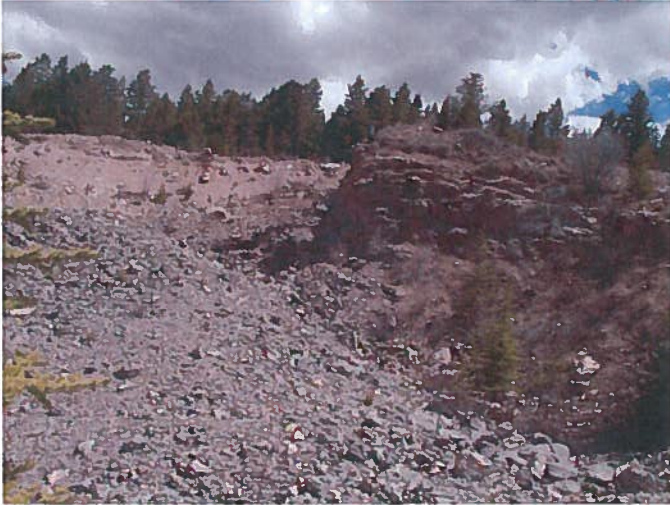
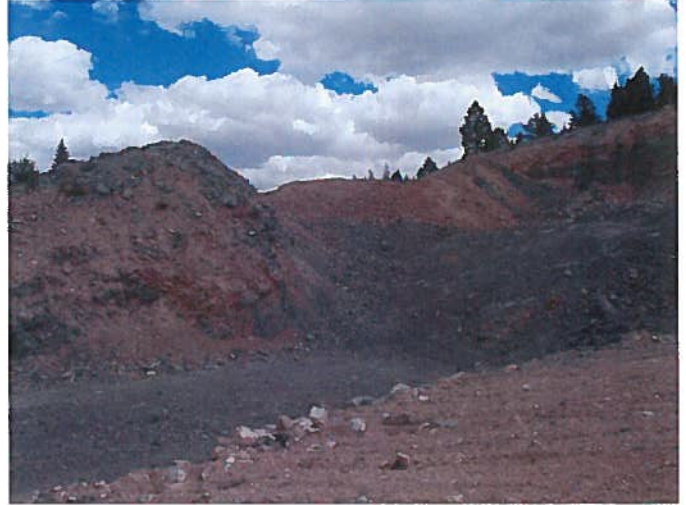
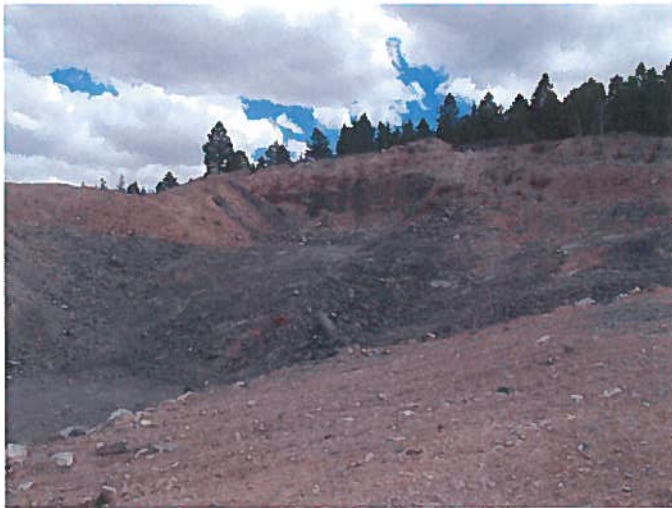
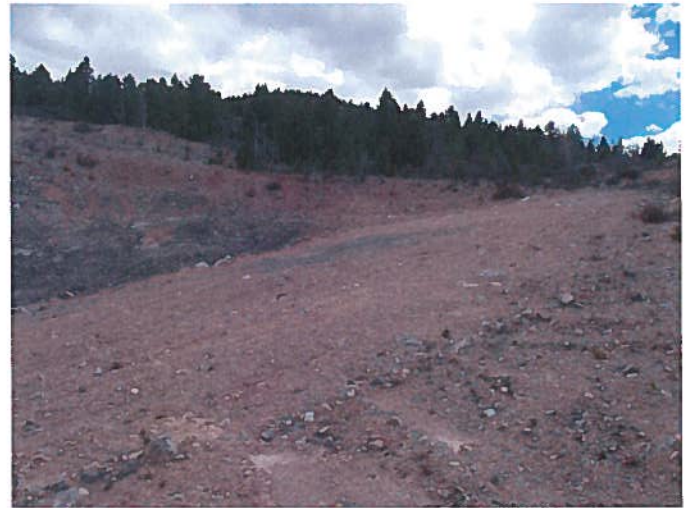
In Mining Area B, reclamation grading has commenced, although some vertical highwall still exists. All slopes appeared stable during this inspection. Signs of excessive erosion were not noted.

Figure 5: Mining Area B

Figure 6: Mining Area B

Figure 7: Mining Area B

Figure 8: Mining Area B
