COLORADO DIVISION OF RECLAMATION, MINING AND SAFETY
MINERALS PROGRAM INSPECTION REPORT
PHONE: (303) 866-3567

MINE NAME: Rock Gulch Gravel Pit	MINE/PROSPECTING ID#: M-1980-041	MINERAL: Sand and gravel	COUNTY: Chaffee
INSPECTION TYPE: Monitoring	INSPECTOR(S): Dustin M. Czapla	INSP. DATE: May 23, 2013	INSP. TIME: 08:30
OPERATOR: James L Treat	OPERATOR REPRESENTATIVE: James Treat	TYPE OF OPERATION: 112c - Construction Regular Operation

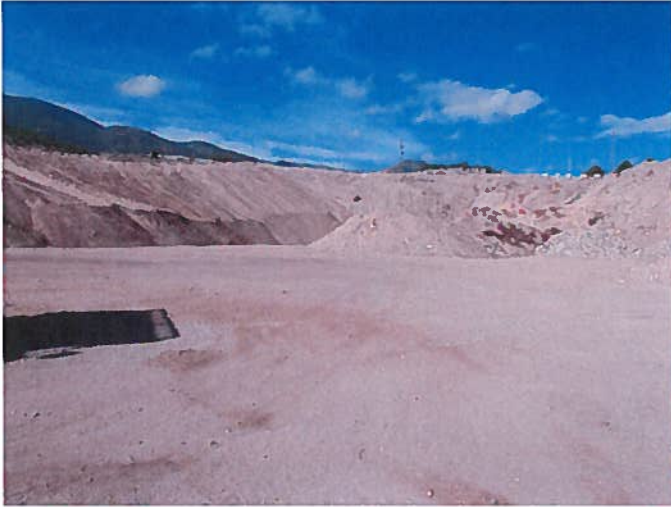
Mining was not occurring during this inspection. Several materials stockpiles were located throughout the pit floor. As noted in the Division's February, 2011 inspection report, the operator has committed to maintaining slopes of 3H:1V or less at the site during the mining operation. At the time CN1 was approved, a significant portion of the highwall was steeper than 3H:1V. The operator has commenced the highwall reduction, but there are still slopes around the pit steeper than 3H:1V. In order to comply with the mining plan approved through CN-1 the operator shall reduce and maintain all mined slopes at 3H:1V or less. This has not been noted as a problem in this inspection report because the slope reduction is in work. If during the Division's next inspection there are still slopes steeper than 3H:1V, enforcement actions may be initiated.

Figure 1: View toward the highwall where slope reduction has commenced, in the southwest part of the pit.

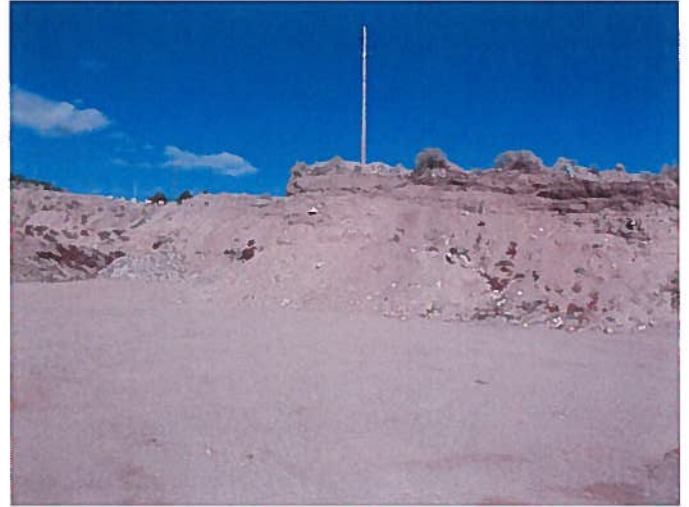
Figure 2: View toward the west side of the pit.

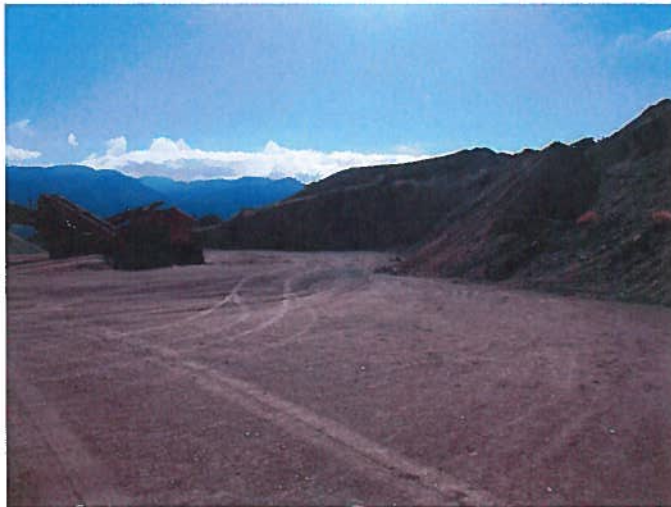
Figure 3: View toward the east side of the pit.

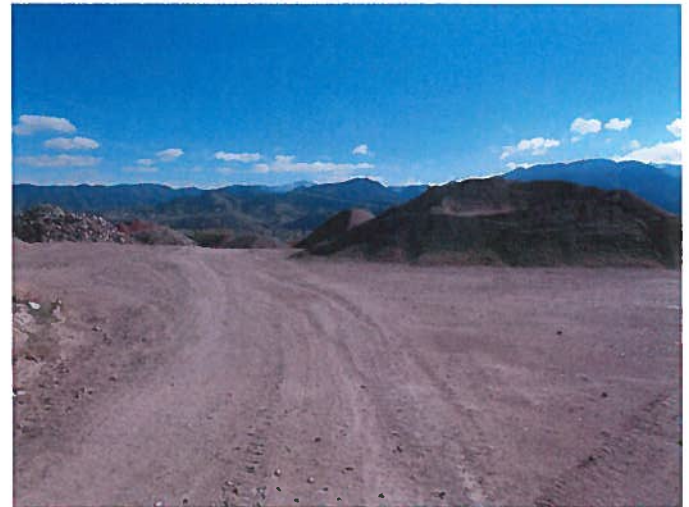
Figure 4: View of the east part of the pit, facing north.
