COLORADO DIVISION OF RECLAMATION, MINING AND SAFETY
MINERALS PROGRAM INSPECTION REPORT
PHONE: (303) 866-3567

MINE NAME: May Day Idaho Mine Complex	MINE/PROSPECTING ID#: M-1981-185	MINERAL: Gold and silver	COUNTY: La Plata
INSPECTION TYPE: Monitoring	INSPECTOR(S): Dustin Czapla	INSP. DATE: June 5, 2013	INSP. TIME: 08:30
OPERATOR: Wildcat Mining Corporation	OPERATOR REPRESENTATIVE: Randy Oser	TYPE OF OPERATION: 112d-1 - Designated Mining Operation	
REASON FOR INSPECTION: Normal I&E Program	BOND CALCULATION TYPE: Complete Bond	BOND AMOUNT: \$204,562.00	
DATE OF COMPLAINT: NA	POST INSP. CONTACTS: None	JOINT INSP. AGENCY: None	
WEATHER: Clear	INSPECTOR'S SIGNATURE:

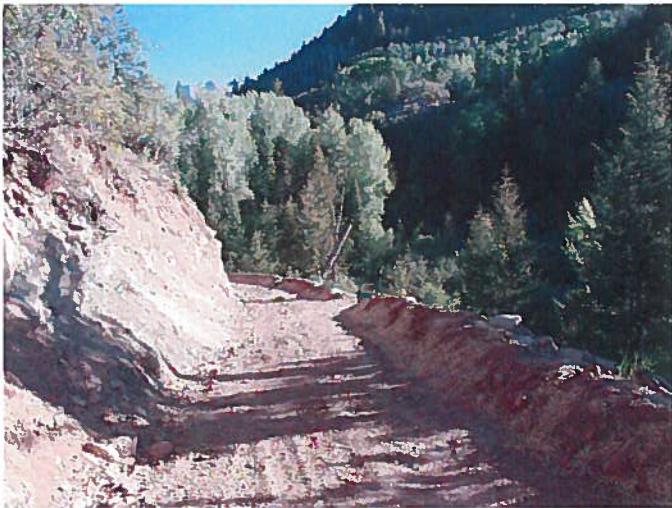
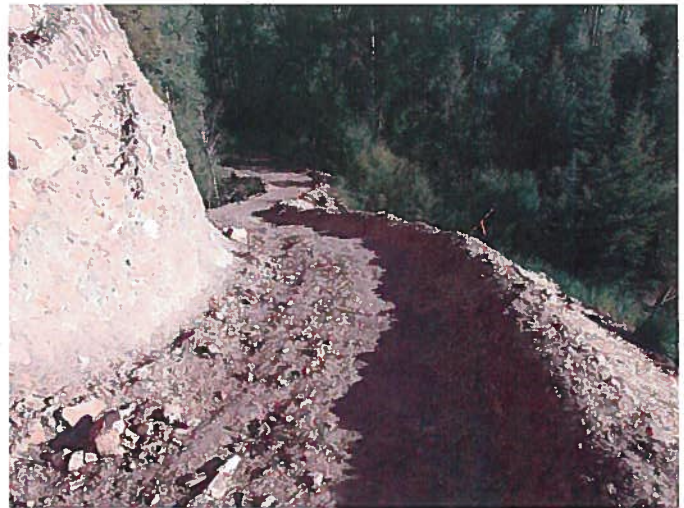
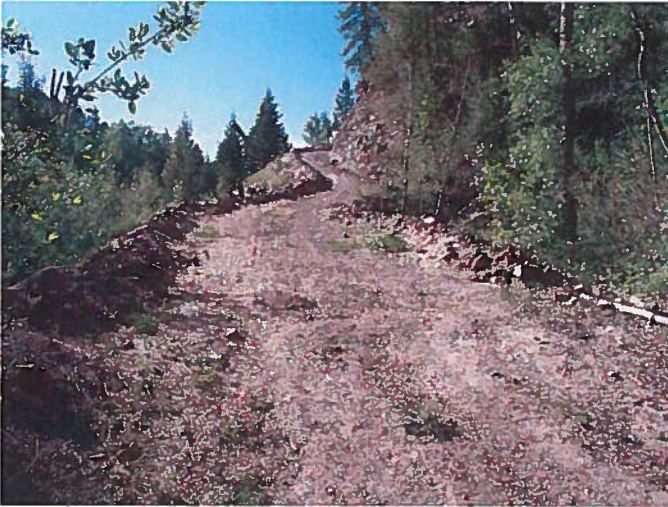
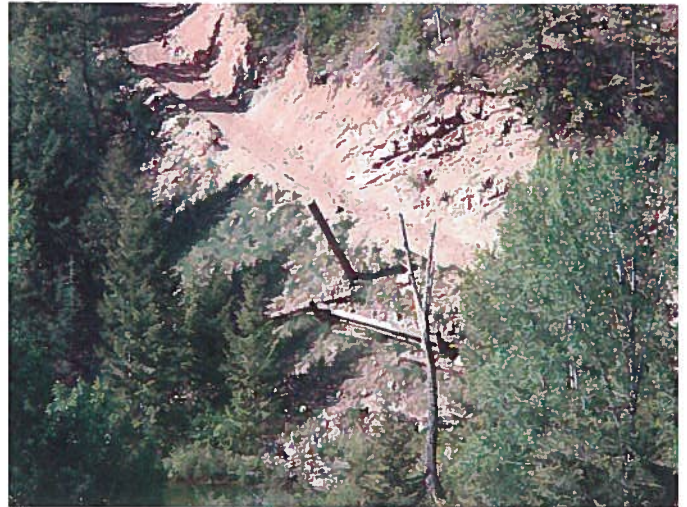
PROBLEM/POSSIBLE VIOLATION: Construction of the new access road as approved through TR-2 has not been completed in a timely manner. The access road, in its current unstable condition continues to present risk to human health, safety and the environment.

Since the Division's last inspection the operator graded the road surface to slope toward the cut-slope in order to divert stormwater away from the wetlands on the east side of the road. A safety berm was also constructed on the outside edge of the road. According to correspondence received from the operator on December 12, 2012, these were preliminary construction activities performed in preparation for conducting the construction of the new access road as approved through TR-2, which is now anticipated to occur during the 2013 construction season. TR-2 proposed that construction of the new access road would commence in June, 2012. Construction of the new access road as approved through TR-2 has not been completed in a timely manner and in its current unstable condition continues to present risk to human health, safety and the environment. Renovation of the La Plata River bridge, as approved through TR-3, has not yet commenced. Evidence of the operator's utilization of the road for vehicular access to the site was not observed during this inspection.

Figure 1: Looking down the access road.

Figure 2: Looking down the access road.

Figure 3: Looking up the access road.

Figure 4: View of the access road from across the canyon.

CORRECTIVE ACTIONS: Complete construction of the New Access Road pursuant to the conditions approved through TR-2.

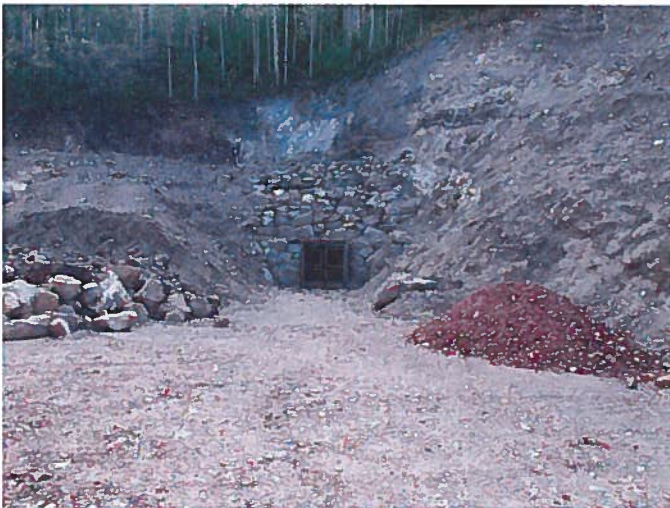
Activities approved through TR-1 appeared to have been completed. The access portal has been reopened. It was secured with a locked gate. Wire mesh and rock bolts were used to stabilize the highwall above the portal. The mill portal door was locked during this inspection. Milling equipment removed from the mill portal was located on the May Day 1 pad, along with four locked storage containers and other various refuse and debris.

Figure 5: May Day 1 access portal and highwall.

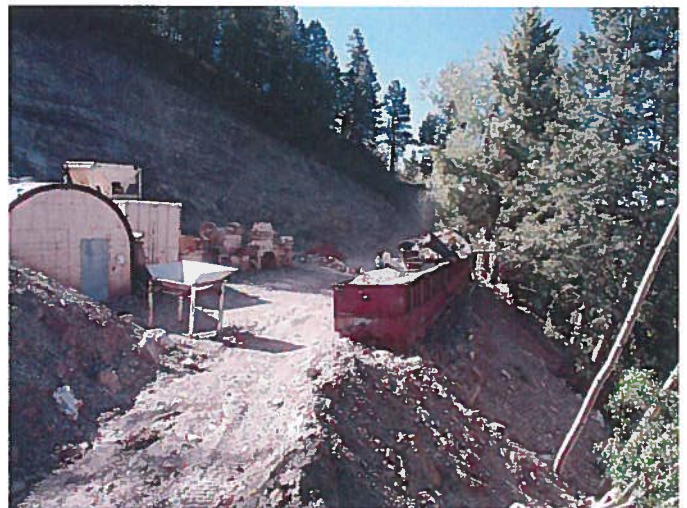
Figure 6: View of May Day 1 area from the north side of the pad.

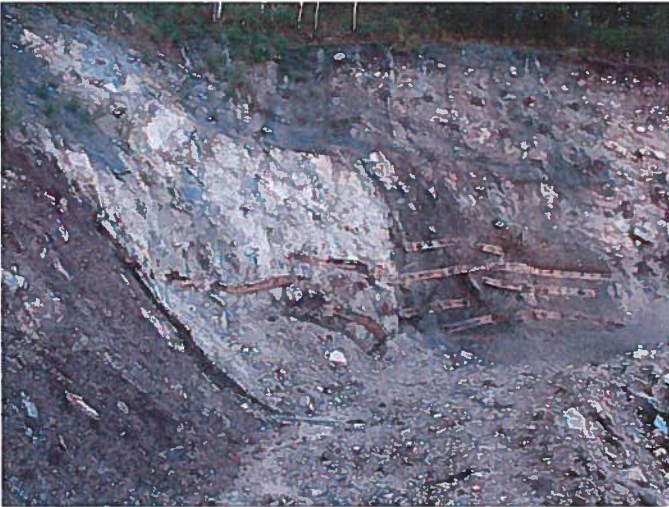
Figure 7: Highwall above the access portal.

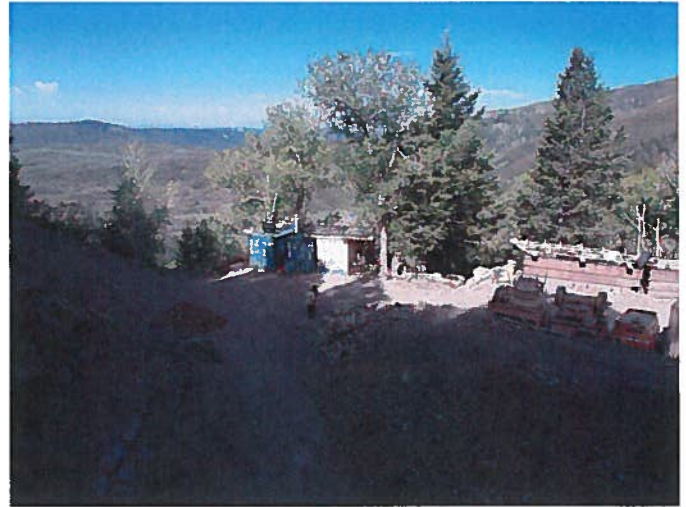
Figure 8: View of the May Day 1 area from the bench above the access portal.

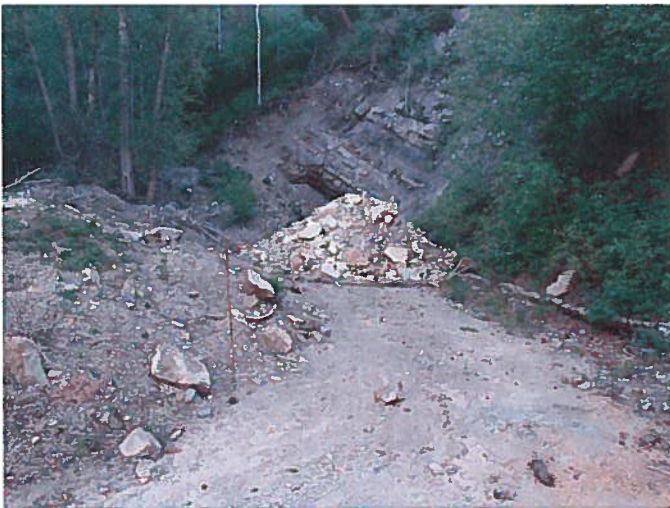
Figure 9: View from access road toward the May Day 2 portal.

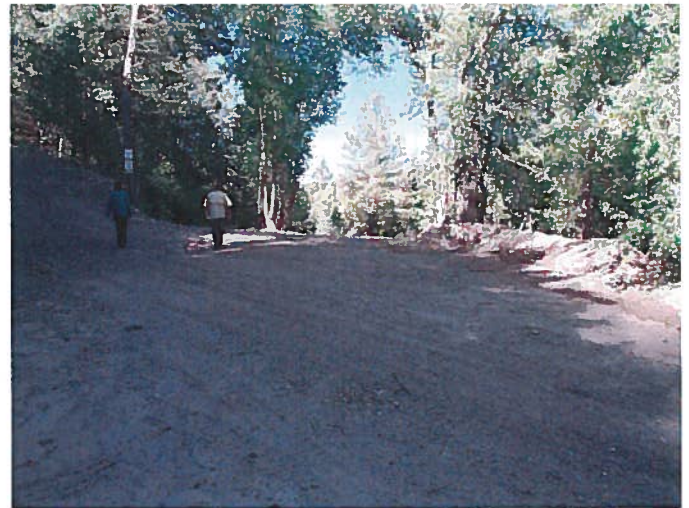
Figure 10: View from access road, facing west.

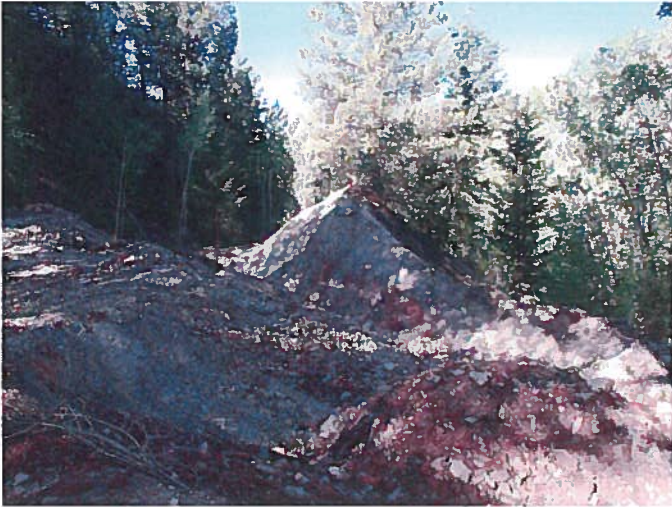
Since the Division's last inspection, the area west of the access road has been graded and the pad area enlarged. It was unclear during this inspection where the material that was previously bermed around the western edge of the pad area during the last inspection has been placed. It appeared to have been pushed over the western edge of the pad. The purpose of this earthwork is unclear at this time. The restoration of Little Deadwood Gulch, as approved through TR-4, has not yet commenced.

Figure 11: View from the pad area west of the access road, facing down slope.

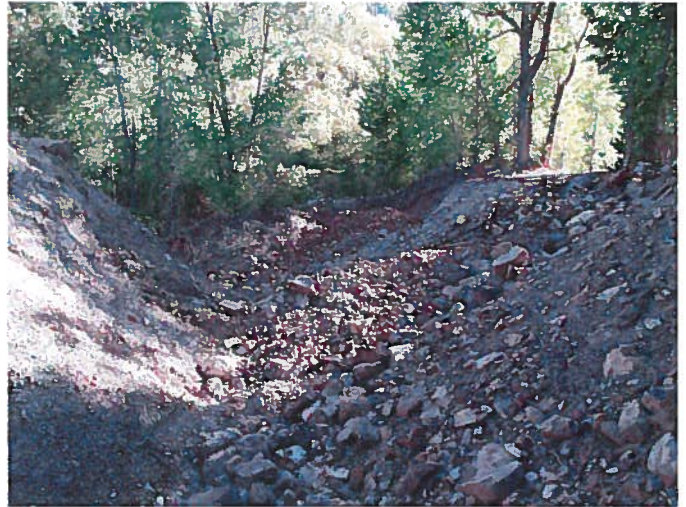
Figure 12: View from the pad area west of the access road, facing down slope.

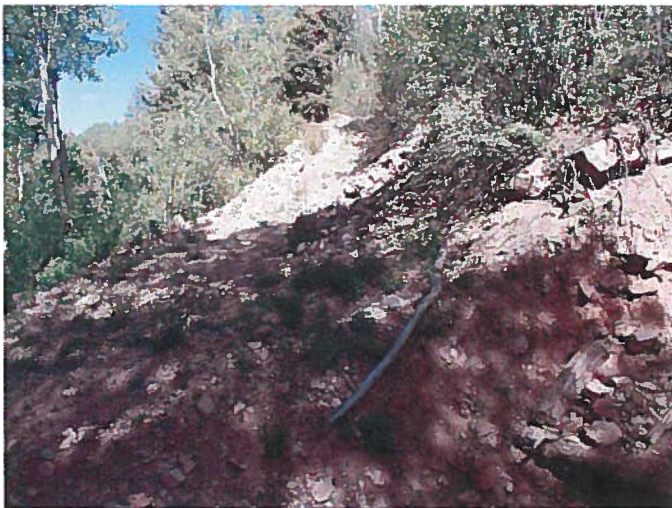
Figure 13: Looking up the access road to the Chief Tunnel.

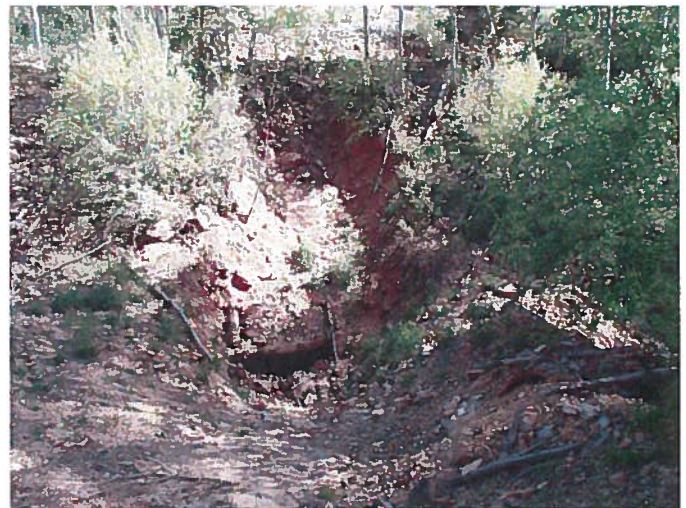
The overall conditions at the Chief Tunnel area appeared unchanged from previous inspections. Evidence of any recent activity in this area was not noted. Rock debris, which appeared to have sloughed from the slope above the tunnel, was located in front of the collapsed opening. Restoration of Little Deadwood Gulch and repair of the Chief Portal, as approved through TR-5, has not yet commenced.

Figure 14: Chief Tunnel collapsed opening.

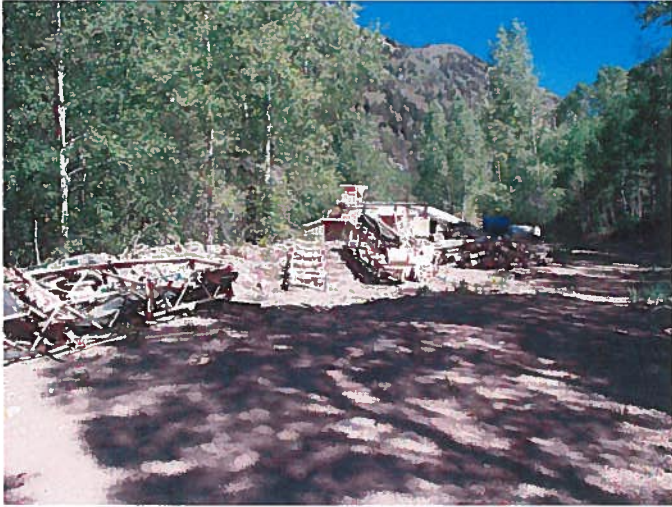
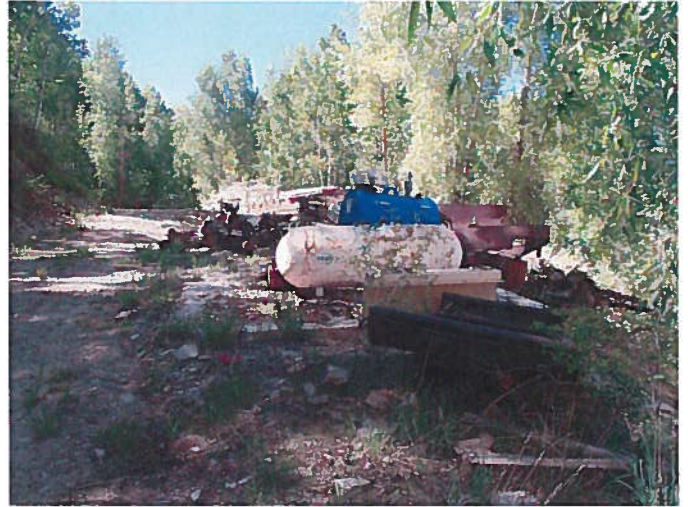
Figure 15: Area on the south side of the mill building.

Figure 16: Area on the south side of the mill building.

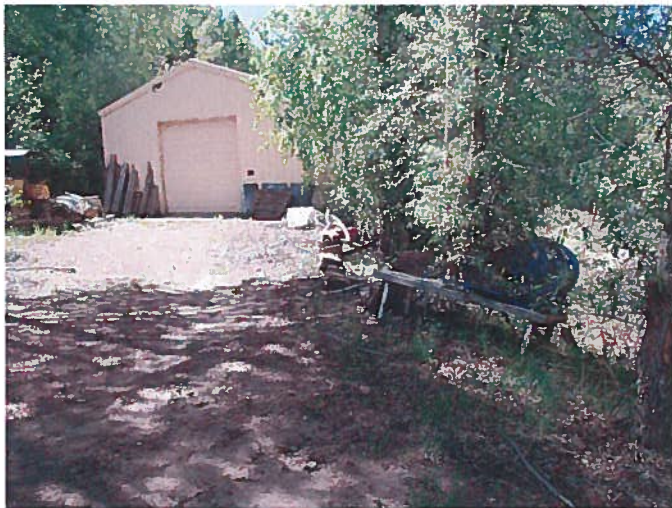
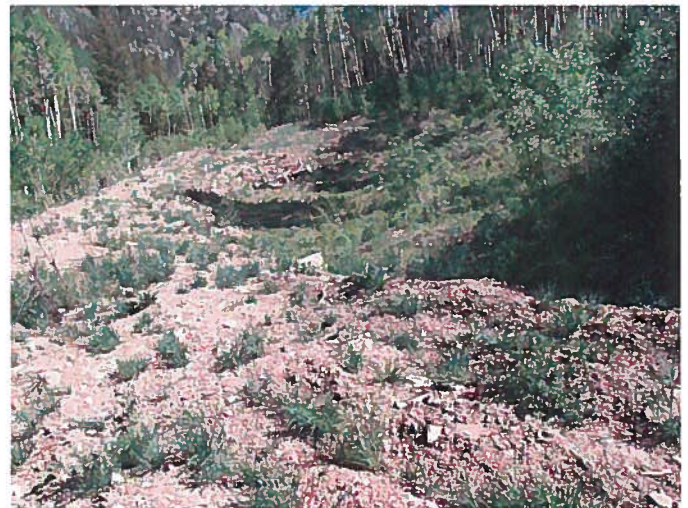
Figure 17: Area on the north side of the mill building.

Figure 18: Area on the north side of the mill building.

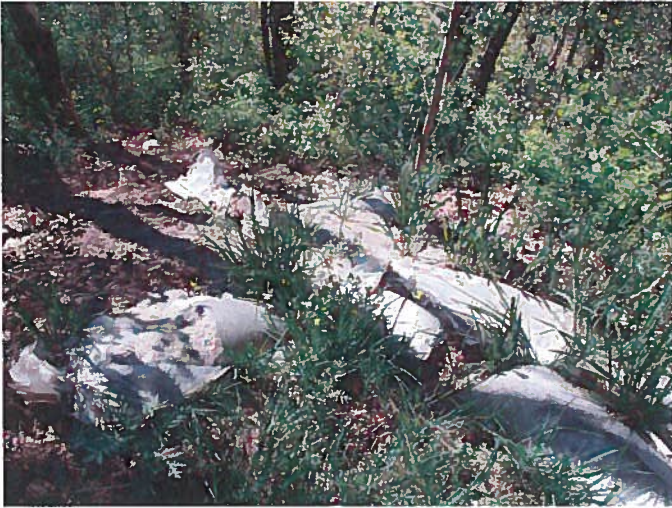
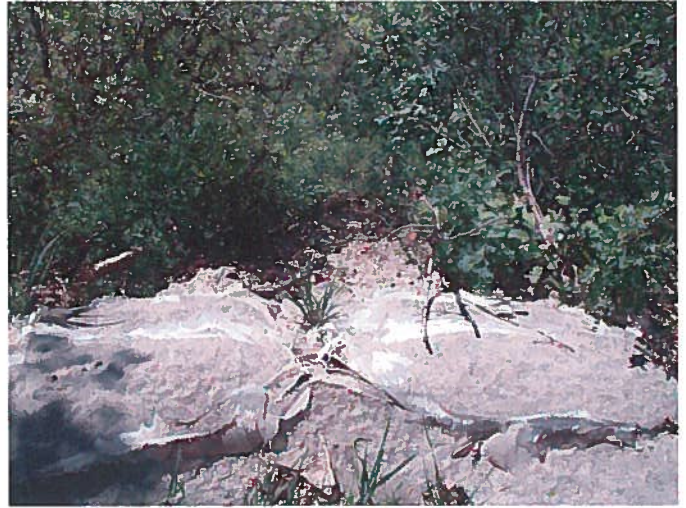
PROBLEM/POSSIBLE VIOLATION: Throughout the affected area the operator has utilized sand bags as part of their sediment detention structures along the access roads. These structures have not been adequately maintained and the bags are deteriorating and spilling sand down the slopes where they were placed, effectively contributing to additional sedimentation of the affected area.

Throughout the affected area the operator has utilized sand bags as part of their sediment detention structures along the access roads. These structures have not been adequately maintained and the bags are deteriorating and spilling sand down the slopes where they were placed, effectively contributing to additional sedimentation of the affected area.

Figure 19: Sand bags utilized for sediment detention structures along access roads are deteriorating and sliding down slope.

Figure 20: Sand bags utilized for sediment detention structures along access roads are deteriorating and sliding down slope.

CORRECTIVE ACTIONS: Clean up spilled sand and repair sediment control structures as necessary to function properly.
