**COLORADO DIVISION OF RECLAMATION, MINING AND SAFETY
COAL PROGRAM INSPECTION REPORT**

Permit Number: C-1996-083 Mine Name: Bowie No. 2 Mine Operator: Bowie Resources, LLC Operator Address: Mr William A Bear P.O. Box 483 Paonia, CO 81428	County: Delta Operation Type: Underground Permit Status: Active Ownership: Federal and Forest
	Operator Representative Present: Bill Bear
Operator Representative Signature: (Field Issuance Only)

Inspection Start Date: June 25, 2013 Inspection Start Time: 08:00 Inspection End Date: June 25, 2013 Inspection End Time: 13:45	Inspection Type: Coal Complete Inspection Inspection Reason: Normal I&E Program Weather: Clear
Joint Inspection Agency: None	Joint Inspection Contacts:
Post Inspection Agency: None	Post Inspection Contacts:
Inspector(s): Susan L. Burgmaier	Inspector's Signature: <i>Susan Burgmaier</i> Signature Date: 06/25/2013

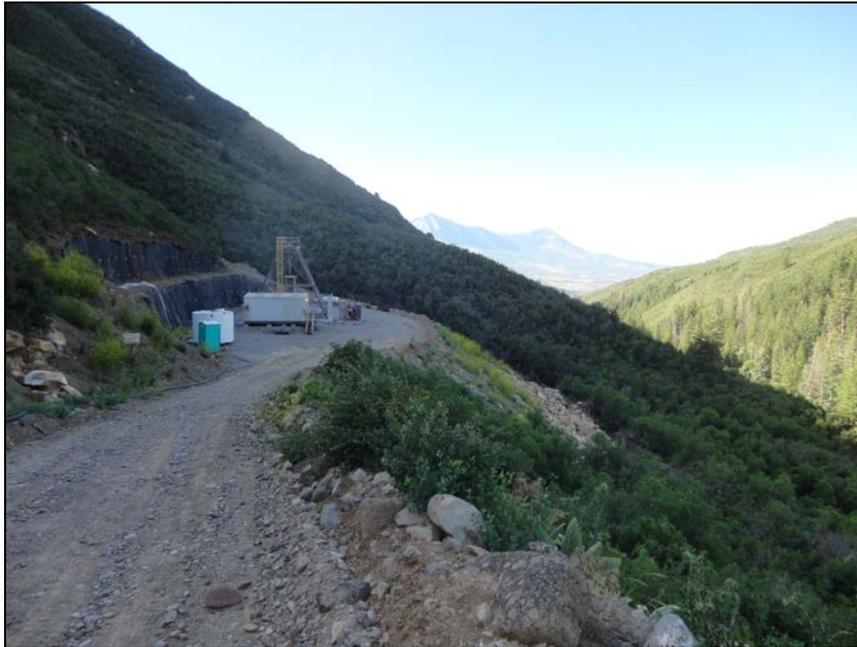
Photo 1

Areas with alternative sediment control and small area exemptions were inspected at several drill hole sites, the Terror Creek fan site, Terror Creek bridge, Hubbard Creek fan site, materials storage bench, and railroad spur. Silt fences and straw wattles were in good condition, with a few minor maintenance issues (straw wattles had been damaged by cattle at DH-SS-7, silt fence nearly full at GVB11, and wattles needed to be overlapped near the Terror Creek bridge). The grass filter area at the railroad spur had well established vegetation.

Terror Creek fan site

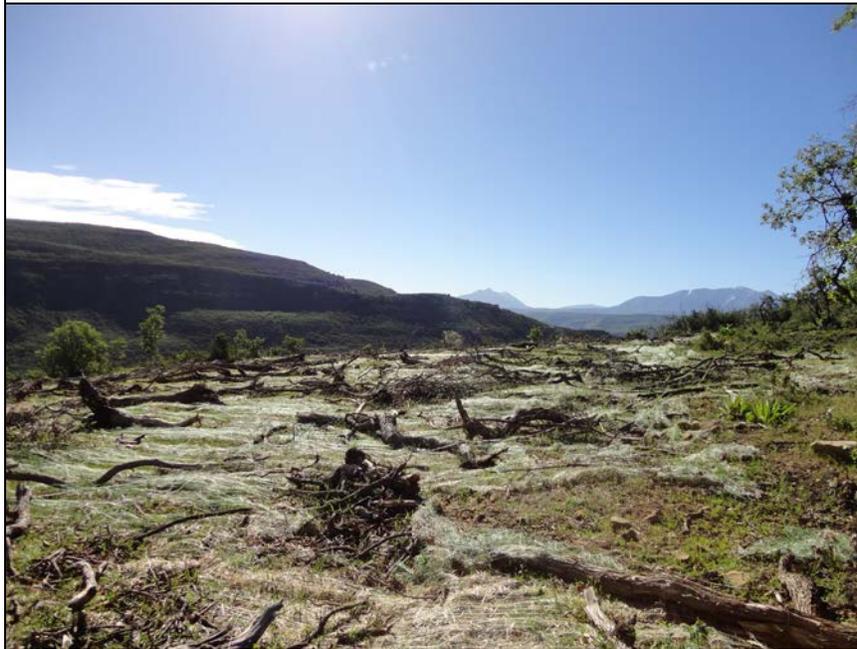
Photo 2

Reclamation on some of the gob vent boreholes was observed. Grasses were emerging on the reclaimed GVBB10A pad; few weeds were observed. The Hubbard Creek fan site revegetation was progressing on the north end, where mulch blanket had been used, but was fairly sparse on the south non-mulched end. The operator indicated that this area would likely be reseeded this year.

GVB10A Reclamation

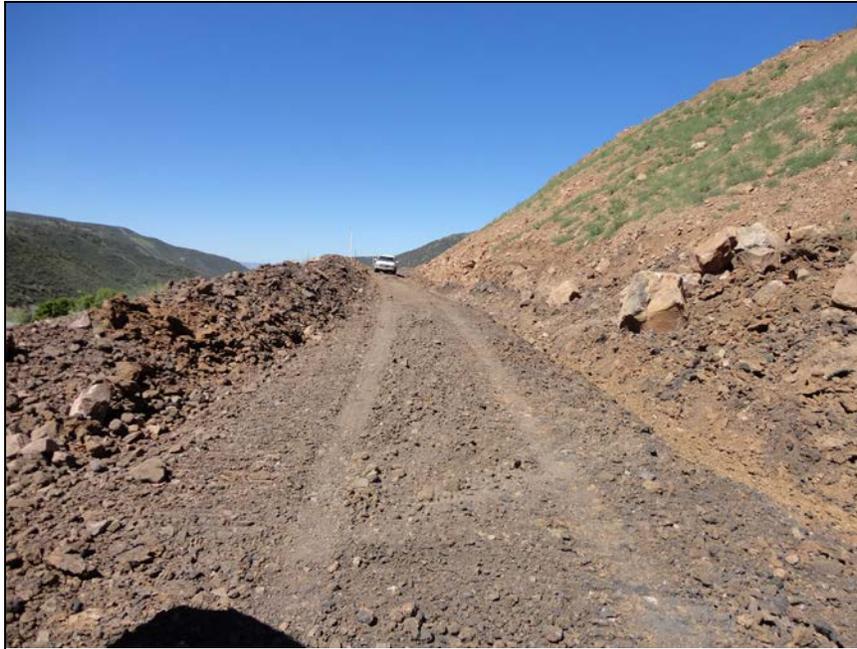
Photo 3

Ditches and culverts were observed to be functional in good condition on the Coal Stockpile, B, and D benches, upper fan site, and gob piles. All of the ditches on the gob pile were unobstructed and appeared to be graded for positive drainage. Clearing the ditches was a required abatement step (Step 2) under NOV CV-2013-004, and was due to be completed no later than June 28, 2013. This step has now been completed.

Ditch F5

Abatement Description: Remove coverfill material from ditches D-F5 and D-F6 and repair or reconstruct all lateral ditches on Gob Piles 2 and 4 to ensure positive drainage as designed in the approved permit application package. – **Completed June 25, 2013**

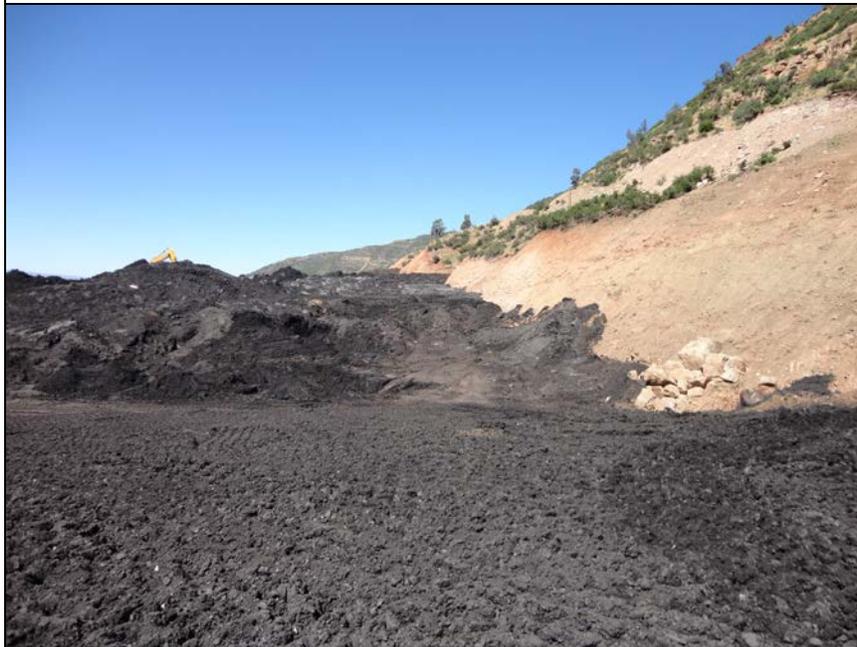
Photo 4

Gob material was being compacted on the upper bench of Gob Pile #2. The operator has made significant progress with placement and compaction of the material that had been end-dumped on the pile over the winter, cited in NOV CV-2013-004. Completing placement and compaction of all gob material, Step 1 of the required abatement, is due July 31, 2013, and it appears that operations are on track to meet this deadline.

Gob Pile 2 expansion area,
upper bench

Abatement Description: Place and compact all existing end-dumped material on Gob Pile #2 in accordance with the Rules and approved permit application package.

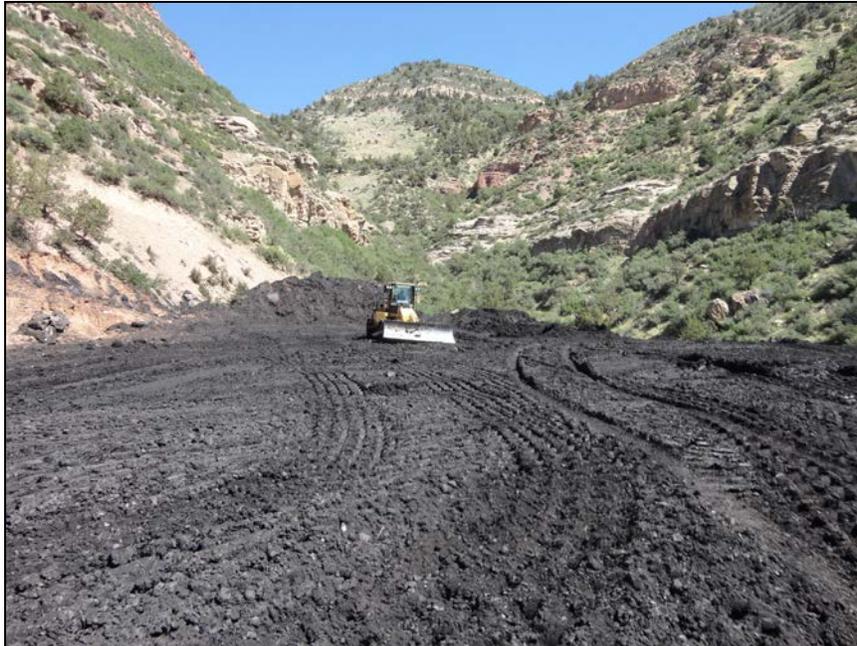
Photo 5

Upper bench of Gob Pile 2

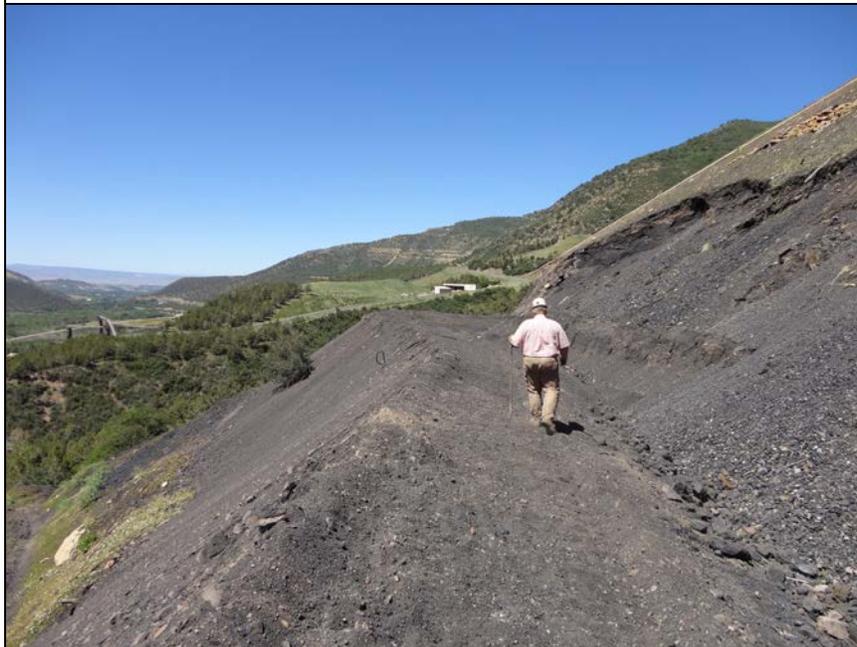
Photo 6

Sloughing was observed along the slope above the newly cut West Diversion over Gob Pile #4. The slope above the ditch is overlain by coal fines from the old King Mine. When the ditch was cut, the loose material on the surface started sloughing off, into the ditch. It looked like the slide was limited to the surficial material, and did not appear to be deep seated. The operator indicated that the ditch would be cleared as fines slide into the ditch.

West Diversion Ditch
above Gob Pile 4

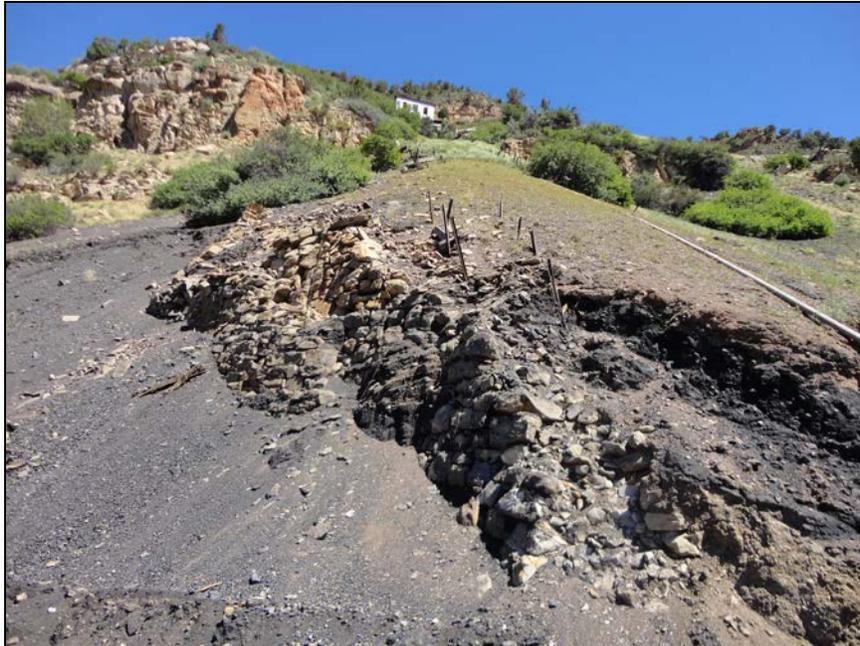
Photo 7

During excavation of the West Diversion ditch above Gob Pile 4, a stone wall (presumably associated with the old King Mine) was discovered. The operator has initiated required SHPO consultation to determine whether the structure has historic value and should be protected. Construction of the ditch, now complete, caused minimal damage to a few of the blocks on the east end of the wall. No further disturbance in the area is proposed at this time, and the wall was intact at the time of the inspection.

Retaining wall from King Mine above West Diversion Ditch

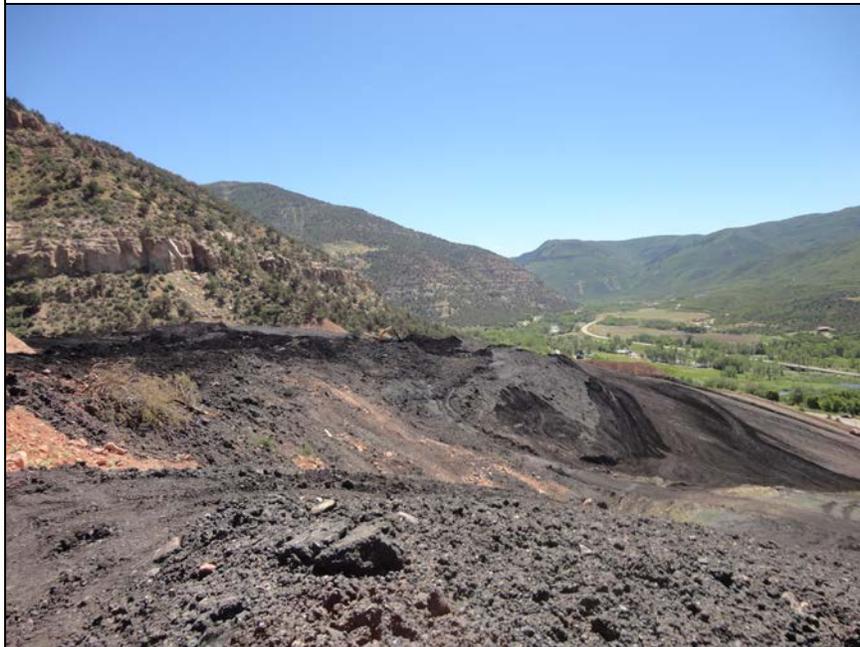
Photo 8

Gob Pile 2 Expansion Area, between Pile #2 and #4

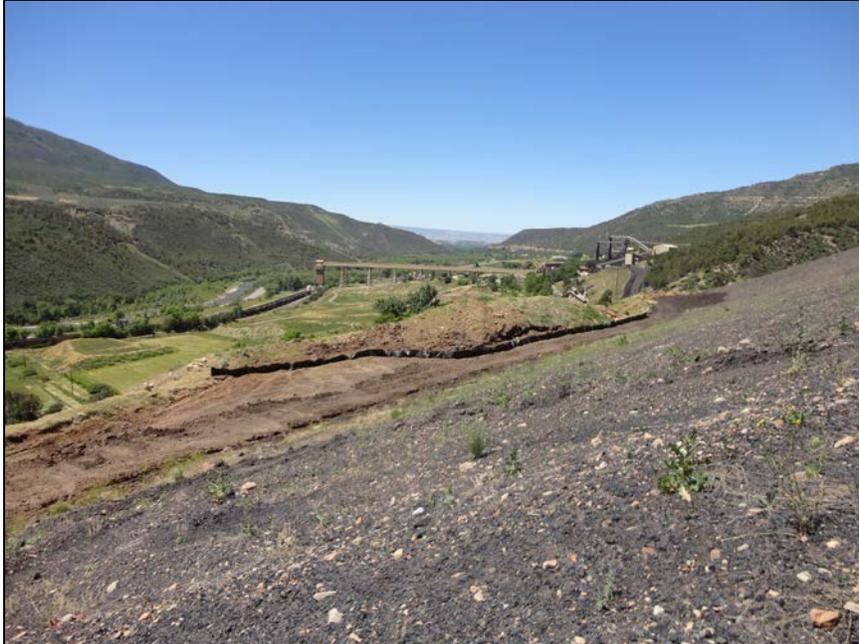
Photo 9

During the May 9, 2013 inspection, the Division identified concerns with the drainage around the gob pile topsoil stockpile. The ditch around the gob pile topsoil stockpile has now been regraded, and the toe of the stockpile was surrounded by silt fence.

Regraded Ditch F17 and topsoil stockpile

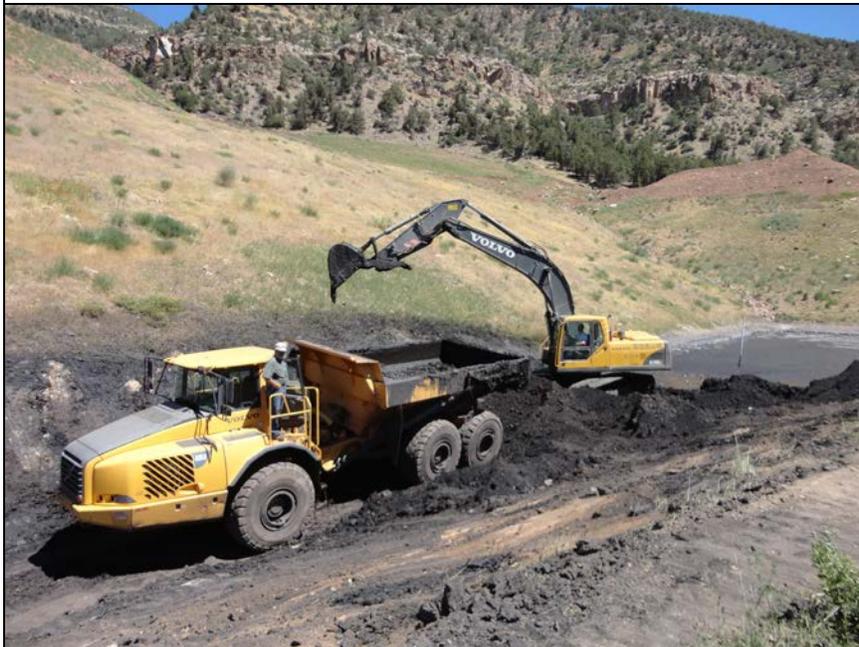
Photo 10

Ponds B, C, D, and F all held water but none were discharging. Ponds J and K were dry. Ponds D and F were being cleaned during the inspection, and the operator indicated that Ponds B and C would also be cleaned this summer. Material from the ponds was being transported to Gob Pile #2. The material from Pond F required mixing with dry gob material to facilitate transport to the pile, so trucks were hauling gob down to the pond inlet for mixing with sediment, then transporting the mixed material back up to the pile. The operator has recently installed indicators in Pond F that are marked with elevations above the pond floor. These indicators will be used by the operator to determine the sediment and water levels in the pond to monitor the need for dewatering or sediment removal.

Cleaning Pond F

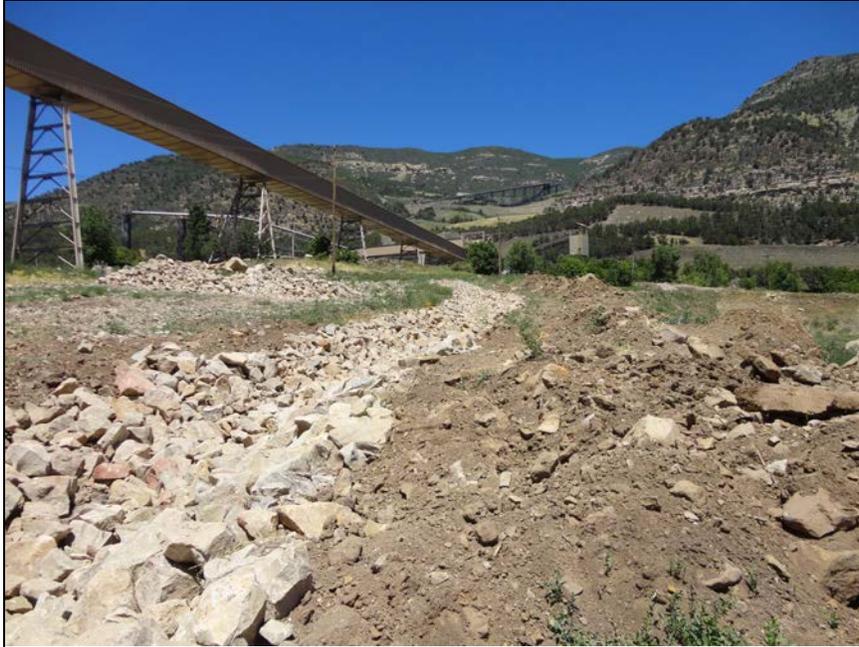
Photo 11

West Diversion ditch on
Gob Pile #3
