COLORADO DIVISION OF RECLAMATION, MINING AND SAFETY COAL PROGRAM INSPECTION REPORT

Permit Number: C-1981-033	County: Gunnison		
Mine Name: Bear Mine	Operation Type: Underground		
Operator: Bear Coal Company, Inc.	Permit Status: Revoked		
Operator Address:	Ownership: Federal		
Mr Daniel Bear	-		
1326 War Emblem Lane	Operator Representative Present:		
Rock Springs, WY 82901			
1 0	None - Revoked Permit		
Operator Representative Signature: (Field Issuance Only)

This was a complete inspection of the Bear No. 3 Mine conducted by Susan Burgmaier of DRMS. Weather conditions were clear and warm; ground conditions were dry.

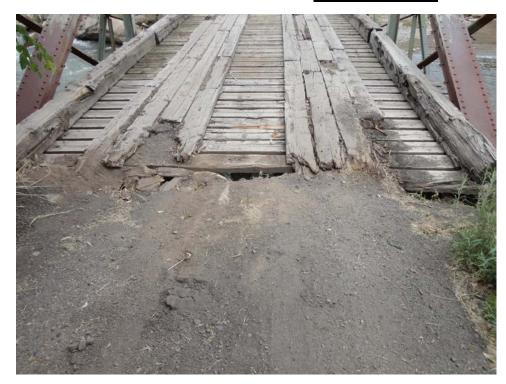
The bridge that provides access to the site was in very poor condition. The decking material has rotted out on both ends, and the embankment material is eroding away from the bridge. Vehicular travel across the bridge is nearly impossible because of the wide gaps at either end.

East end of bridge

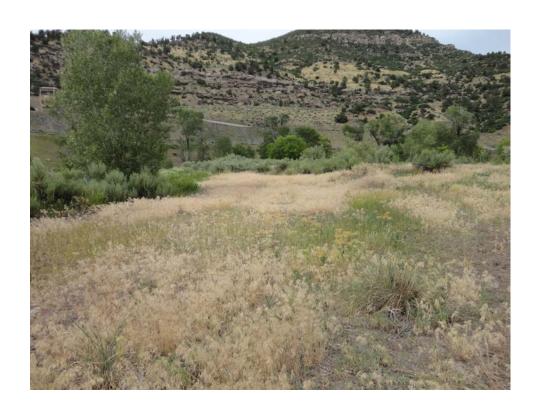
The facilities area was covered with a considerable amount of cheatgrass and thistle.

Cheatgrass at facilities area

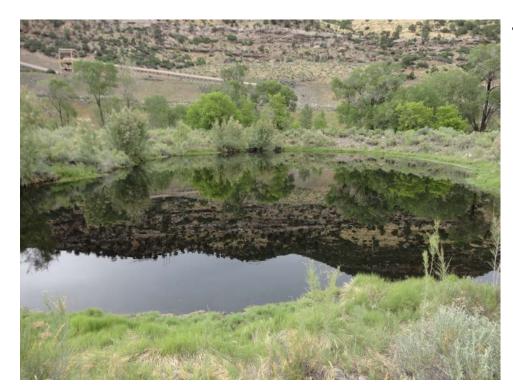
The sediment pond was dry; the treatment pond was full and discharging to the North Fork of the Gunnison River.

Treatment Pond

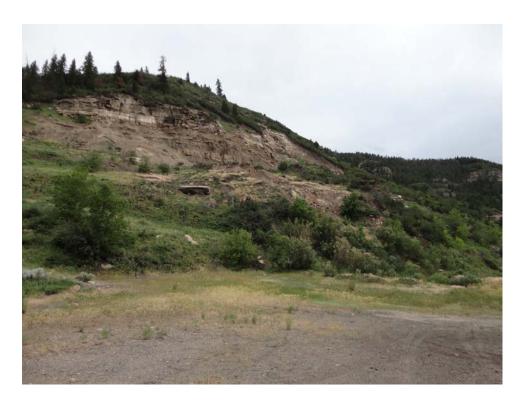
The portal faceup appears to be settling and exposing a concrete buttress that was buried in the backfill.

Portal slope

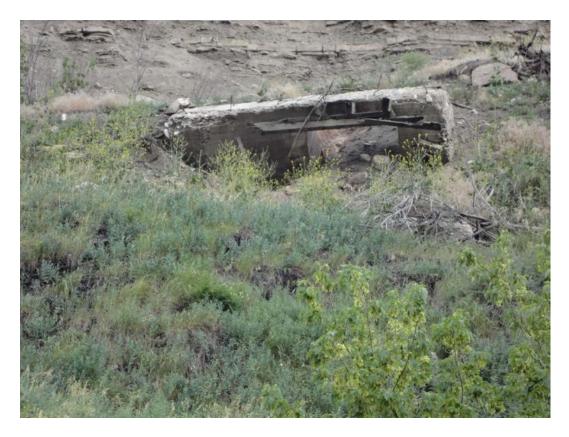
Concrete abutment protruding from backfill
