## COLORADO DIVISION OF RECLAMATION, MINING AND SAFETY COAL PROGRAM INSPECTION REPORT

<b>Permit Number:</b> C-1981-022 <b>Mine Name:</b> Elk Creek Mine <b>Operator:</b> Oxbow Mining, LLC <b>Operator Address:</b> Mr. Jim Kiger P.O. Box 535 3737 Highway 133 Somerset, CO 81434	<b>County:</b> Delta, Gunnison <b>Operation Type:</b> Underground <b>Permit Status:</b> Active <b>Ownership:</b> Federal
	<b>Operator Representative Present:</b>  Jim Kiger
<b>Operator Representative Signature: (Field Issuance Only)</b>

<b>Inspection Start Date:</b> June 19, 2013 <b>Inspection Start Time:</b> 08:00 <b>Inspection End Date:</b> June 19, 2013 <b>Inspection End Time:</b> 12:00		<b>Inspection Type:</b> Coal Partial Inspection <b>Inspection Reason:</b> Normal I&E Program <b>Weather:</b> Clear	
<b>Joint Inspection Agency:</b>  None		<b>Joint Inspection Contacts:</b>  	
<b>Post Inspection Agency:</b>  None		<b>Post Inspection Contacts:</b>  	
<b>Inspector(s):</b>  Brock F. Bowles	<b>Inspector's Signature:</b>

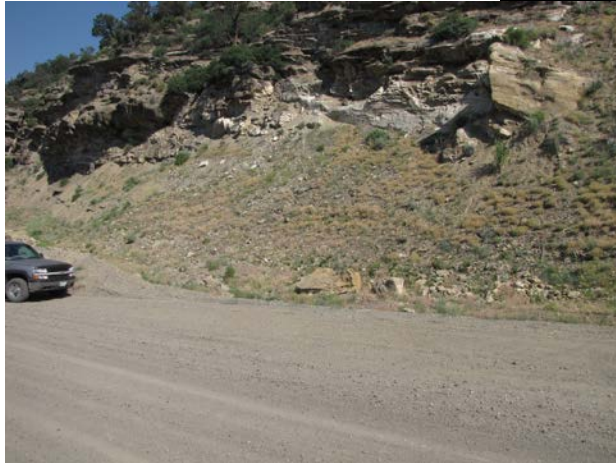
Photo 1 - Sanborn Creek Portals

There were no signs of slumping or cracking at the Sanborn Creek portals (photo 1).

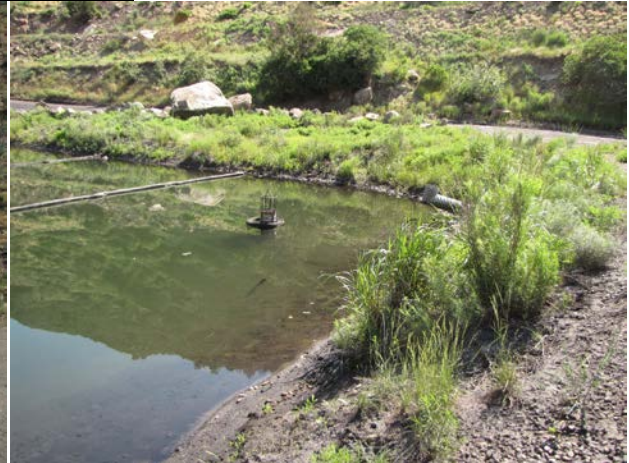
Photo 2 - Pond D

Ponds B and D contained water and neither were discharging (photo 2). Ponds A and East Yard were recently cleaned. Pond E did not contain water. Straw waddles were installed as sediment control structures in the road side ditch along the Pond C Light Use Road. A flexible propane pipe was in ditch D-6, west of the Elk Creek

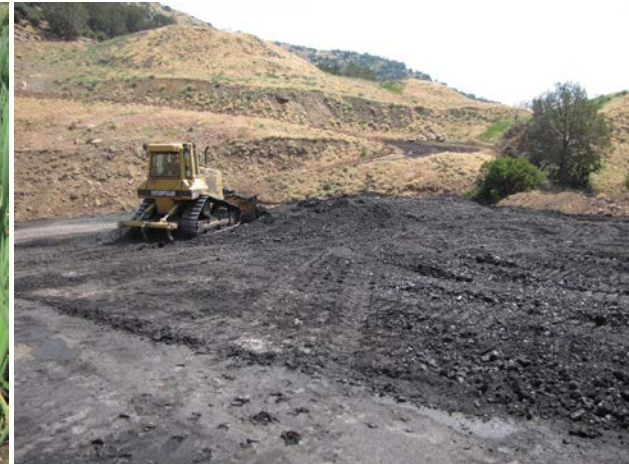
Photo 4 - Coal Waste Being Spread Into a Lift

Coal waste was being stacked on the II West refuse pile and a bulldozer was spreading the material into a uniform lift (photo 4). An excavator was removing soil from the hillside preparing for the next lift (photo 5).

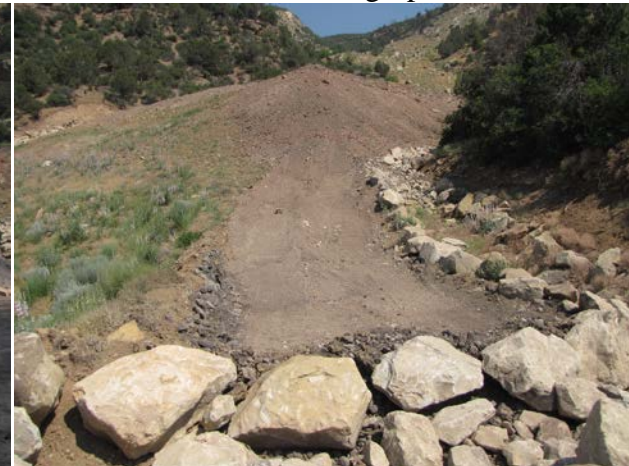
Photo 6 - II West Refuse Pile Lower Access Road

The lower access road to the II West Refuse Pile was blocked off by large boulders where the road entered the refuse area. The road area is being backfilled with waste material and is now considered closed. A rock lined ditch separates the undisturbed hillside to the east and the former road/backfill area (photo 6).

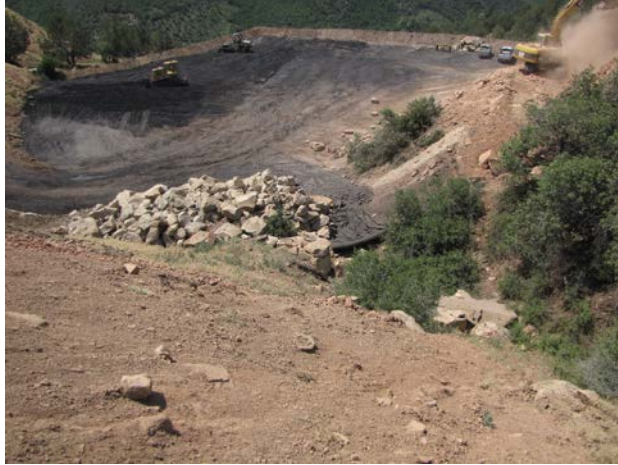
Photo 7 – Underdrain Construction

Rocks and barrier blanket were staged for the continued construction of the II West Refuse pile underdrain (photo 7).

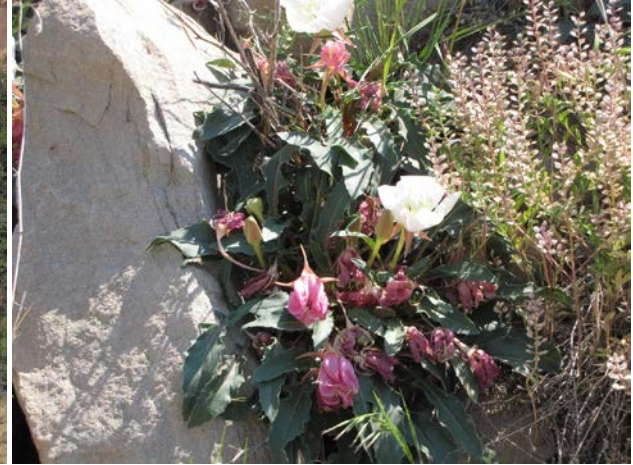
Photo 8 - *Oenothera caespitosa*

Two wildflowers of special note were growing on the II West Refuse pile: stemless evening primrose (*Oenothera caespitosa*) (photo 8) and Palmer penstemon (*Penstemon palmeri*).

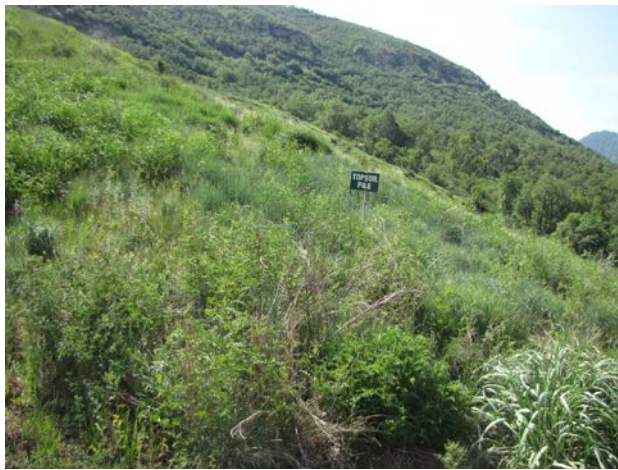
Photo 9 – Elk Creek Fan Topsoil Pile

The topsoil sign was in place on the Elk Creek Fan topsoil pile (photo 9). The main entrance sign had all the required information.

The Elk Creek fan topsoil stockpile was well vegetated. No rills or gullies were noted (photo 9).
