**COLORADO DIVISION OF RECLAMATION, MINING AND SAFETY
COAL PROGRAM INSPECTION REPORT**

Permit Number: C-1981-046 Mine Name: Sunlight Mine Operator: Garfield Energy Corporation Operator Address:	County: Garfield Operation Type: Underground Permit Status: Revoked Ownership: Private
	Operator Representative Present: None
Operator Representative Signature: (Field Issuance Only)

Inspection Start Date: June 18, 2013 Inspection Start Time: 09:00 Inspection End Date: June 18, 2013 Inspection End Time: 11:00	Inspection Type: Coal Complete Inspection Inspection Reason: Normal I&E Program Weather: Clear	
Joint Inspection Agency: None	Joint Inspection Contacts:	
Post Inspection Agency: None	Post Inspection Contacts:	
Inspector(s): Brock F. Bowles James R. Stark	Inspector's Signature:

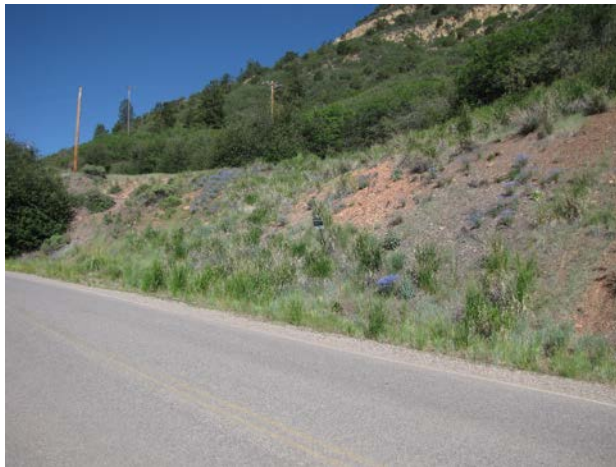
Photo 1 – Upper Bench Portal

The backfilled portal area above the road did not have signs of slumping or cracking (photo 1).

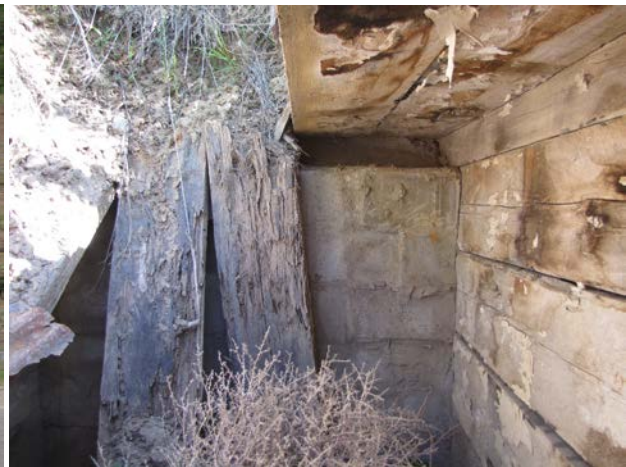
Photo 2 – Fan Portal Block Wall

The integrity of the block wall in the lower fan portal appeared to be good. The block structure was not cracked and appeared to be stable. Some of the wood planks above the block wall have collapsed but do not appear to have compromised the walls integrity (photo 2).

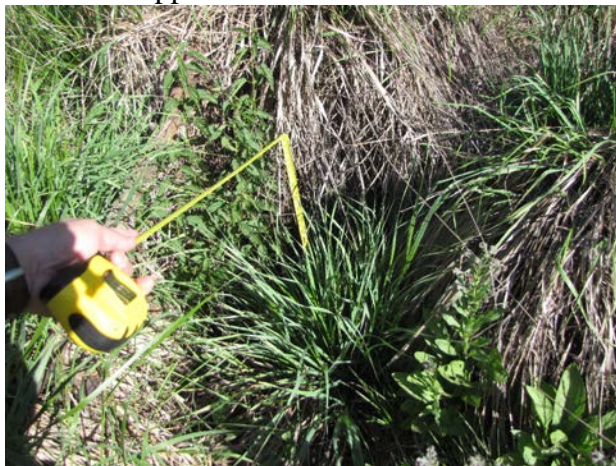
Photo 3 – Subsidence Above Fan Portal

The soil above the lower fan portal is collapsing and has created a hole. The hole did not appear to be bigger than it was during the April 2013 inspection. The hole is located approximately 12 feet uphill of the fan portal block wall and was measured approximately 3 feet deep and 5 feet across (photo 3). There may be additional holes uphill of the one noted but due to dense vegetation and safety concerns, the area was not investigated. Steve Renner of the DRMS AML program will investigate the area in July.
