COLORADO DIVISION OF RECLAMATION, MINING AND SAFETY COAL PROGRAM INSPECTION REPORT

Permit Number: C-1981-014 Mine Name: Southfield Mine Operator: Energy Fuels Coal, Inc. Operator Address: Mr George Patterson P.O. Box 459 Florence, CO 81226	County: Fremont Operation Type: Underground Permit Status: Permanent Cessation Ownership: Private
	Operator Representative Present: George Patterson
Operator Representative Signature: (Field Issuance Only)

Inspection Start Date: June 24, 2013 Inspection Start Time: 12:15 Inspection End Date: June 24, 2013 Inspection End Time: 15:00	Inspection Type: Coal Partial Inspection Inspection Reason: Normal I&E Program Weather: Cloudy
Joint Inspection Agency: None	Joint Inspection Contacts:
Post Inspection Agency: None	Post Inspection Contacts:
Inspector(s): Janet H. Binns	Inspector's Signature:

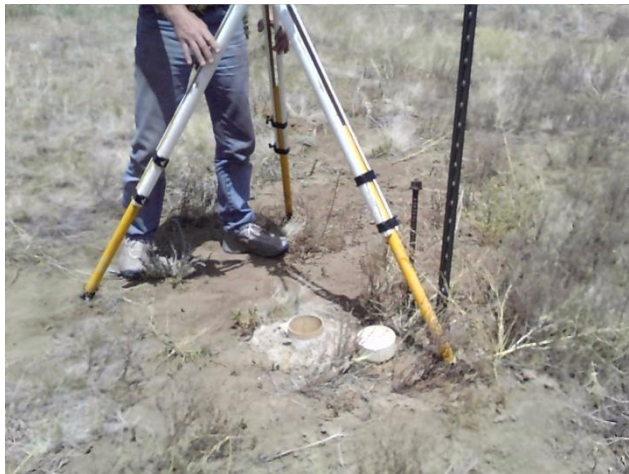
The access to and surface vegetation around MW 23 was very, dry. EFCI rinsed the sample probe with de-ionized (DI) water prior to lowering the probe into MW-23. The tone sounded at 141.9 feet below the top of the casing indicating the water level.

Photo 1: collecting water sample at MW-23

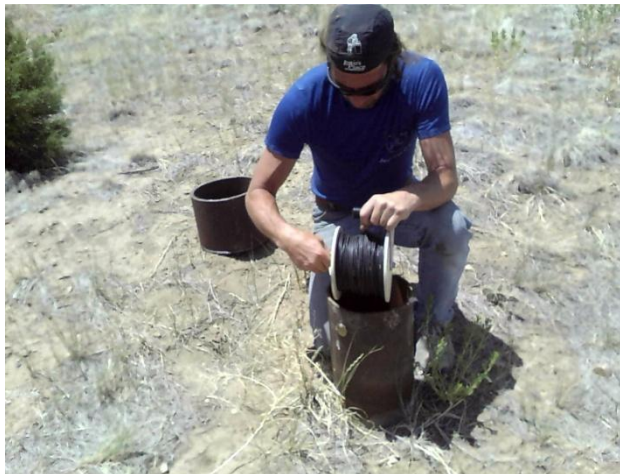
MW-NW. A fence post has been placed in the middle of the access road to the monitoring well. EFCI checked for black widow spiders under the cap of the well. The Division has previously identified a blockage in MW-NW at 354 feet below the top of the casing. EFCI lowered the probe to 360' feet of cable. Then raised and lowered the line attempting to establish if there was water in the well. There was no water identified by the probe (no tone sounded). MW-NW was dry at 354 feet below the top of the casing.

Photo 2: measuring depth to water in MW-NW (well was dry)

Abatement Description: Remove the obstruction from MW-NW or establish a replacement water monitoring well that intercepts the Southfield Mine workings in the Red Arrow or Jack O' Lantern Coal seam.

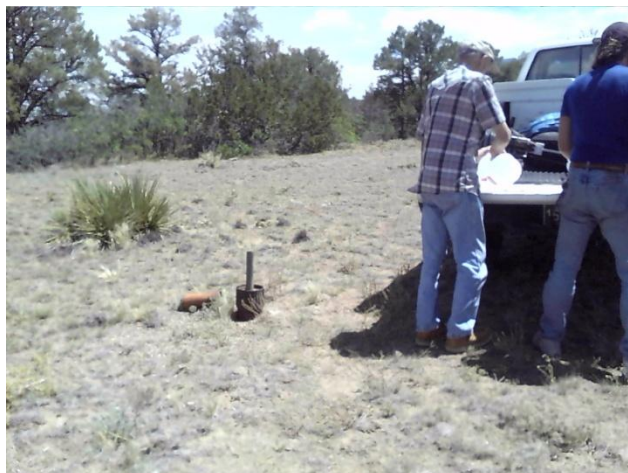
Photo 3: Rinsing sampling equipment at MW-65

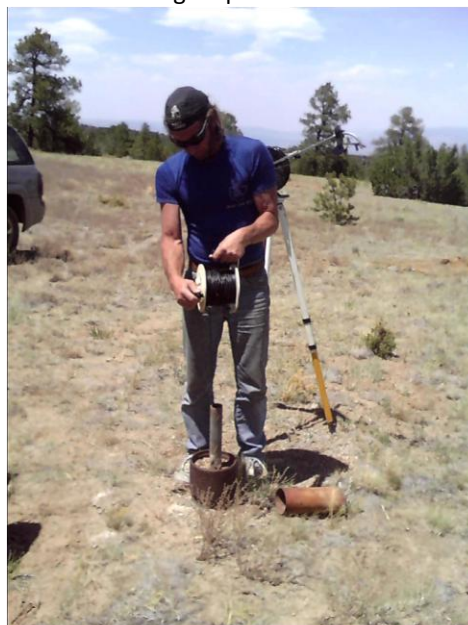
Photo 4: measuring water level at MW-65

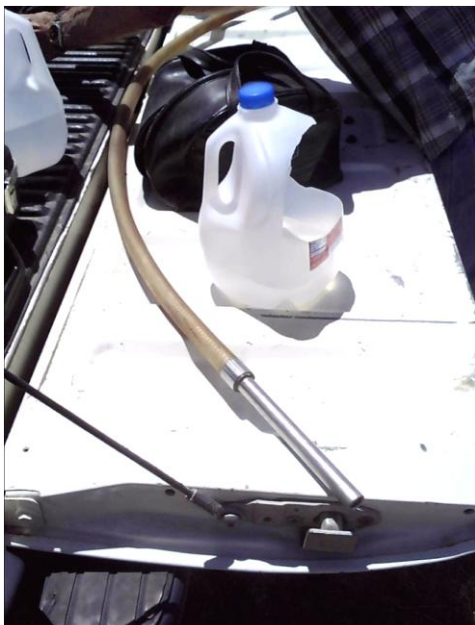
The inspection proceeded to MW-65. MW-65 is constructed of a 1.5 inch diameter casing. The stainless steel bailer is too large for sampling MW-65, so EFCI uses a flexible tubing bailer with stainless steel ends. EFCI rinsed the 1.5 inch diameter bailer with DI water. EFCI rinsed the water level probe prior to lowering it into the well. Water was recorded at 284.3 feet from top of the casing. The casing is 17 inches from ground to top of casing. The first bail of water was collected and transferred to the rinsed sampling container. Water temperature measured 18.2 C. EFCI collected 3 bails of water. There was a slight sulfide smell to the water sample and the sample was slightly cloudy. EFCI filled sample bottles, minimizing air bubble at the top of the bottle and put samples in cooler on ice as soon as collected. EFCI will send cooler overnight to ACZ laboratory Steamboat this afternoon.

Photo 5: Sampling equipment and flexible bailer

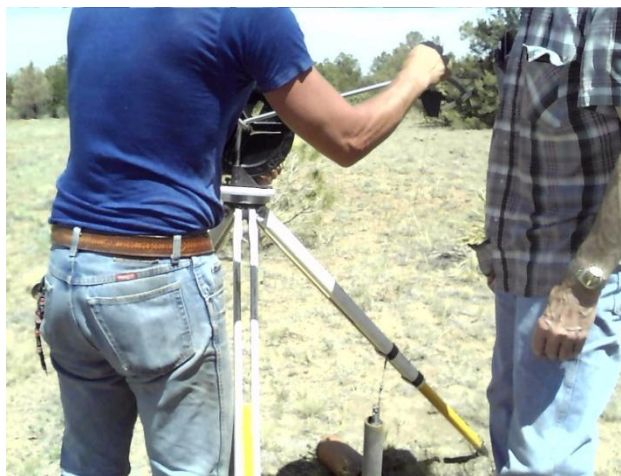
Neither well that registered water in the well was purged prior to EFCI collecting a water quality sample.

Photo 6: Collection water quality sample @ MW-65
