**COLORADO DIVISION OF RECLAMATION, MINING AND SAFETY
COAL PROGRAM INSPECTION REPORT**

Permit Number: C-1981-041 Mine Name: Roadside Portals Operator: Snowcap Coal Company, Inc. Operator Address: Ms. Tonya Hammond P.O. Box 1430 Palisade, CO 81526	County: Mesa Operation Type: Underground Permit Status: Permanent Cessation Ownership: Federal
Operator Representative Present: Tonya Hammond	
Operator Representative Signature: (Field Issuance Only)

Inspection Start Date: June 21, 2013 Inspection Start Time: 08:30 Inspection End Date: June 21, 2013 Inspection End Time: 15:00	Inspection Type: Coal Complete Inspection Inspection Reason: Normal I&E Program Weather: Clear
Joint Inspection Agency: None	Joint Inspection Contacts:
Post Inspection Agency: None	Post Inspection Contacts:
Inspector(s): Michael P. Boulay	Inspector's Signature: <i>Michael P. Boulay</i> Signature Date: 6/26/13

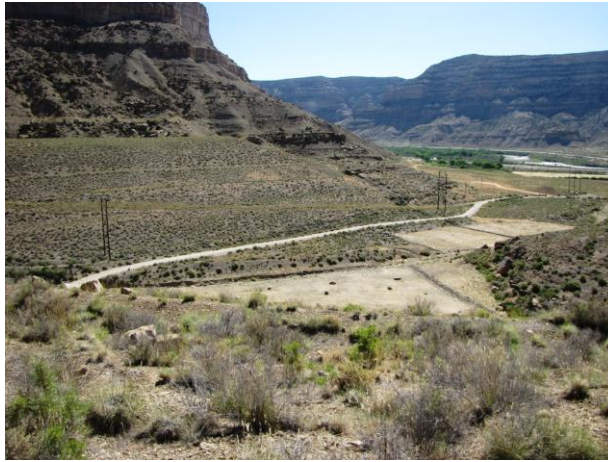
All former site sedimentation ponds have been fully reclaimed. During this inspection we viewed all of the former pond locations including 6, 7, 8, 9, 10, 11, and 13. The reclaimed site of Ponds 6 and 10 located below the CRDA-1 is shown in Photograph No. 1. Reclamation was recently completed at Pond 9 located at the South Portal area (see attached Photograph No. 2). The reclaimed pond locations look very good with no erosion or stability issues noted.

Photo No. 1 – Location of reclaimed Ponds 6 & 10.

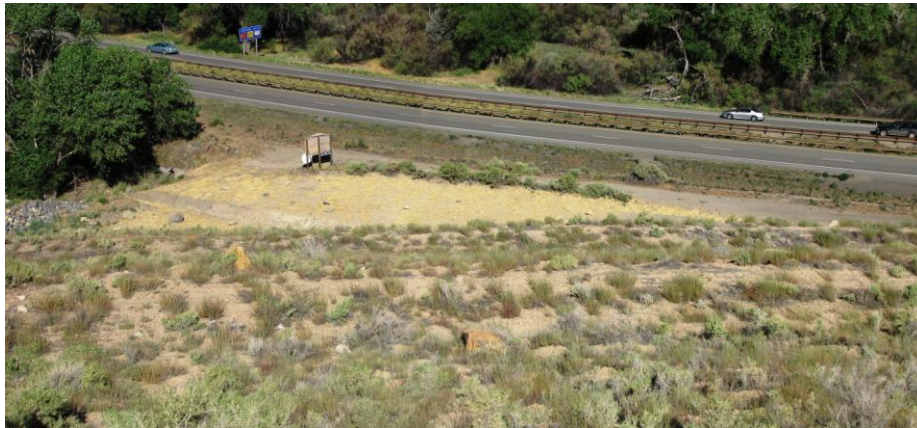
Photo No. 2 - Location of reclaimed Pond 9.

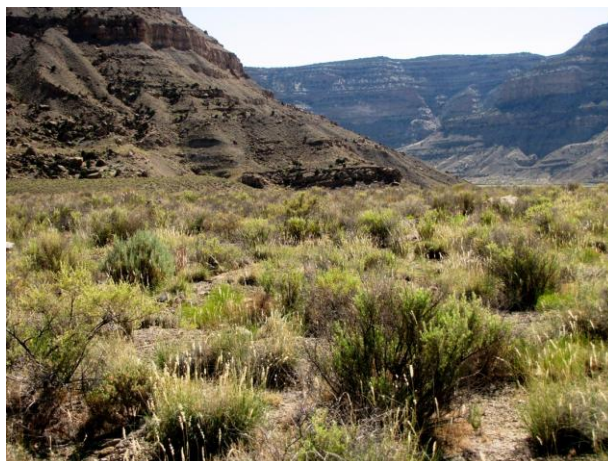
Photograph No. 3 was taken from atop CRDA-1; as seen in the photo the revegetation looks very good with both shrubs and grasses well established. The RSRDA at the south portal area was in very good condition with no erosion or instability noted.

Photo No. 3 – Good vegetation establishment on top of CRDA-1.

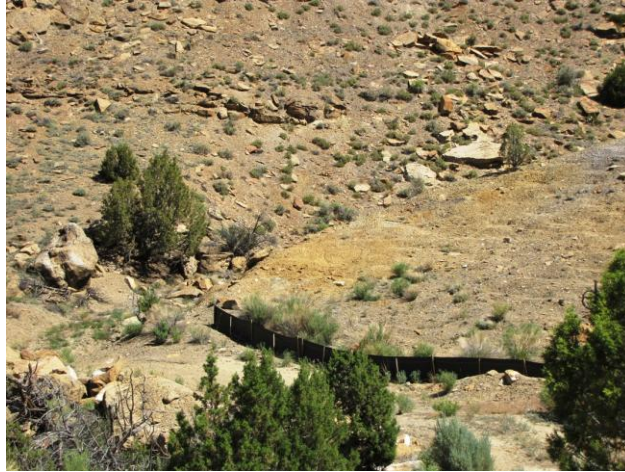
At the II-W Portals the silt fences were replaced at both the south and north locations. The silt fences were properly installed. Photograph No. 4 shows the south II-W portal location. The south and north II-W portals are stable and well maintained. No signs of erosion or instability were noted at any of the support facility locations during this inspection.

Photo No. 4 - repaired silt fence at II-W portals.

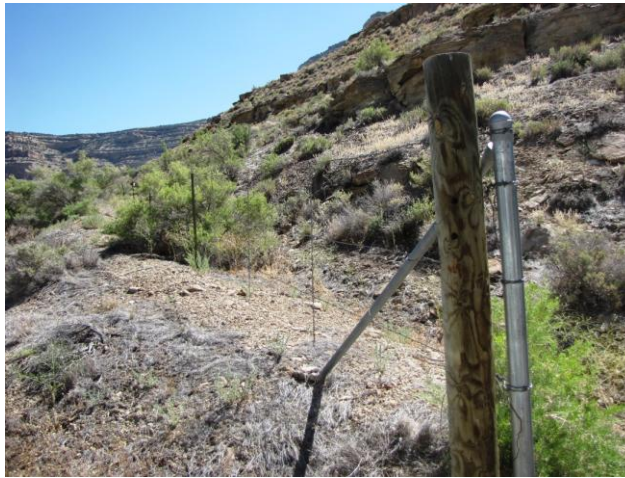
Fencing along Coal Creek access road on both sides of the road on property owned by SCC;
Barbed wire fence and gate on the Fontanari property at the North Decline (Photograph No. 5); and Barbed wire fencing and gate located on Ute Water property at the II-W Portals access road (Photograph No. 6).

Photo No. 5 - Fence located on Fontanari property.

As discussed during the inspection, any issues regarding the retention of these fences to remain as permanent will be addressed in the pending Technical Revision No. 64 and will be included in the Division's forthcoming adequacy review letter for TR-64. SCC will need to obtain requests from the applicable property owners indicating that they wish to retain the fences and gates as permanent features.

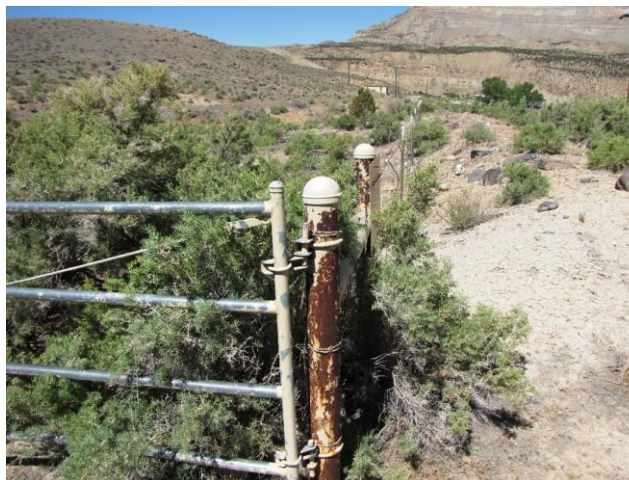
Photo No. 6 - Fence and gate located on Ute water property.
