**COLORADO DIVISION OF RECLAMATION, MINING AND SAFETY
COAL PROGRAM INSPECTION REPORT**

Permit Number: X-2011-231-02 Mine Name: Peabody Sage Creek 2011 Exploration Project Operator: Peabody Sage Creek Mining, LLC Operator Address: Mr Scott Cowman 36600 Routt County Road 27 Hayden, CO 81639	County: Routt Operation Type: Coal exploration Permit Status: Active Ownership: Federal
	Operator Representative Present: Scott Cowman
Operator Representative Signature: (Field Issuance Only)

Inspection Start Date: June 20, 2013 Inspection Start Time: 07:00 Inspection End Date: June 20, 2013 Inspection End Time: 09:00		Inspection Type: Coal Exploration Inspection Inspection Reason: Surety Release Requested Weather: Clear	
Joint Inspection Agency: None		Joint Inspection Contacts:	
Post Inspection Agency: None		Post Inspection Contacts:	
Inspector(s): Elliott R. Russell	Inspector's Signature:

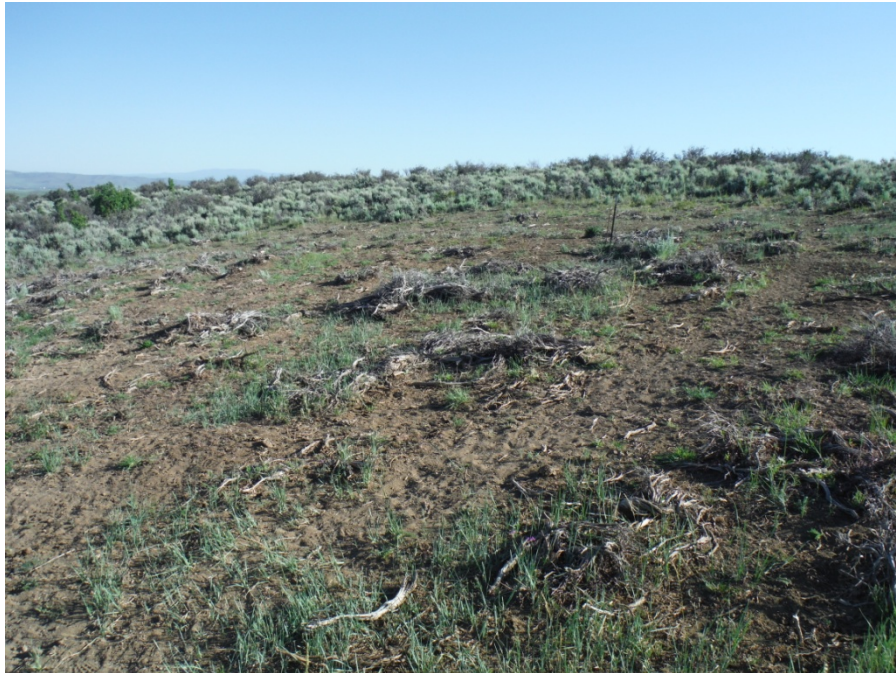
Sites CCU072, CCU073, and CCU074 were drilled along the Yoast Mine's haul road to determine the hinge point in the coal seam. CCU071 was drilled approximately 2000 ft. west of the haul road. These four sites were well vegetated at the time of the inspection, with some sites exhibiting more vegetation than others. All areas of disturbance showed no signs of erosion, evidence of noxious/invasive species, or any other problems as a result of exploration. These sites had an approved borehole marker which was a rebar and survey cap, with the site ID stamped into it. A t-post was also near the borehole marker.

Based on this inspection, the Division determines that the exploration activities associated with X-2011-231-02 have been adequately reclaimed, except the monitoring well that remains at site CCU069. The Division recommends the reclamation bond release of CCU071, CCU072, CCU073, and CCU074.

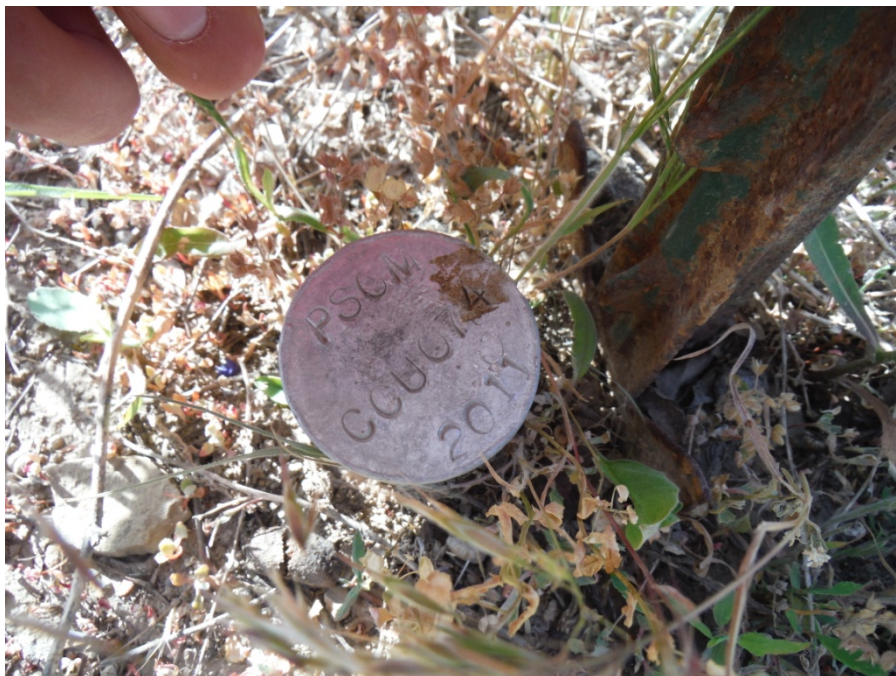
Borehole marker at CCU074

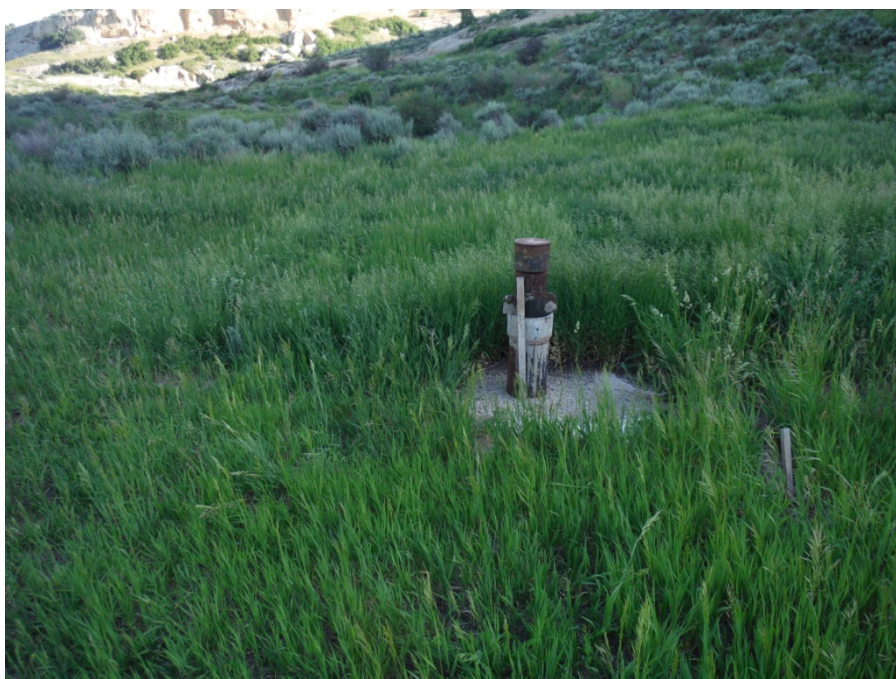
CCU069 was located north of Routt County Road 27A. The drill pad was reclaimed and showed no signs of erosion, evidence of noxious/invasive species, or any other problems as a result of exploration, except for the one monitoring well that remains. Straw wattles were present on east side of site. Scott stated this well would be

properly sealed and abandoned by fall 2013.

CCU069, monitoring well remains
