COLORADO DIVISION OF RECLAMATION, MINING AND SAFETY COAL PROGRAM INSPECTION REPORT

| Permit Number: C-1980-002 Mine Name: O.C. Mine No. 2 Operator: Operator Address: | County: Gunnison Operation Type: Underground Permit Status: Revoked Ownership: Federal |

| Inspection Start Date: June 17, 2013 Inspection Start Time: 12:00 Inspection End Date: June 17, 2013 Inspection End Time: 13:00 | | Inspection Type: Coal Complete Inspection Inspection Reason: Normal I&E Program Weather: Clear | |

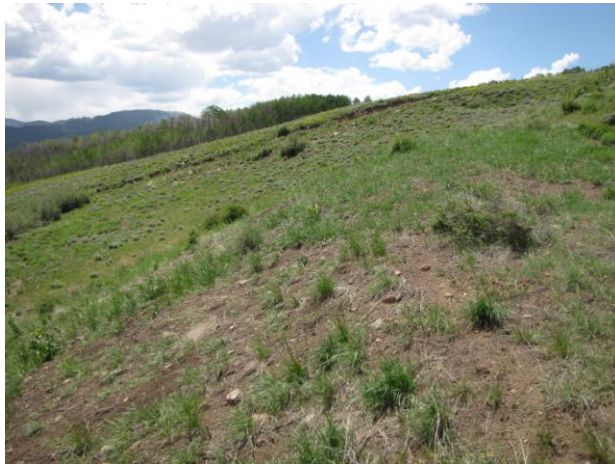
The portal area appears to be stable. There were no signs of slumping or cracking (photo 1).

Photo 1 – Portal Area Appears Stable

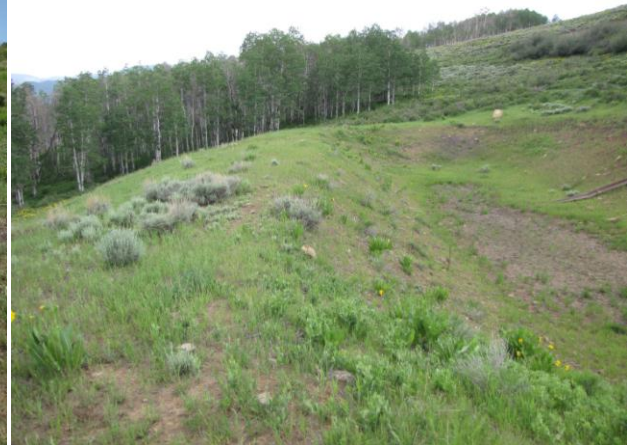
Photo 2 – Sediment Pond

The sediment pond was dry. The pond embankment was well vegetated and appeared to be stable (photo 2).

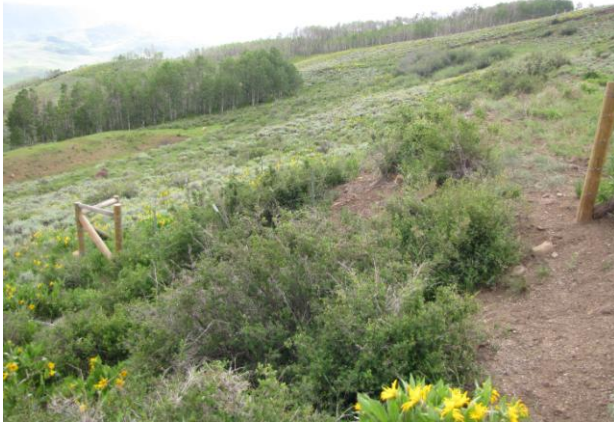
The fence around the mine site was in good condition (photo 3). The gate was closed and a “Keep Gate Closed” sign was posted on the gate. No livestock was in the reclamation area. The vegetation looked very good throughout the area.

Photo 3- Fence was in Good Condition

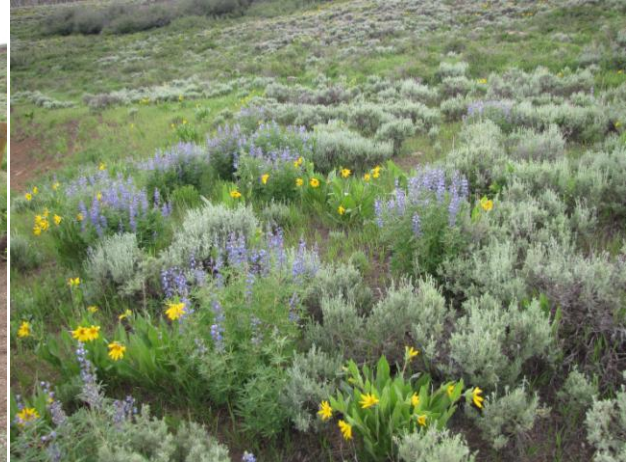
The vegetation looked very good (photo 4) and there were many species blooming including: snowberry, mules

ear, lupine, Lewis' flax, Wood's rose, Indian paintbrush, Rocky Mountain penstemon, yellow sweet clover, dandelion, choke cherry, sagebrush, rubber rabbitbrush, yellow salsify, pennycress, shepherd's purse, curly doc, houndstongue, green rabbitbrush, peavine, western stickseed, Scotch thistle, curlycup gumweed and Agoseris glauca.. Many grass species were also noted including: smooth brome, Kentucky bluegrass, cheatgrass, orchard grass, western wheatgrass, bluebunch wheatgrass, Nelson's needlegrass and Letterman's needle grass.

Photo 4 – Vegetation Looked Very Good

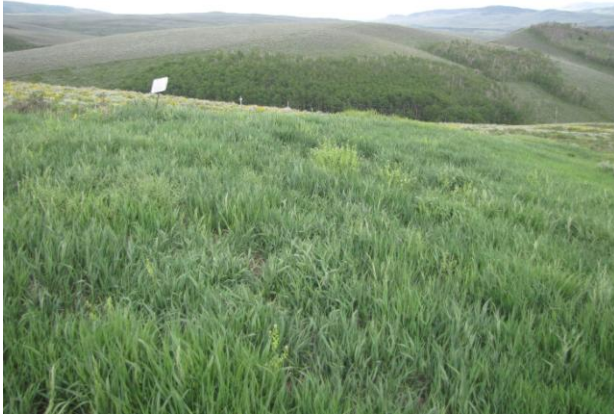
Photo 5 – Topsoil Stockpile

The topsoil pile was well vegetated and had a topsoil sign marker in place (photo 5).
