COLORADO DIVISION OF RECLAMATION, MINING AND SAFETY COAL PROGRAM INSPECTION REPORT

Permit Number: C-1981-025 Mine Name: North Thompson Creek Mine Operator: MINREC, Inc. Operator Address: Mr. James E Stover 2352 N 7th St, Ste B Grand Junction, CO 81501	County: Garfield Operation Type: Underground Permit Status: Inactive Ownership: Federal
	Operator Representative Present: None
Operator Representative Signature: (Field Issuance Only)

Inspection Start Date: June 18, 2013 Inspection Start Time: 12:00 Inspection End Date: June 18, 2013 Inspection End Time: 13:00	Inspection Type: Coal Complete Inspection Inspection Reason: Normal I&E Program Weather: Clear
Joint Inspection Agency: None	Joint Inspection Contacts:
Post Inspection Agency: None	Post Inspection Contacts:
Inspector(s): Brock F. Bowles	Inspector's Signature:

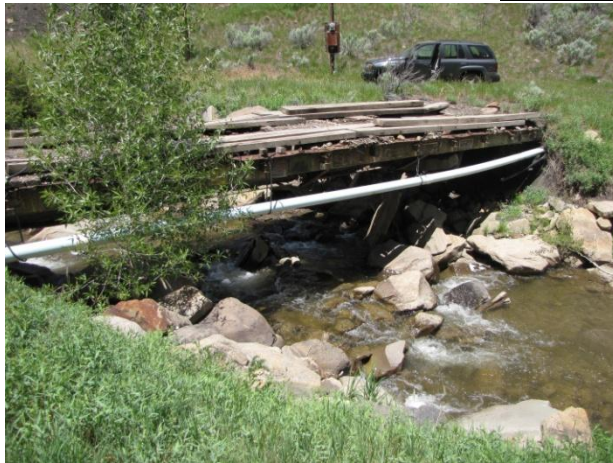
The pipe carrying water across the bridge from the #1 Portal to the long pond appeared to be in good condition (photo 1). Water was flowing from both the #1 and #3 portal discharge pipes into the long pond (photo 2). The water from both discharges was clear. The long pond contained water and the banks appeared to be stable. Water was flowing from the Long Pond to T1 through the spillway pipe. Pond T1 contained water and the banks appeared to be stable. Water flowed from T1 to T2 through the open ditch. Pond T2 contained water and the banks appeared to be stable. Water was then directed to Pond P9. Pond P9 contained water and was not discharging. No water passed through Outfall 001A. The unapproved ditch that went from Pond P9 to the adjacent pasture intended for irrigation (see inspection report 10/27/2012) was filled in with dirt.

Photo 1- Discharge Pipe From #1 Portal

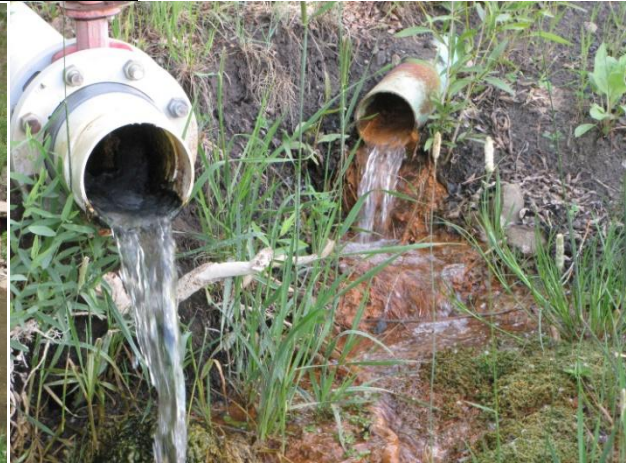
Photo 2- Mine Discharge #1(left) and #3 (right)

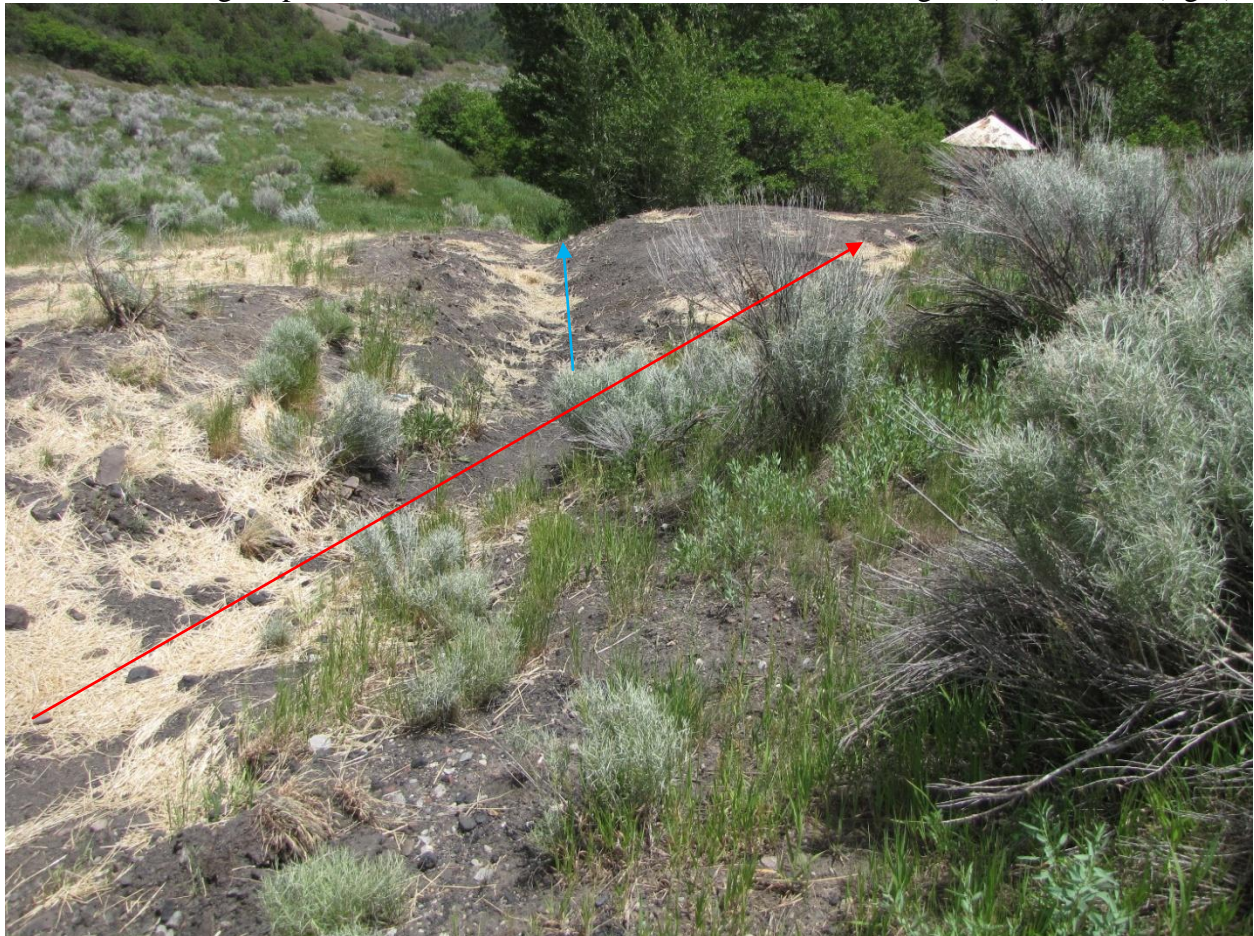
The emergency spillway from Pond P9 to Outfall 001 was re-directed away from Outfall 001 to the refuse disposal pond ditch (photos 3 and 4). No water was flowing through the ditch. J. E. Stover & Associates and Stan Muhr were unaware of the change. After contacting the landowners, Stan Muhr explained that the landowners changed the ditch configuration because they want to keep all the water on the property. Stan Muhr is scheduling a meeting with the landowners and DRMS to discuss the changes in the mine water discharge plan. It does not appear that the change in the emergency spillway direction will have any impacts offsite, decrease the capacity of the passive water treatment facility or cause harm to the water treatment facility. DRMS suggested that no further changes be made to the permit or the mine site until after the meeting with the landowners when a new mine water discharge plan is agreed upon by all parties.

The area that was disturbed by redirecting the emergency spillway from Pond P9 was covered with straw mulch. It was unclear from the visual inspection if the area had been seeded (photos 3 and 4).

Photo 3 – The red line shows the location where the permitted emergency spillway ditch is supposed to be. The blue line shows the current ditch directing water to the Refuse Pile Pond Ditch.

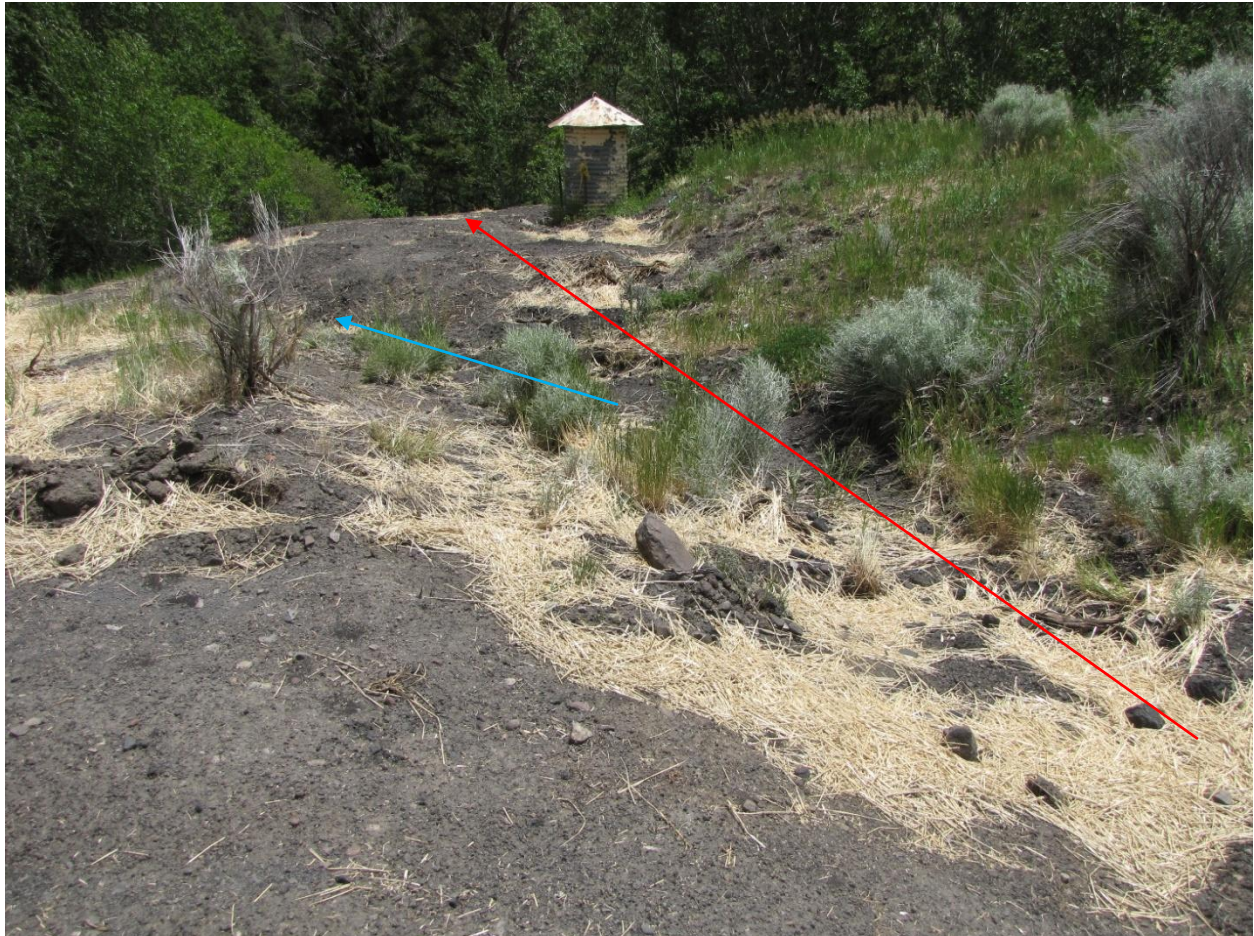
Photo 4 – The red line shows the location of the permitted emergency spillway ditch, which has been filled in. The blue line shows the direction of the current ditch directing water to the Refuse Pile Pond Ditch.

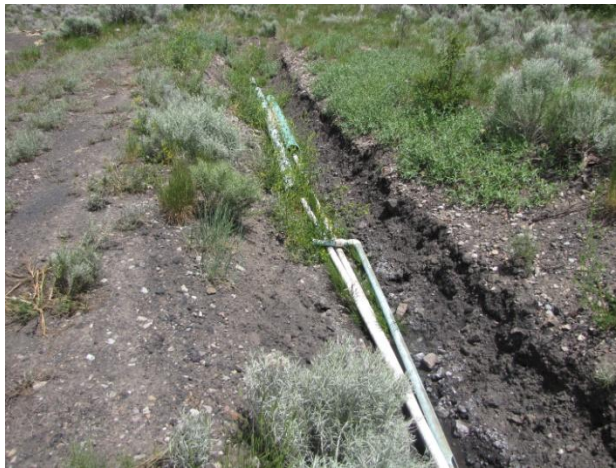
Some pipe pieces were in the ditch between Pond T2 and Outfall 001. These pipes could prevent or hinder water flow and need to be removed (photo 5).

Photo 5 – Pipes in Ditch Need to be Removed

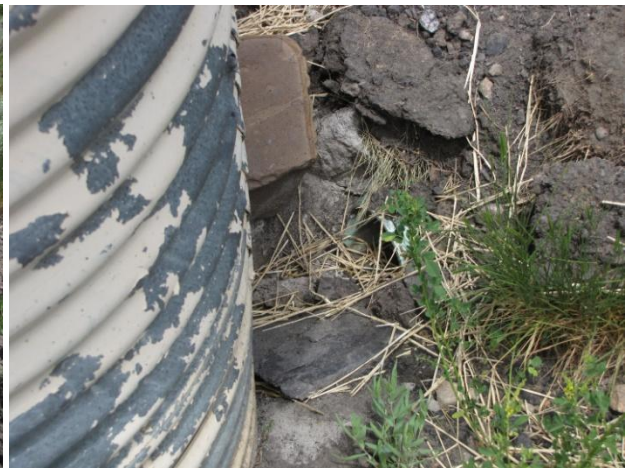
The discharge pipe leading from Outfall 001 was obstructed and needs to be cleaned (photo 6).

Photo 6 – Outlet Pipe Needs to be Cleaned
