**COLORADO DIVISION OF RECLAMATION, MINING AND SAFETY
COAL PROGRAM INSPECTION REPORT**

Permit Number: C-1981-028 Mine Name: Keenesburg Strip Mine Operator: Coors Energy Company Operator Address: Mr Benjamin Moline P.O. Box 4030 Suite 400 Golden, CO 80401	County: Weld Operation Type: Surface Permit Status: Active Ownership: Private
	Operator Representative Present: Danny Kipp
Operator Representative Signature: (Field Issuance Only)

Inspection Start Date: June 27, 2013 Inspection Start Time: 09:00 Inspection End Date: June 27, 2013 Inspection End Time: 10:00	Inspection Type: Coal Partial Inspection Inspection Reason: Normal I&E Program Weather: Clear
Joint Inspection Agency: None	Joint Inspection Contacts:
Post Inspection Agency: None	Post Inspection Contacts:
Inspector(s): Brock F. Bowles	Inspector's Signature:

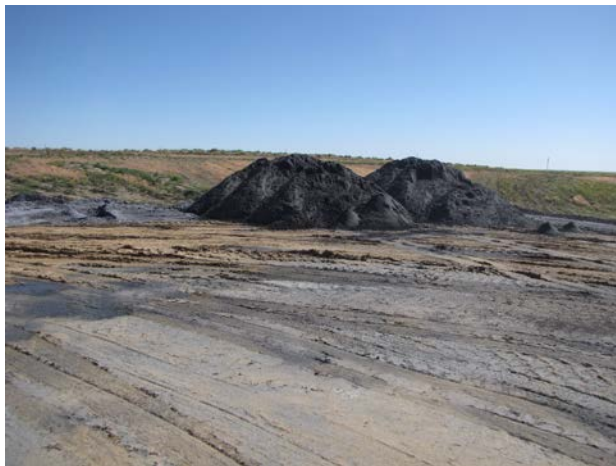
Photo 1 – Ash Ready for Backfilling

Coal ash was stacked in the north end of the B-Pit ready for backfilling (photo 1). Backfill material continued to be moved from the spoil area to the south side of the active B-Pit area (photo 2). The backfill was being spread in 6 foot lifts.

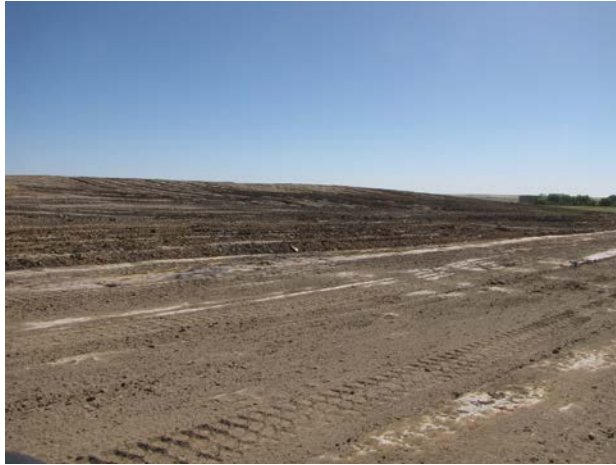
Photo 3 – Road from Long Term Spoil Pile

The main haul road to the B-Pit was well maintained. The roads between the long-term spoil pile and the B-Pit backfill area were recently maintained (photo 3).

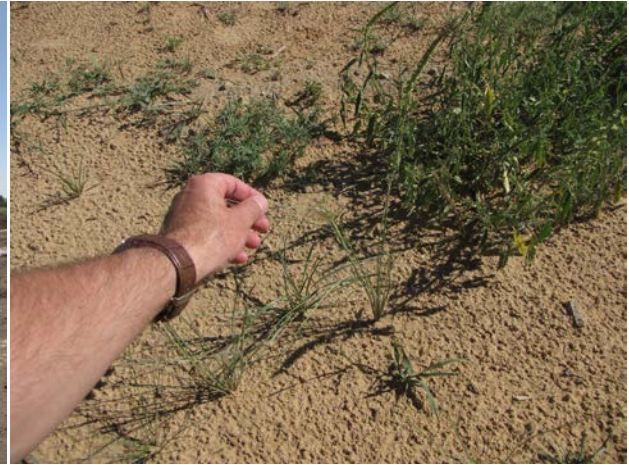
Photo 4 – Indian Ricegrass Inflorescence.

The vegetation in Area 25 looks good. Many annual species were noted but this is expected during the first season after seeding. Many planted grasses were starting to grow including western wheatgrass and Indian ricegrass, which was already going to seed (photo 4). A large patch of Rumex venosus was growing in Area 25.
