COLORADO DIVISION OF RECLAMATION, MINING AND SAFETY COAL PROGRAM INSPECTION REPORT

Permit Number: C-1981-017 Mine Name: Coal Basin Mines Operator: Mid-Continent Resources Operator Address:	County: Pitkin Operation Type: Underground Permit Status: Revoked Ownership: Federal
	Operator Representative Present: None
Operator Representative Signature: (Field Issuance Only)

Inspection Start Date: June 18, 2013 Inspection Start Time: 13:00 Inspection End Date: June 18, 2013 Inspection End Time: 15:00	Inspection Type: Coal Complete Inspection Inspection Reason: Normal I&E Program Weather: Clear	
Joint Inspection Agency: None	Joint Inspection Contacts:	
Post Inspection Agency: None	Post Inspection Contacts:	
Inspector(s): Brock F. Bowles	Inspector's Signature:

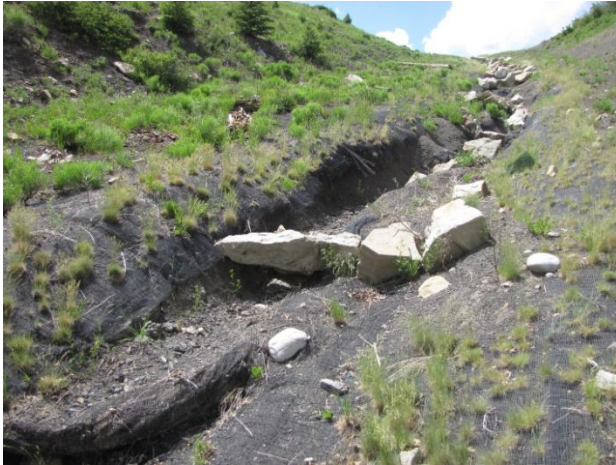
The checkdams in the ditch on the east side of the Sutey Pile have been compromised (photo 1). The ditch is deeply incised which dislodged the rock checkdams. The erosion matting placed in the bottom of the channel has eroded away and is balled up in many places along the ditch bottom. The erosion matting is in good condition above the third bench (photo 2). The little plastic check dams placed in the ditch bottom are loaded with sediment and have failed.

Photo 1 - Sutey Pile East Ditch

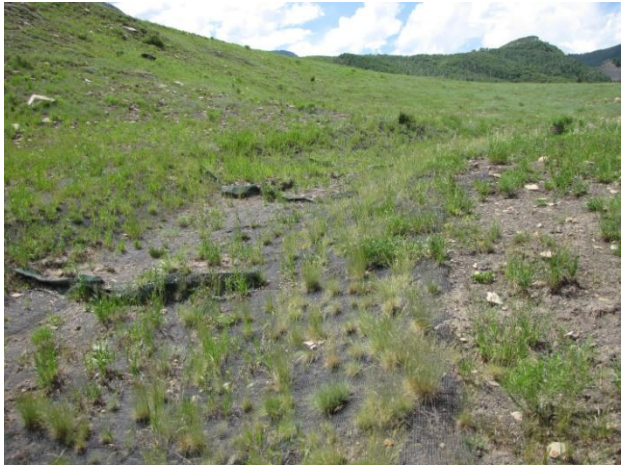
Photo 2 – East Ditch Above 3rd Bench

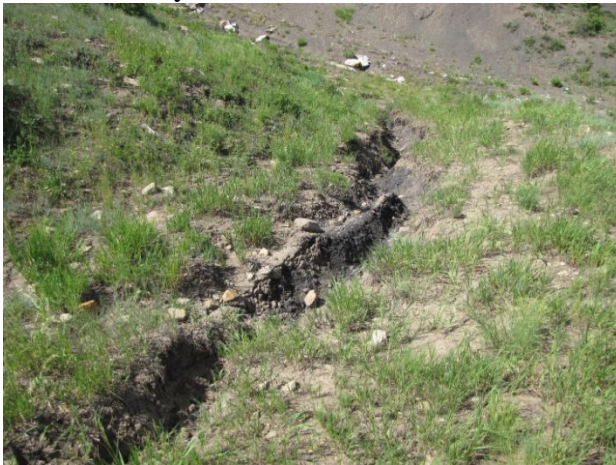
The first and second benches up the Sutey Pile each have a large gulley leading to the east ditch (photo 3).

Photo 3 – Gulley on Second Bench

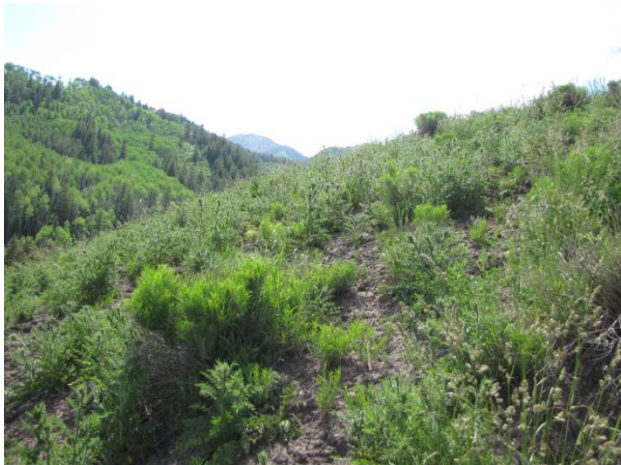
The vegetation on top of the Sutey Pile looked really good. It did not appear that cattle had been brought in to graze this area yet. Some of the species seen where: Rocky Mountain penstemon, orchard grass, Kentucky bluegrass, rubber rabbitbrush, yarrow, houndstongue, western wheatgrass, alfalfa, spruce trees, snowberry, dandelion, plumeless thistle, yellow sweet clover, smooth brome and scarlet gilia. The south side of the pile had significant amount of thistle plants (photo 4).

Photo 4 – Thistles on South Side of Sutey Pile
